Town of Chapel Hill Legion Pond Dam

Preliminary Engineering Report

May 2023

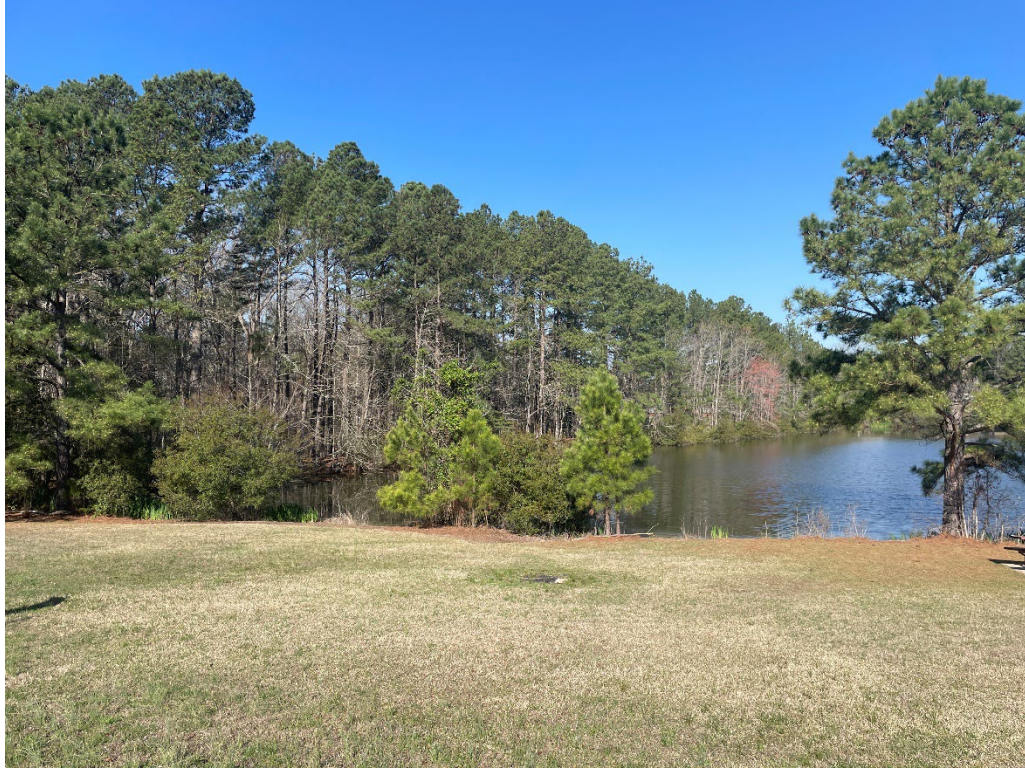
- **Upstream:** The visible portion of the upstream face of the dam is generally regular with a slope of approximately 3:1. The upstream face of the dam exhibits extensive mature tree growth with trees up to 17-inches in diameter

between the dam crest and the normal pool. Freeboard at the normal pool elevation is between 2.5-ft and 3-ft based on field observation. Heavy brush and undergrowth obscure approximately $\frac{1}{4}$ of the upstream face of the dam at the western end, preventing further visual assessment.

Photograph 1 – Impoundment Area and Upstream Dam Face from East Shore

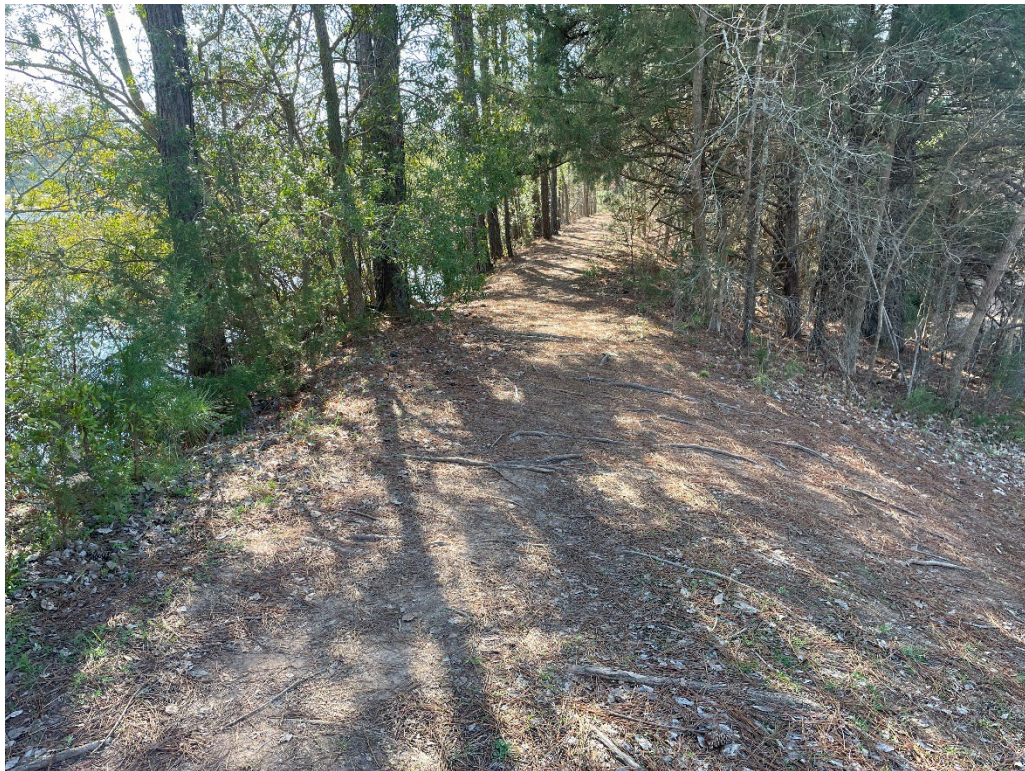
- **Crest:** The width of the dam crest fluctuates slightly between 8-ft and 10-ft and is approximately flat. The crest is covered with pine straw with intermittent, isolated stands of grass. No trees are present, however roots spanning the crest are visible at the ground surface.

Photograph 2 – Dam Crest Facing East from West Abutment

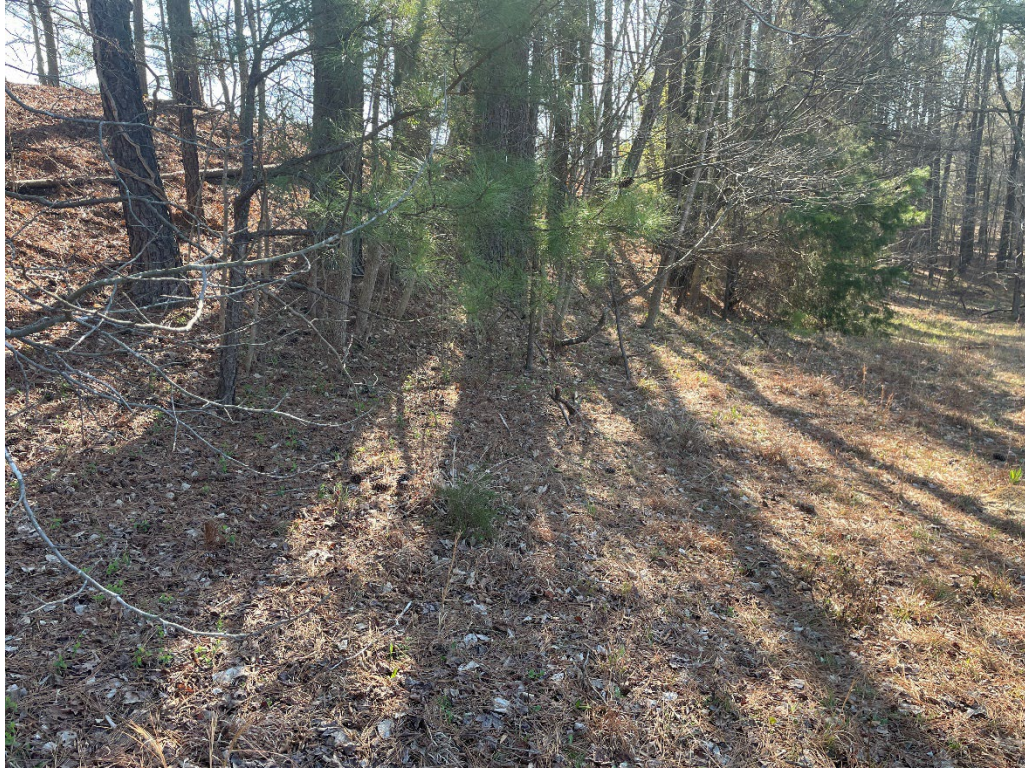
- **Downstream:** The maximum height of the dam, measured between the dam crest and the stream channel at the toe, is approximately 20-feet high according to 2015 bare-earth LiDAR data obtained from the North Carolina Emergency Management Spatial Data Download. Slopes are generally between approximately 1.5:1 and 2:1. Slopes are generally regular, with an erosion cavity beneath an outlet structure pipe joint. Tree growth is extensive end-to-end and top-to-toe, with mature trees up to 21-inches in diameter.

The most specific concern is the extensive pine tree vegetation on the downstream face of the dam. If any of the large pine trees were to blow over and expose the root ball, a dam failure could become possible.

Photograph 3 – Downstream Face, Facing East from Western Groin

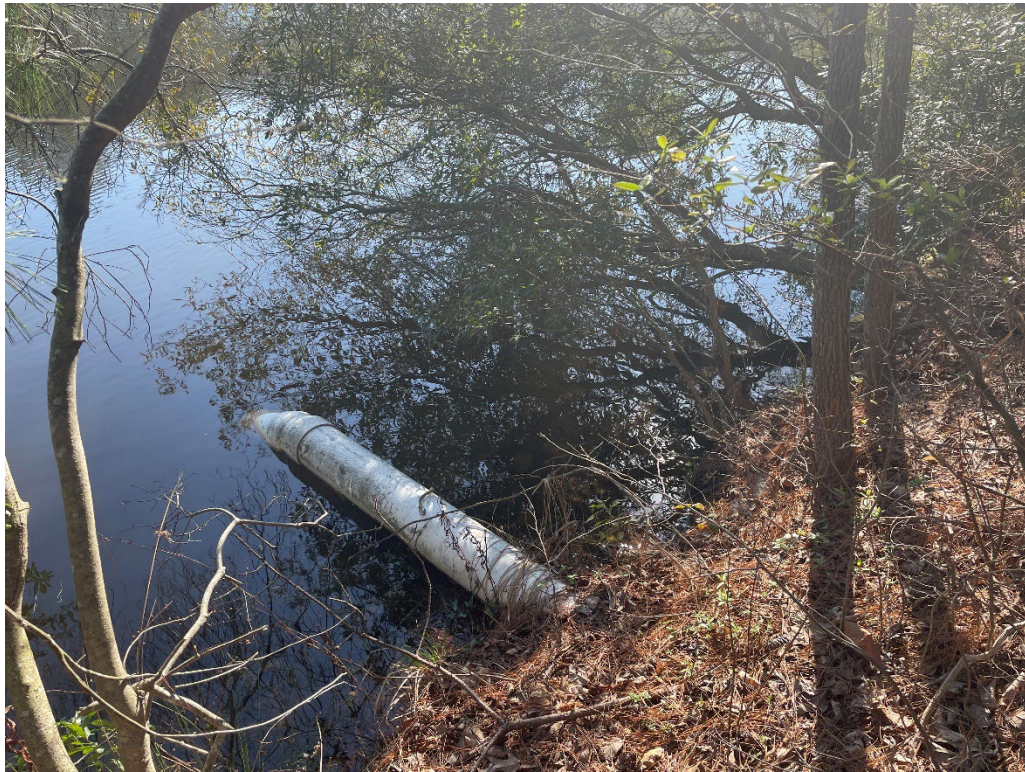
Photograph 4 – PVC Overflow Device Inlet

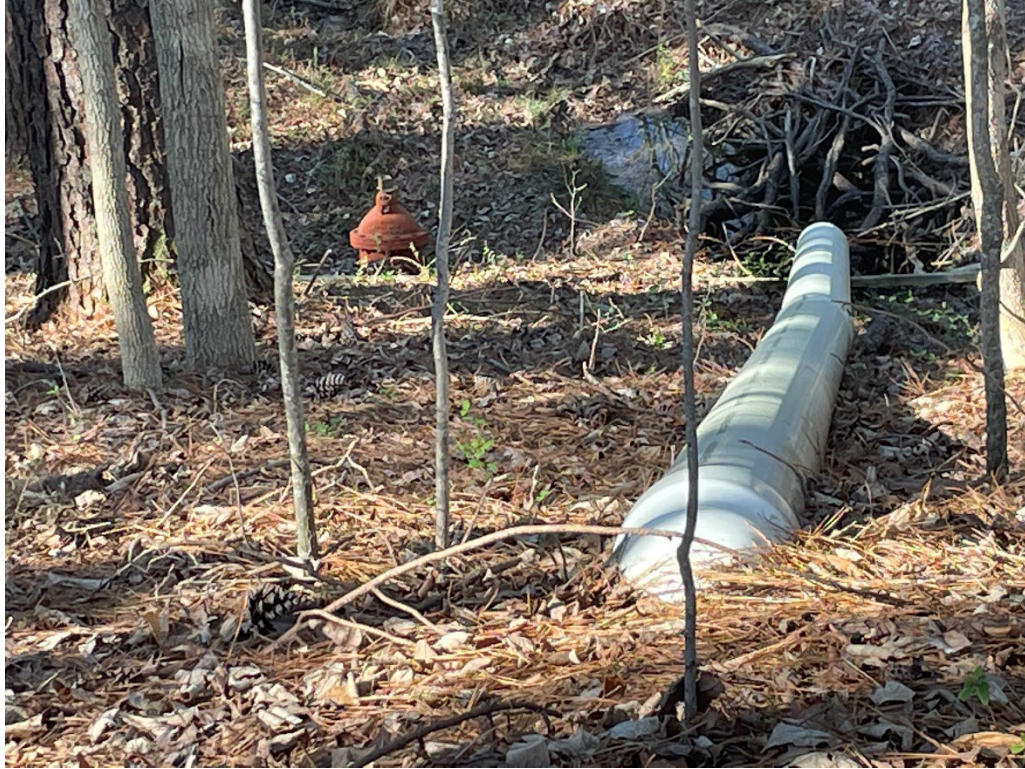
- **Outlet Structures:** Observed outlet structures include the original ductile iron pipe outlet, an 8-inch PVC pipe overflow device, and an approximate 10'-wide emergency spillway on the eastern abutment of the dam. The inlet of the original outlet structure was submerged and could not be observed. The downstream end of the original outlet structure includes a ductile iron butterfly valve that was closed at the time of observation. None of the observed outlet structures included energy dissipating structures. All outlets discharge to a well-defined drainage channel.

Photograph 5 – Overflow Outlet and Primary Outlet Valve from Dam Crest

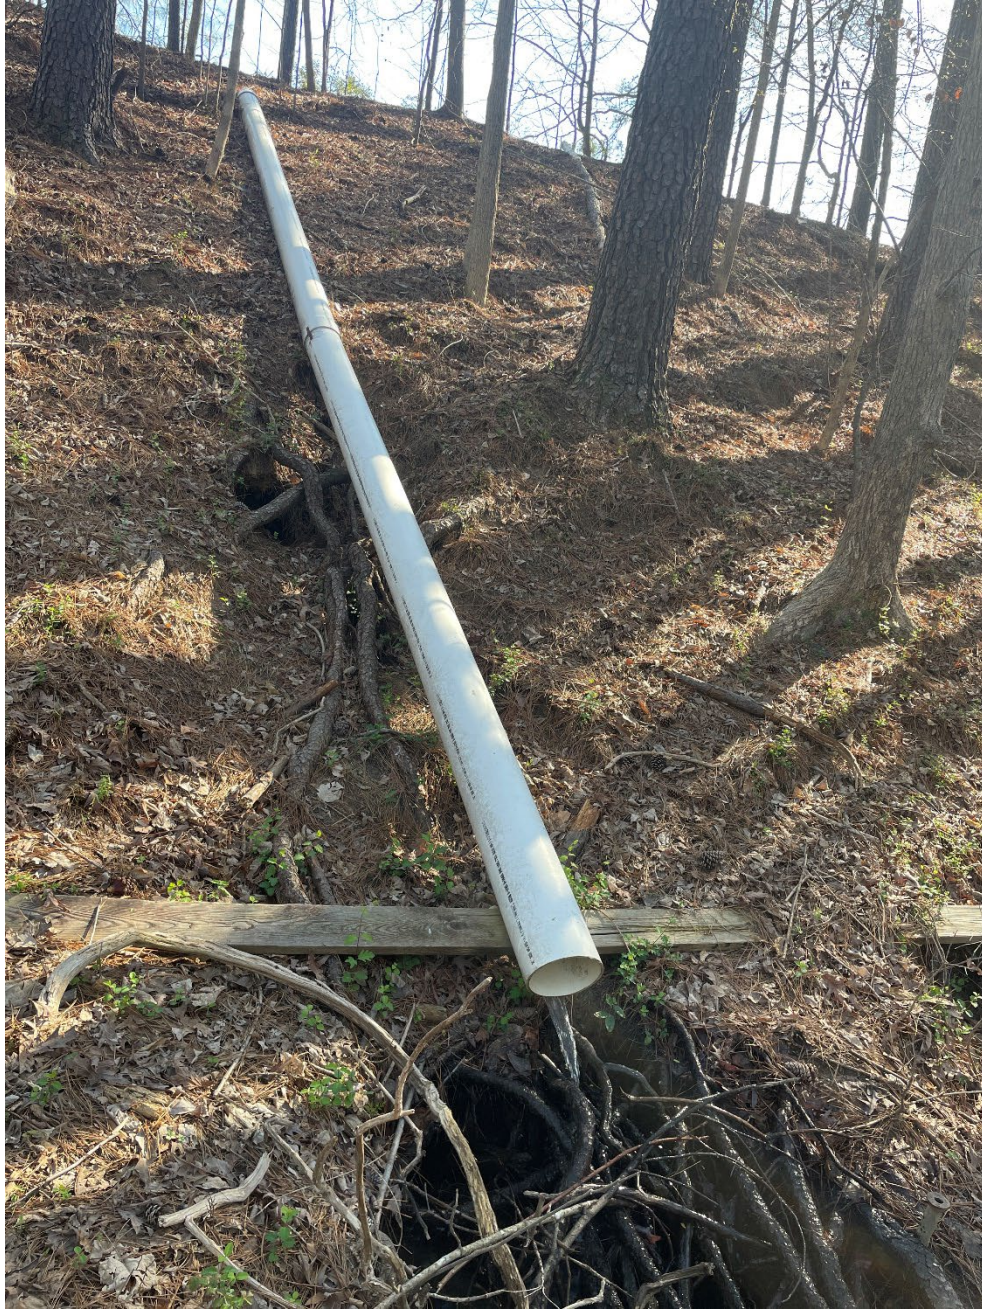
Photograph 6 – Overflow Device Outlet, Erosion Cavity Below Repaired Joint, Erosion Cavity at Outlet

Dam Repair: Dam repair will include dewatering the pond, riser barrel structure replacement, and a filter diaphragm, an outlet energy dissipater, and a drainage blanket will be added.

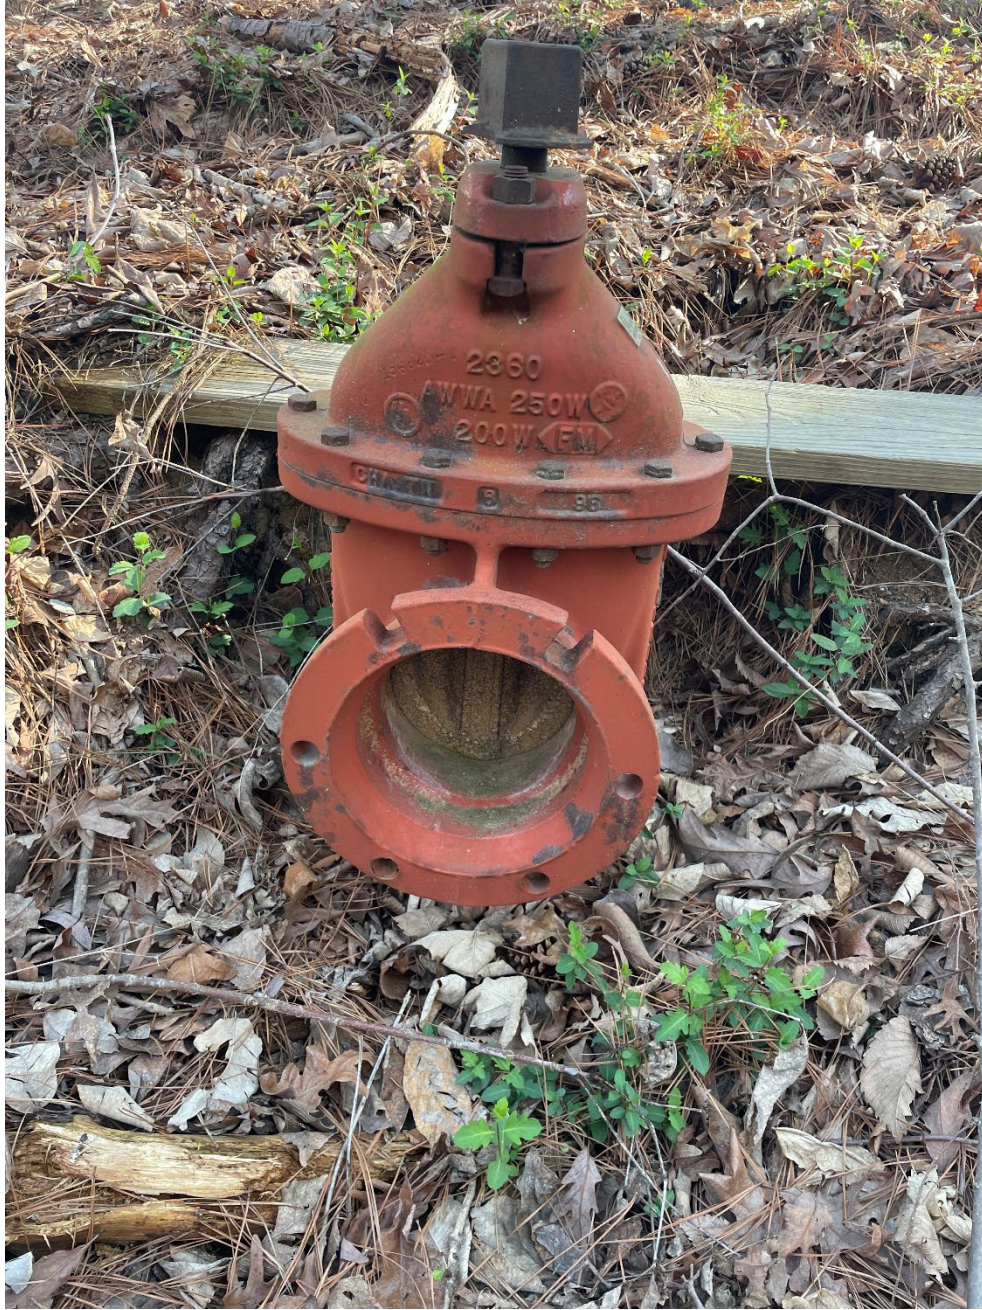
Photograph 7 – Butterfly Valve at Downstream End of Primary Outlet

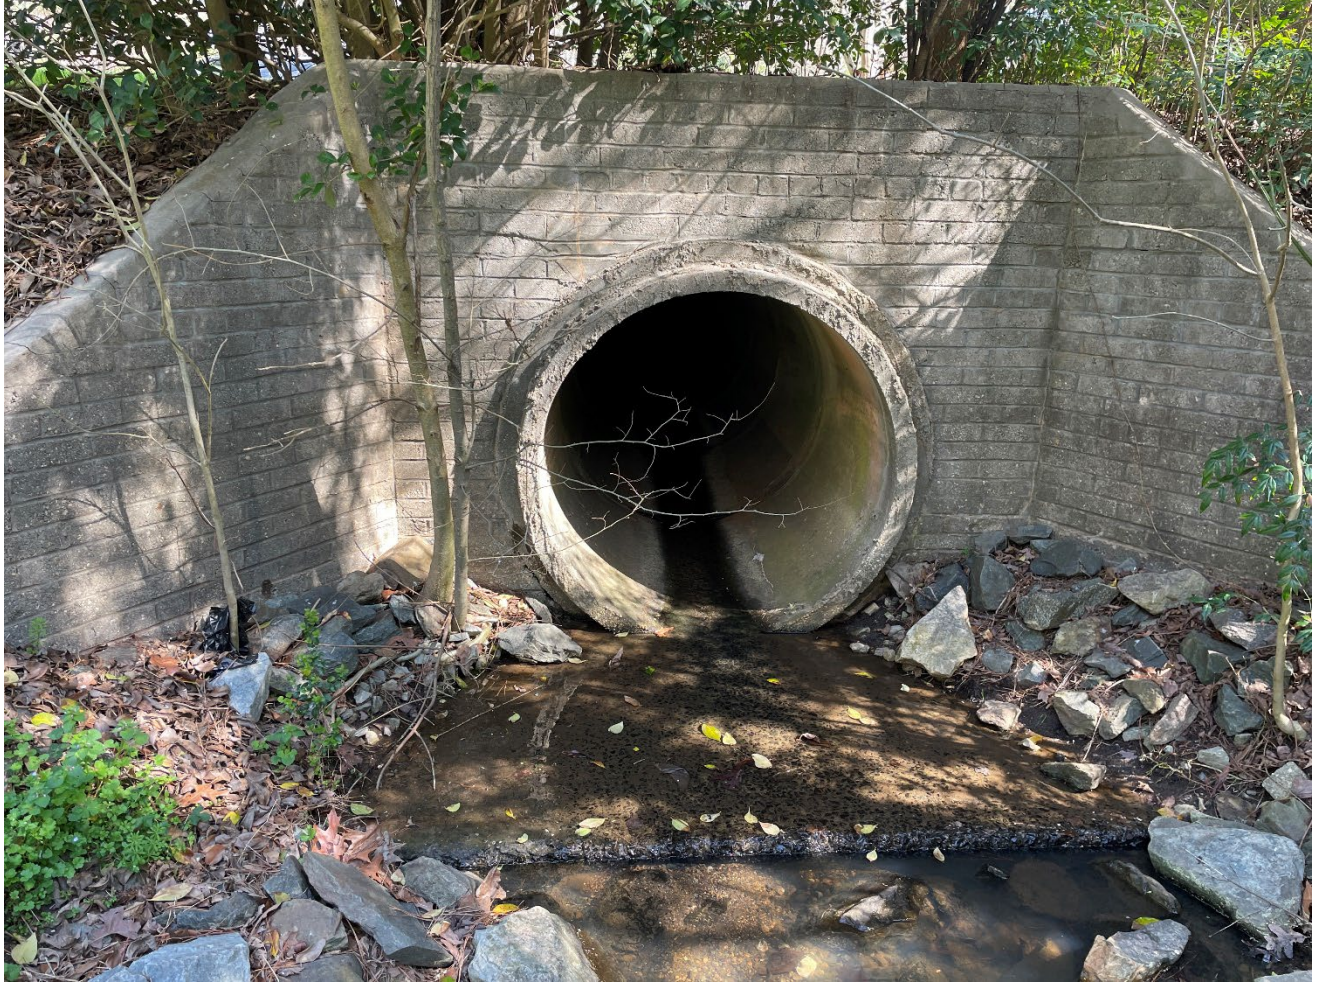
- **Downstream Channel:** The dam outlets discharge to well-defined drainage channel. Private residences are adjacent to the drainage channel ranging between 50 ft and 200 ft (measured horizontally) from the channel. The drainage channel enters a single 102-ft long 48" reinforced concrete pipe culvert under Clover Drive approximately 900 ft to the southwest of the dam. Clover Drive is classified as a local road maintained by the Town and is the only means of ingress and egress for The Meadows subdivision, which contains 54 residences. The channel then daylights for approximately 300 feet before entering a 509-ft long culvert underneath Ephesus Church Road. Ephesus Church Road is classified as an arterial road maintained by NCDOT.

Photograph 8 – Pipe Culvert Outlet at Clover Drive
