Chapel Hill Historic District Certificate of Appropriateness Application	Project:	18-126
Project Description: Replacement and Repair of Fire Escapes at 233 & 235 McCauley Street	Permit:	
	STAFF REVIEW	
	<input checked="" type="checkbox"/> Application complete and accepted	
	<input type="checkbox"/> Application not complete and returned with a notation of deficiencies	
Instructions: Submit one paper copy and a digital copy of all application materials collated in one file (pdf preferred) Deadlines: Applications are due by the close of business 30 calendar days prior to the scheduled meeting date. Note: Only complete applications may be accepted for Certificate of Appropriateness review. Applications that are not complete will be returned with a notation of deficiencies.

COA Application Section A. Property Information

PROJECT NAME:	233 & 235 McCauley Street Fire Escape Assessment	PROJECT NO.:	17-409
PROJECT ADDRESS:	233 & 235 McCauley Street Chapel Hill, NC 27516	FIELD REPORT NO.:	SUMMIT - 1
		DATE:	09/11/2017
Owner:	Ted Parenti, Rampart Management	REPORT DISTRIBUTION:	OWNER <input checked="" type="checkbox"/> ARCHITECT <input type="checkbox"/> CONSULTANT <input type="checkbox"/> F

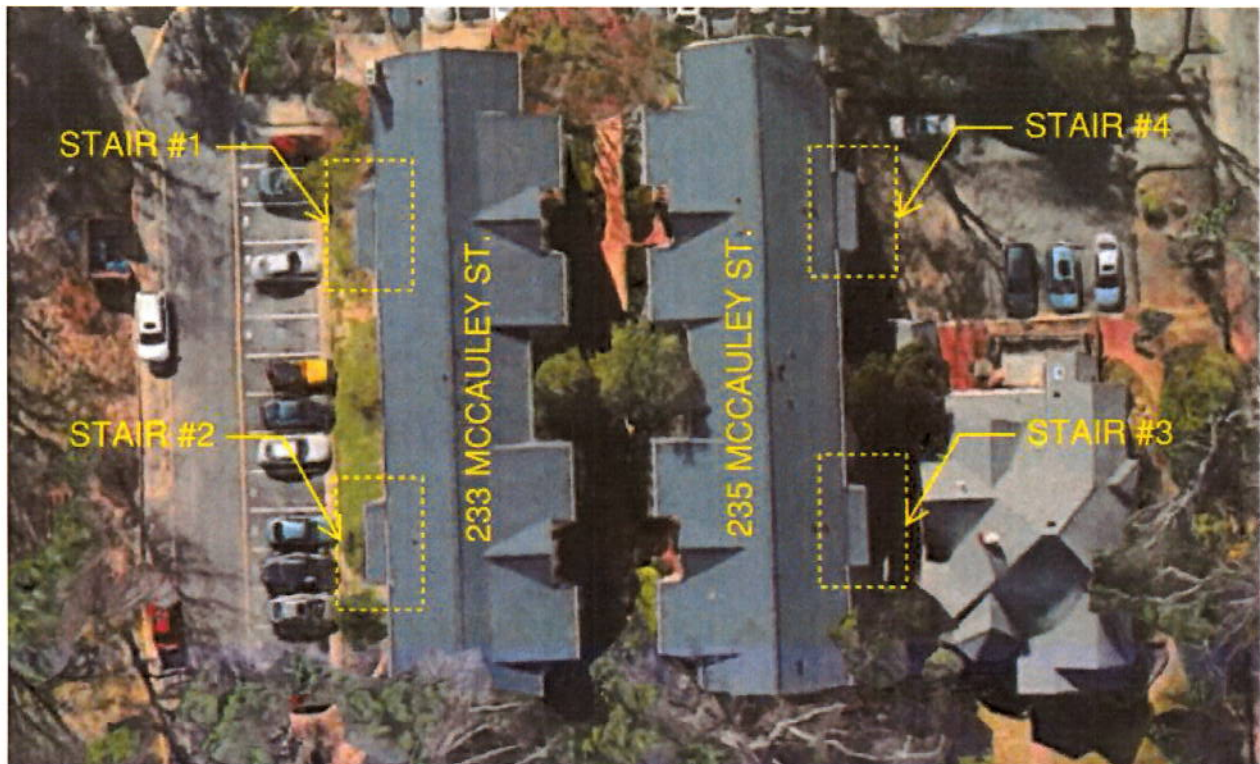
IMAGE 1 – Aerial Overview

See **IMAGE 1** for a labelled aerial overview of the stairs and their associated number designation as further referenced within this report. The condition of each stairway will be addressed in the subsequent sections.

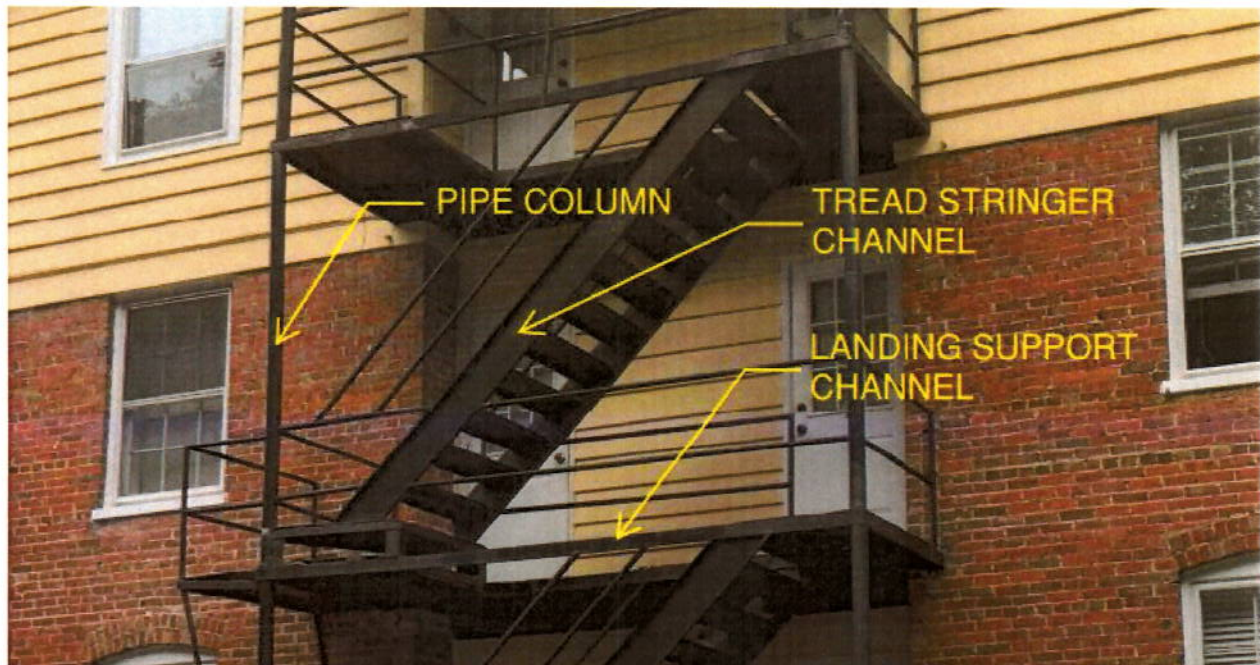
IMAGE 2 – Member Label Reference

The Town of Chapel Hill Inspections Division letter to Rampart Management dated August 23, 2017, has specified that the stairway structures should be evaluated for a 100 psf applied load. Three members were evaluated for their fitness to support the specified loading condition: landing support channels, tread stringer channels, and pipe columns; see **IMAGE 2** for member label reference.

The landing support channels were measured at a 3-inch depth, with a flange width and thickness of 1 inch and 1/4 inch, respectively. Calculations show that the landing support channels are not adequate when evaluated against the demand loads as defined by the Town of Chapel Hill. The tread stringer channels were measured at a 10-inch depth, with a flange width and thickness of 1.5 inches and 1/4 inch, respectively. Calculations show that the tread stringer channels are adequate. The pipe columns were measured at a 3-inch diameter, and the section was assumed to be a P3 STD pipe section. Calculations show that the columns are adequate.

The four stairs assessed at the subject address require, at a minimum, maintenance repairs by removal of rust and replacement of heavily corroded members and welded connections. Further, the landing support framing (see **IMAGE 2**) requires reinforcement of the existing members or replacement with a larger section to meet the demand load requirements as defined by the Town of Chapel Hill. In addition to these basic requirements, it is our strong recommendation that the handrails be replaced with a present code compliant system, further outlined in the attached Architects Field Report. It is our opinion that besides the corrosion problems, the existing handrail system is the greatest safety concern regarding the stairways.

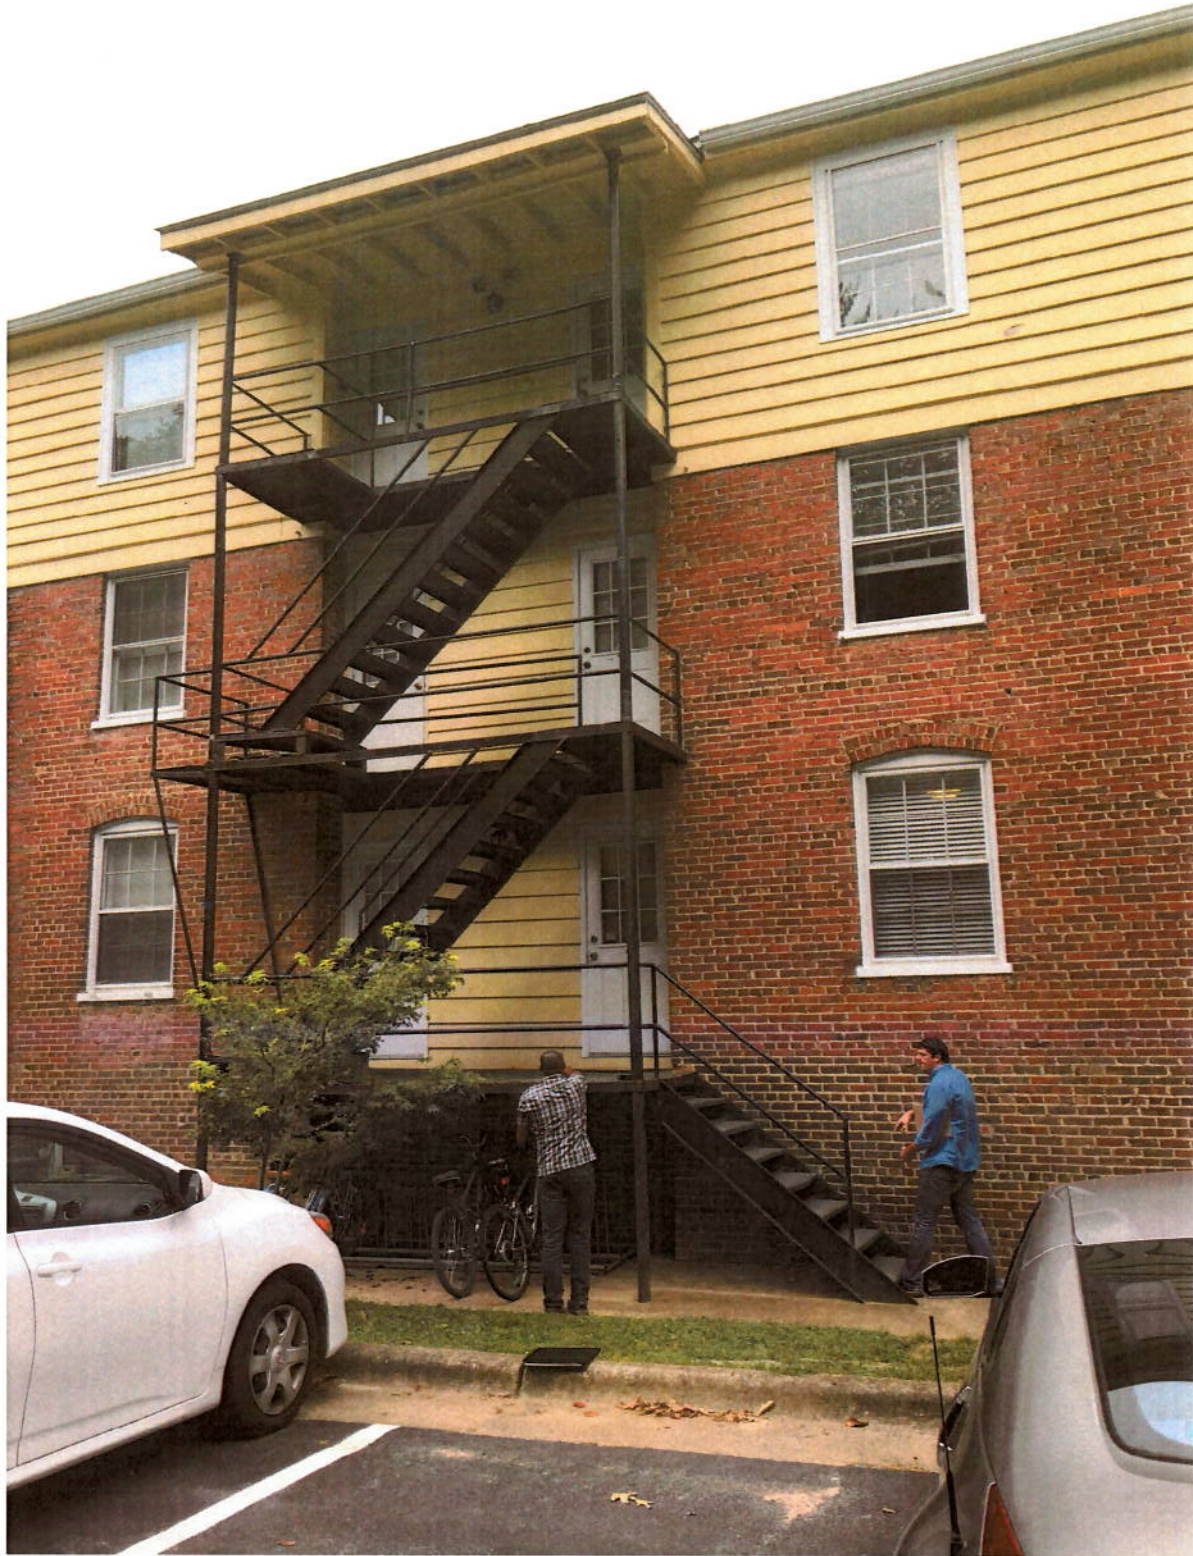
IMAGE 3 - Stair #1 Overall

An overall image of the stairway can be seen in **IMAGE 3**. The checkered plate deck which comprises the landing surface of the stairway is heavily corroded. The corrosion is most significant at the perimeter of the landing and joints between individual plates (See **IMAGE 4-7**). Most of the weld between the deck and the perimeter framing has corroded away, which is evidenced by the deck curling or bubbling upward from the support framing below (See **IMAGE**

It is our professional opinion that stairs #1 and #2 will require repairs which exceed fifty percent of the structure's value. Therefore, the stairways should be brought up to present code requirements: maximum rise to run of tread, egress turn dimensions, etc. The footprint of these stairways is not sufficient to meet these requirements. Complete removal and replacement of stair #1 and #2 is recommended.

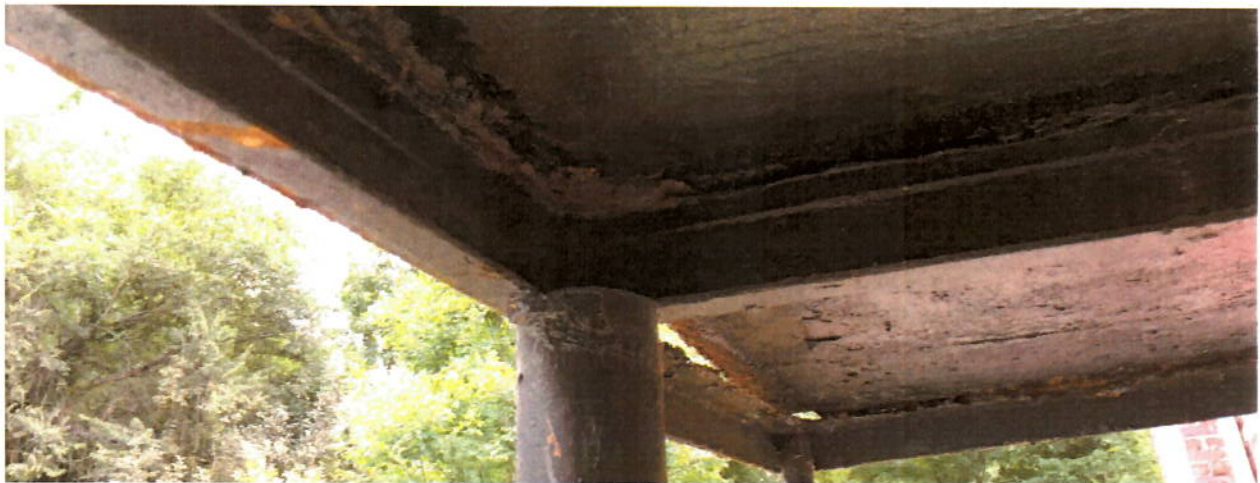
IMAGE 8 – Stair #1 Landing Deck

8). Framing members which are in contact with the plate deck have experienced varying degrees of corrosion; some members having lost nearly all the cross-sectional area and connection welds (See **IMAGE 9**). The checkered plate stair treads have varying degrees of surface to deep penetration rusting, located predominately on the underside of the plate and at the end connection to the stringers (See **IMAGE 10**). Some treads appear to have been repaired in the past by the addition of an angle support at the connection to the stringer; the repair angles are mostly in a similar state of corrosion (See **IMAGE 11**). The connection to the building structure on the inside of the stairways appears to be angles slotted into grout joints of the structural brick exterior wall (See **IMAGE 12**).

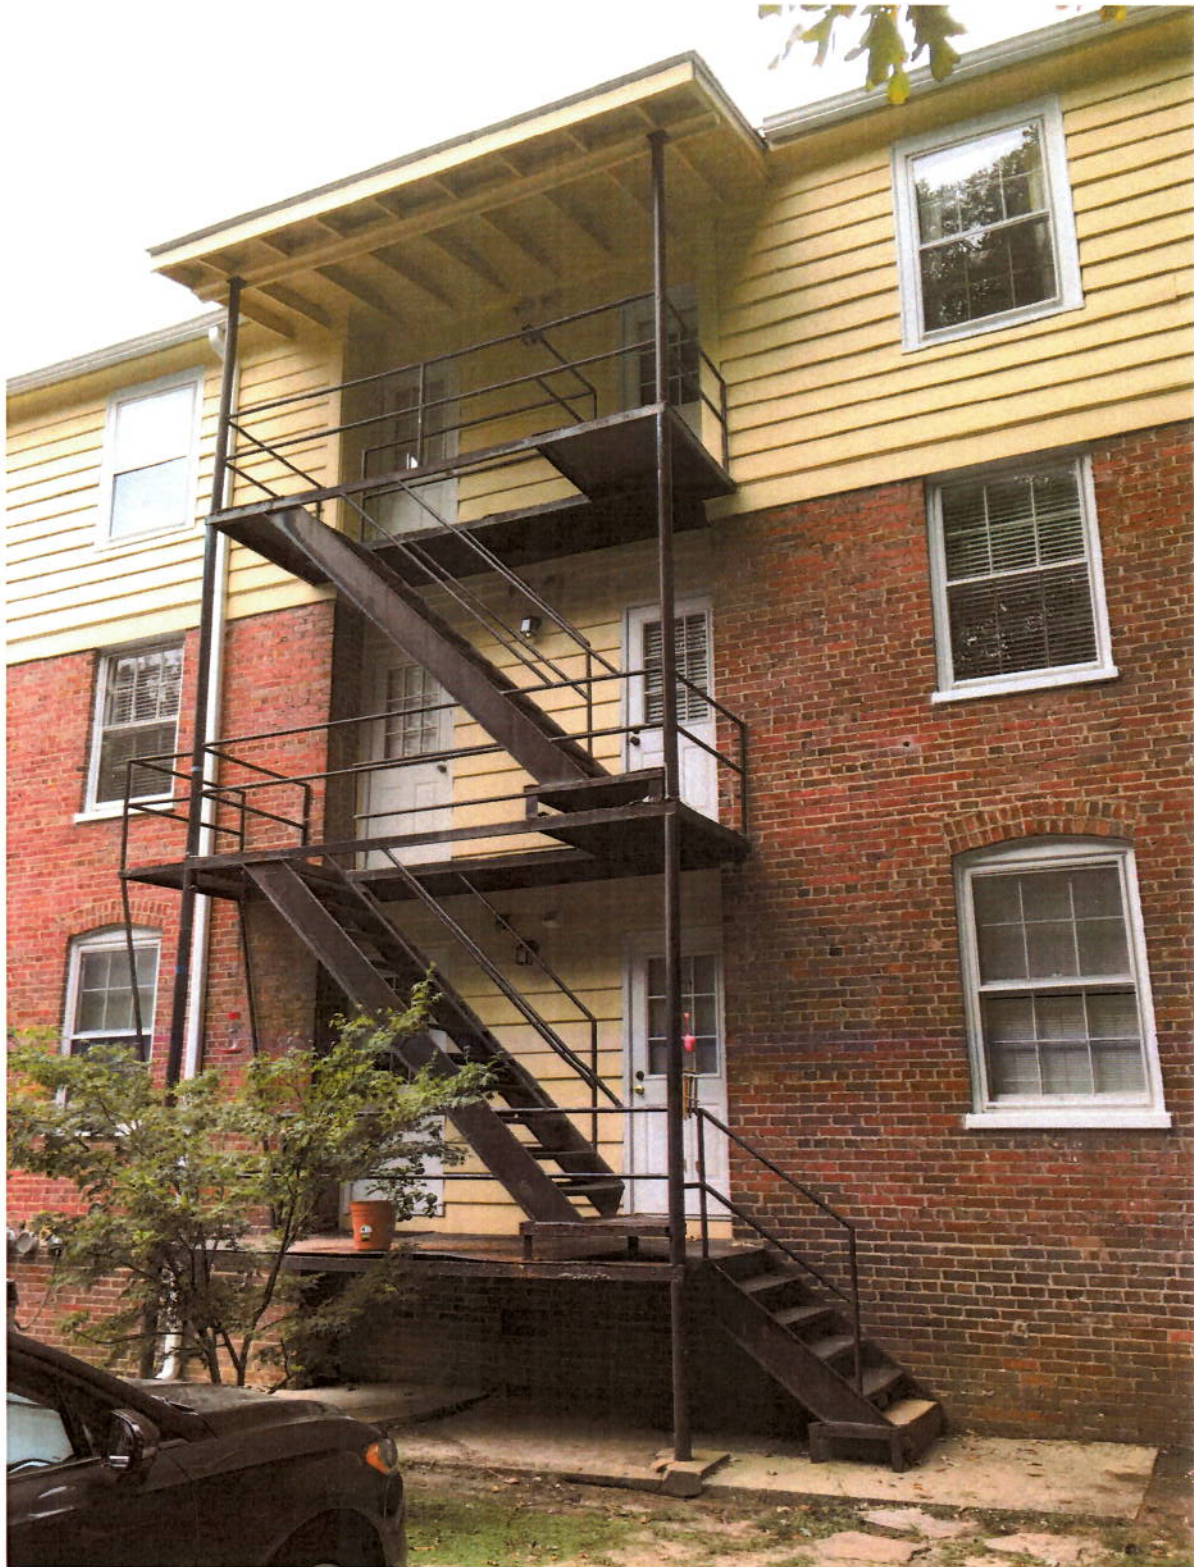
IMAGE 13 – Stair #2 Overall

An overall image of the stairway can be seen in **IMAGE 13**. A similar level of corrosion damage is present on stair #2 as stair #1. The checkered plate decking has experienced significant loss of area in several locations (See **IMAGE 14-17**). The deck has bubbled and curled upward from the support framing predominately at the landing perimeter and joints between decking pieces. Welds between the deck and support framing are compromised or non-existent in several locations. Framing members have some loss of area due to corrosion, mostly in locations where in contact with the plate decking. The stair treads are in varying degrees of corrosion, with some treads experiencing near full loss of area and welds at the connection to the

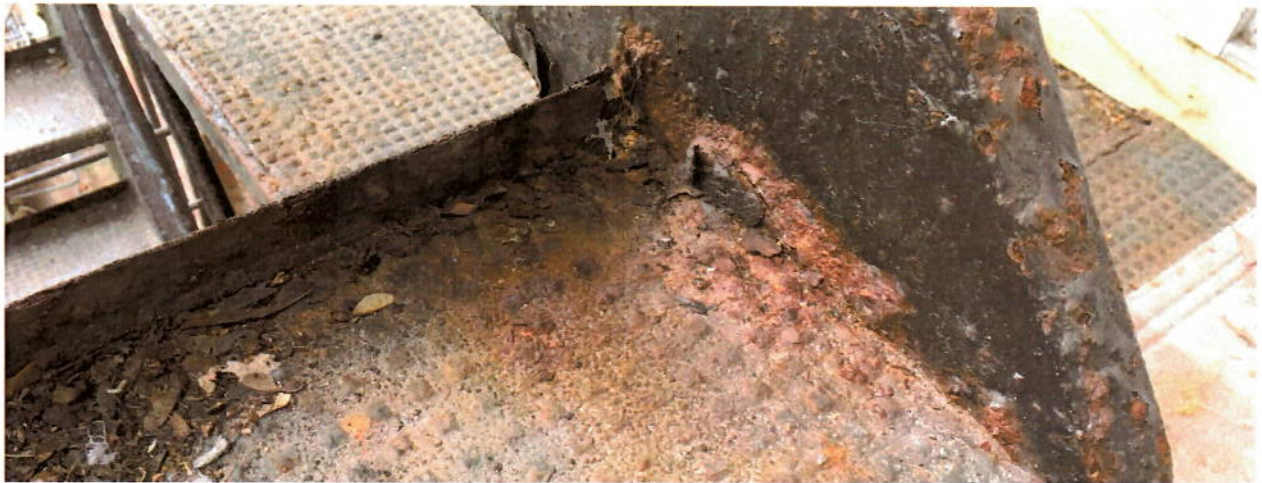
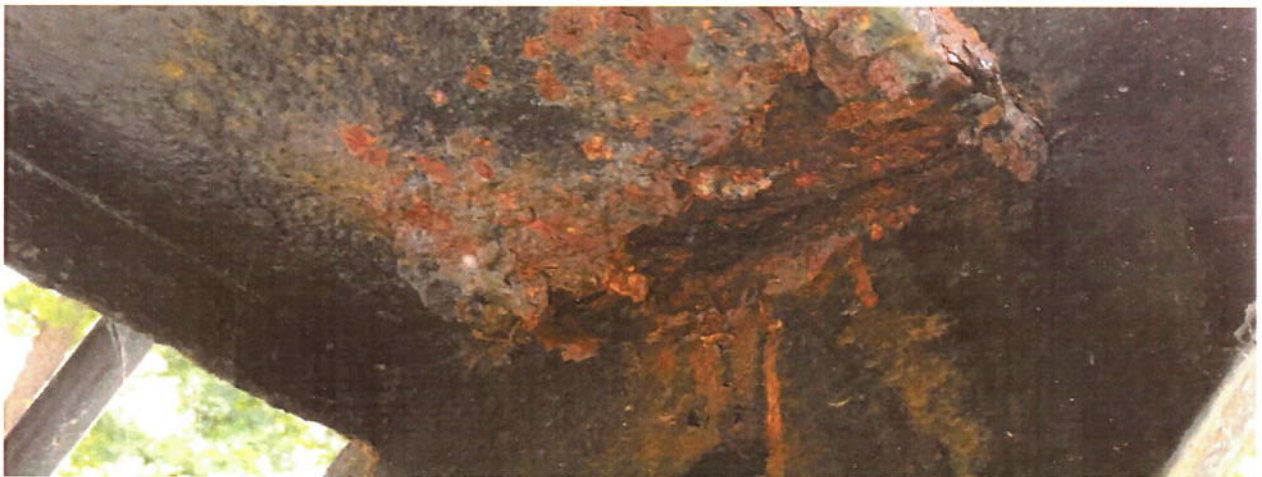
stringers (See **IMAGE 18-19**). It appears select locations were repaired in the past with the addition of a support angle at the tread to stringer connection (See **IMAGE 20**). The pipe columns are connected to a concrete grade slab. It is typical for these foundations to extend below the frost depth to eliminate yearly frost heave during the transition of seasons from winter to spring. It was observed that the foundation sits inches below the grade elevation with no additional footing extending below the frost depth (See **IMAGE 21**). Significant splitting of the foundation slab was observed; the slab does not contain any steel reinforcement in the form of a welded wire frame or deformed rebar (See **IMAGE 22**).

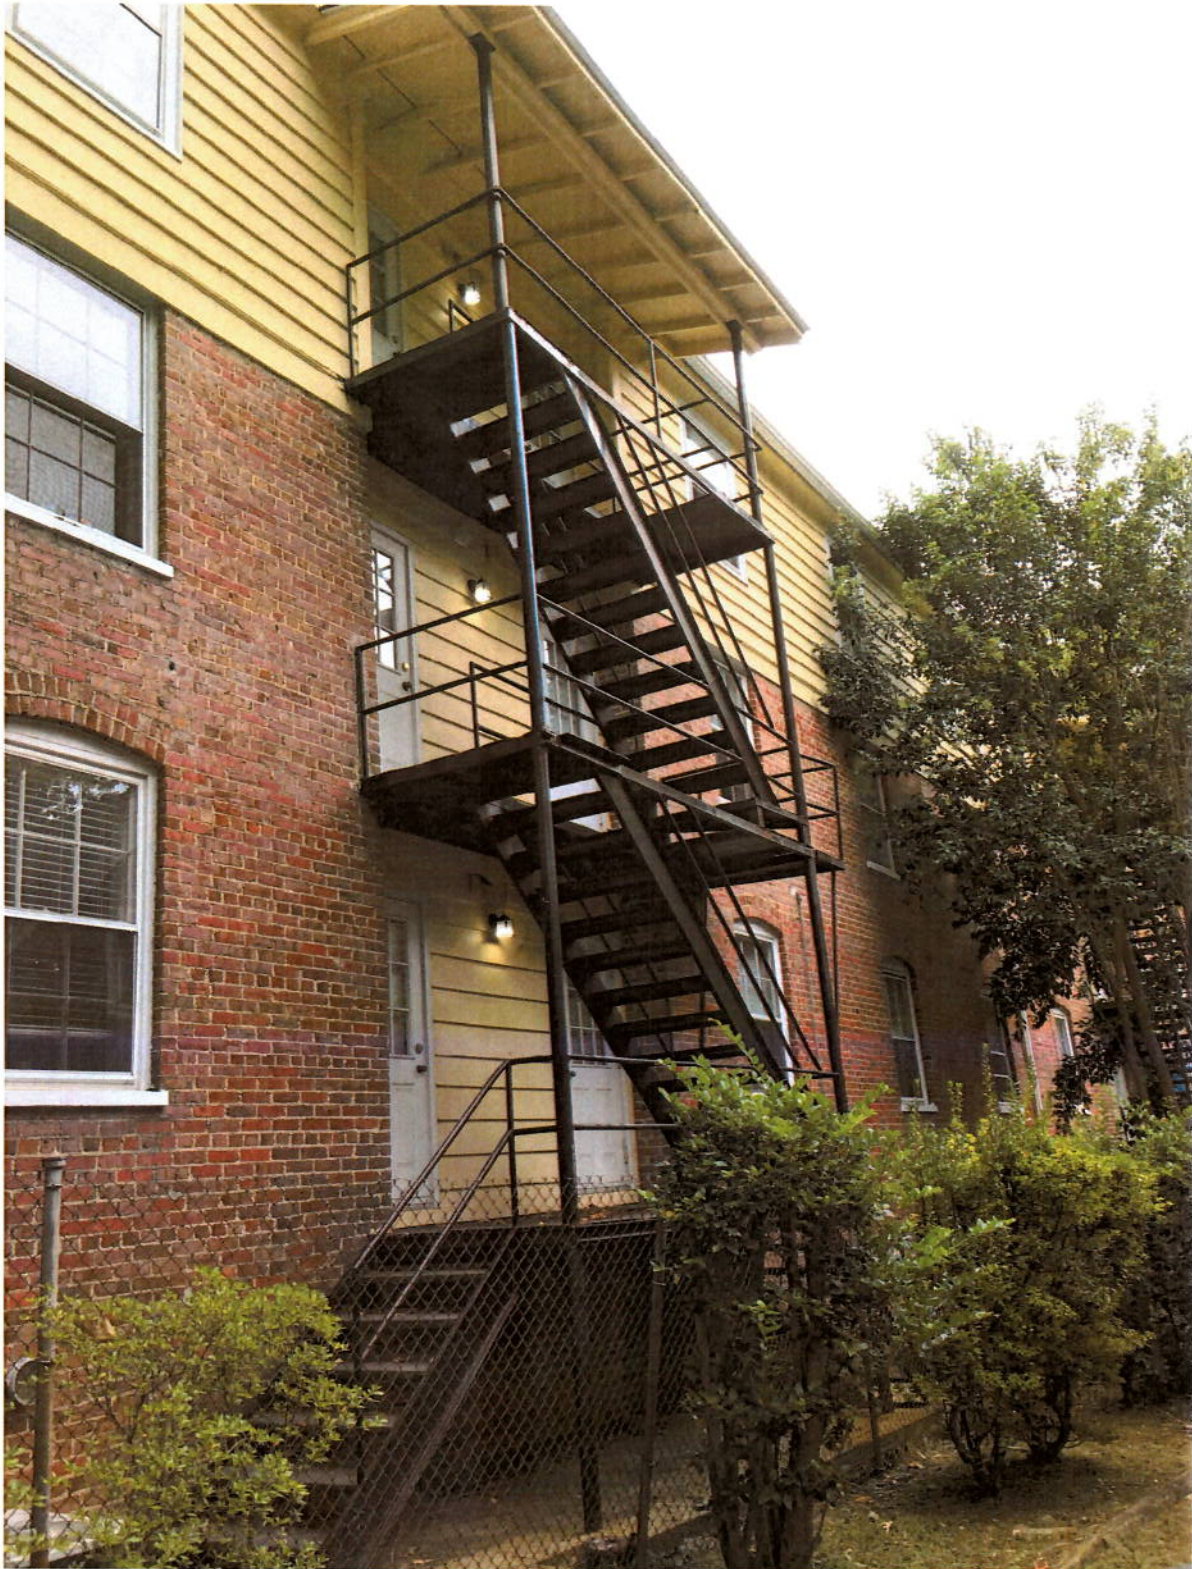
IMAGE 23 – Stair #3 Overall

An overall image of the stairway can be seen in **IMAGE 23**. The stairway is in better condition than noted for stairs #1 and #2. The corrosion of the stair structure is mostly limited to the perimeter and joints of the checkered plate decking, as well as connected framing surfaces (See **IMAGE 24-26**). Similar bubbling of the decking was observed, with most perimeter welds no longer connecting the deck to the support framing. Some of the support framing has concerning loss of area at locations with heavily corroded deck, with most of the framing having minor surface rust at the top flange. Some of the stair treads and connection welds are in poor conditions, with significant loss of area due to long term corrosion (See **IMAGE 27-28**). A portion of these members appear to have been repaired in the past by the addition of a support angle. The connection of the stairway to the building is unique to those observed for stairs #1 and #2 (See **IMAGE 29**). A vertical angle is connected to the perimeter framing, and bolted into the brick wall.

It is our professional opinion that stairs #3 and #4 is in a condition such that the repair and reinforcement cost will not exceed the fifty percent threshold. As previously noted, complete removal and replacement of the handrail system to meet present code requirements is advised. A repair and reinforcement plan would be the next step towards being the stairways into operating condition.

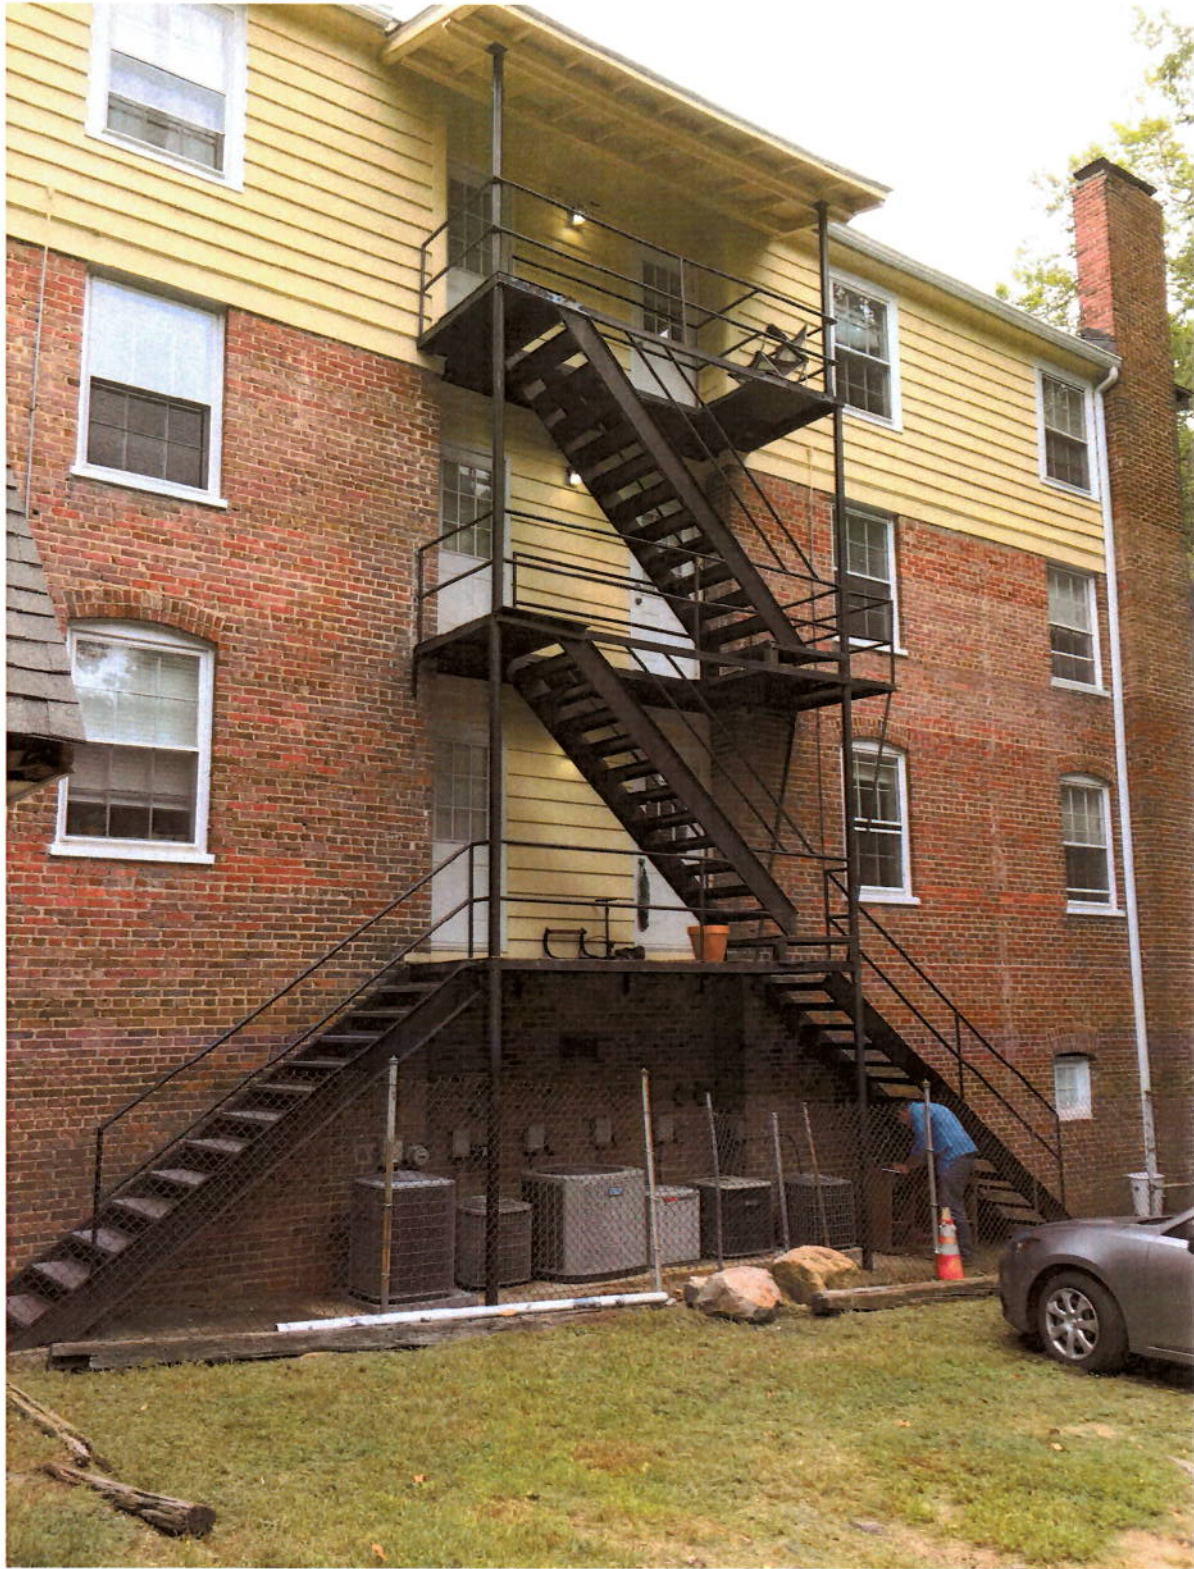
IMAGE 30 – Stair #4 Overall

An overall image of the stairway can be seen in **IMAGE 30**. The stairway is in similar condition as noted in stair #3. At the perimeter of the checkered plate decking, corrosion has degraded the steel significantly. At these locations connecting welds with the support framing have rusted away. Support framing members adjacent to the heavily corroded deck see similar levels of degradation at the contact surfaces (See **IMAGE 31-34**). Select stair treads have significant rust penetration, predominately on the underside and at the welded connection to the stringers (See **IMAGE 35**). Angle reinforcement of treads was observed at some locations like those previously noted. Connection of the stairway with the building is the same as stair #3 (See **IMAGE 36**).

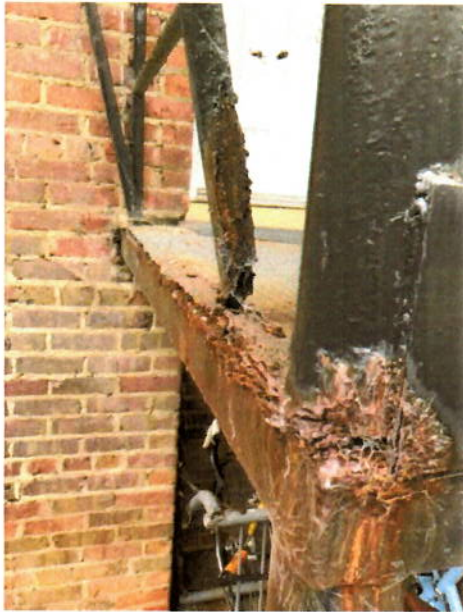
Photo 01

Fire Escape #1 Landing

- Diagonal brace weld compromised
- Heavy rust and corrosion

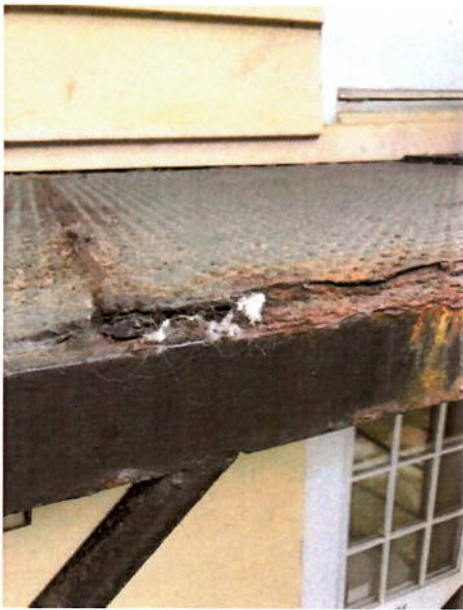
Photo 02

Fire Escape #1 Landing

- Heavily corroded deck, typical

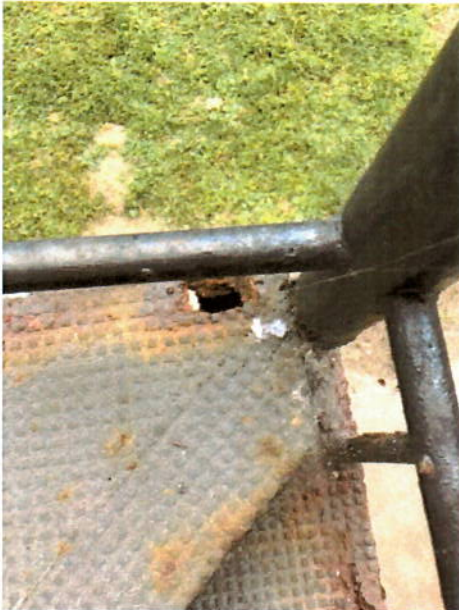
Photo 03

Fire Escape #1 Landing

- Hole in deck due to rust

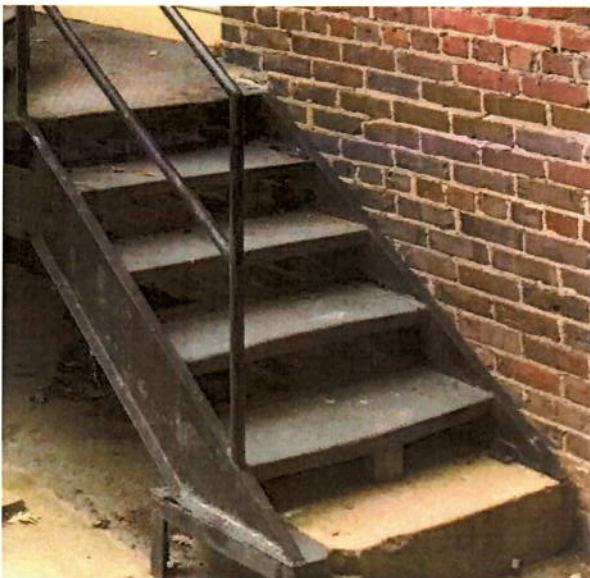
Photo 04

In addition to the General Life Safety and Building Code Observations, this fire escape presents another life safety issue that is a cause for concern: The first riser at grade is 8" high concrete pad and the remainder of the risers are roughly 6 ¾" high. This irregular riser creates a tripping hazard.

Fire Escape #2, at grade

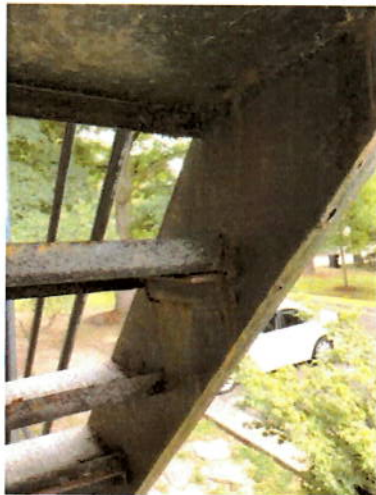
Photo 05

Fire Escape #1 Tread Support

- Support angle present at some treads, but not present at others

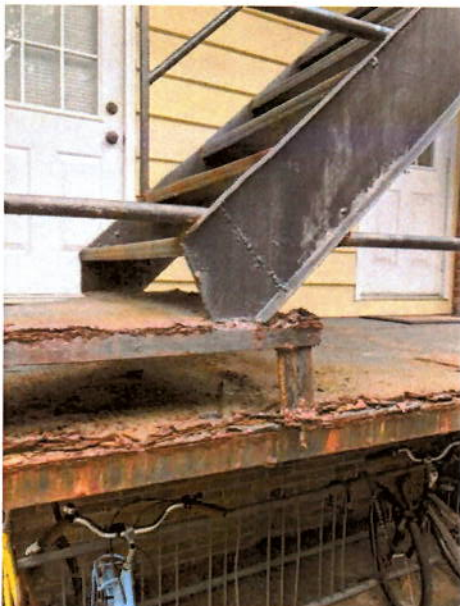
Photo 06

- Different riser heights, typical for all fire escapes
- Also depicted is that residence finish floor is approximately 6" above the landing height, typical

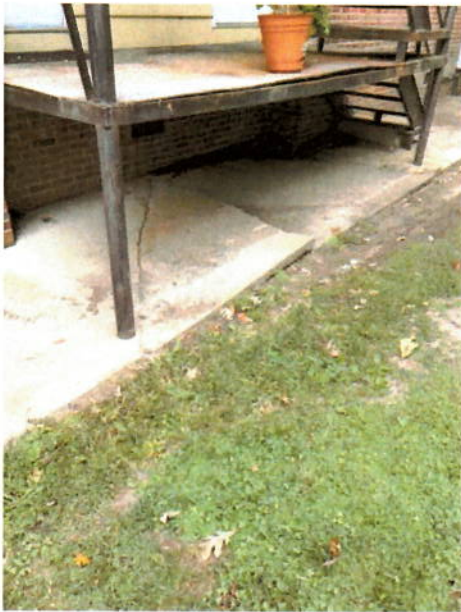
Photo 07

- Discontinuous pipe columns, typical.
- Current photo shows the settlement at Fire Escape #2 as well.

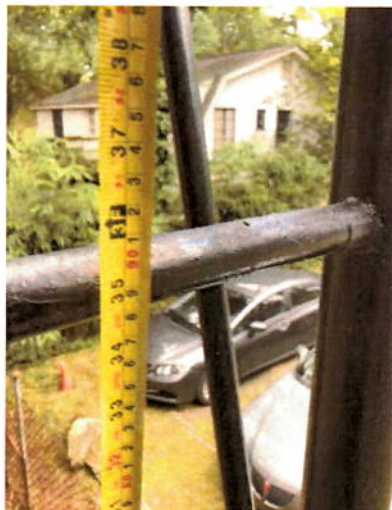
Photo 08

- Railing height is approximately 36" above landing height, typical.
- Also note that there are no vertical balusters to prevent falling through the structure.

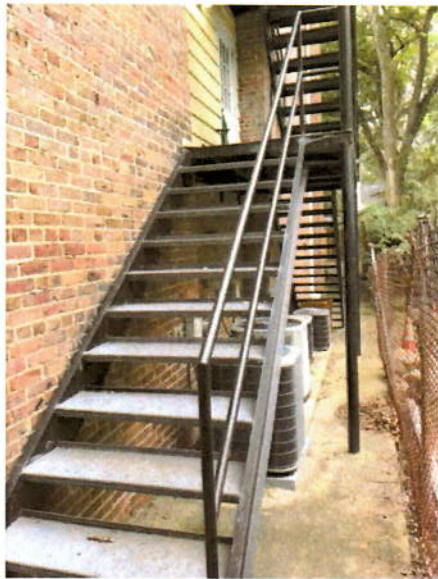
Photo 09

Fire Escape #3 & #4

- Proximity of stair to fence makes travel to parking lot difficult.
- There is no barrier under the stringer to prevent people from walking under the stairs.
- Open risers

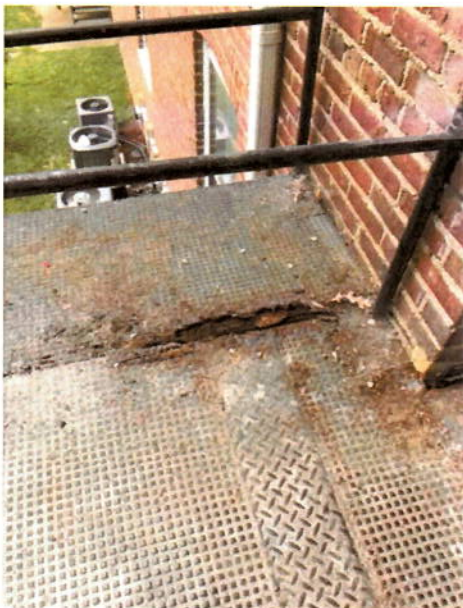
Photo 10

- Holes in deck due to rust, typical.

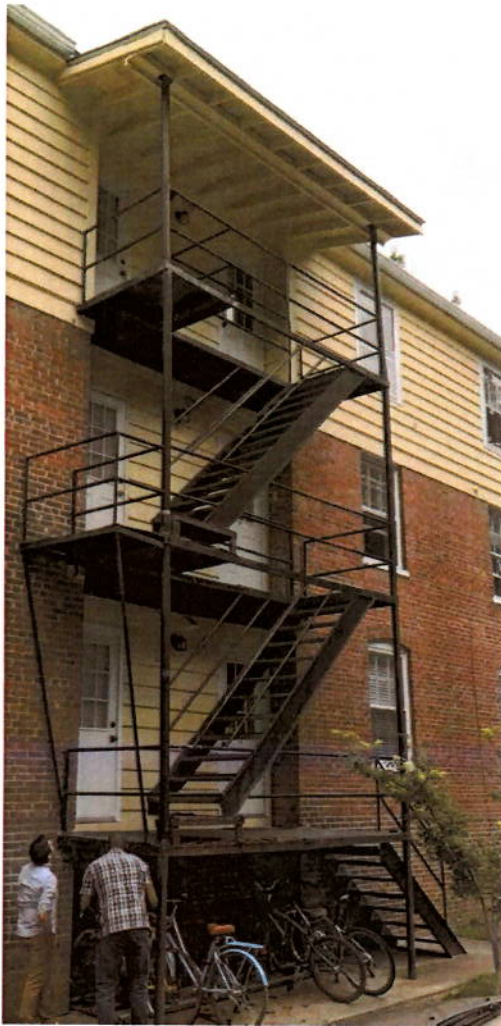
Photo 11

- Image shows the overall picture of the fire escapes. The open railing presents a safety issue

Therefore, we recommend removing the existing fire escapes and replacing with new stairs that are compliant with the North Carolina Building Code.

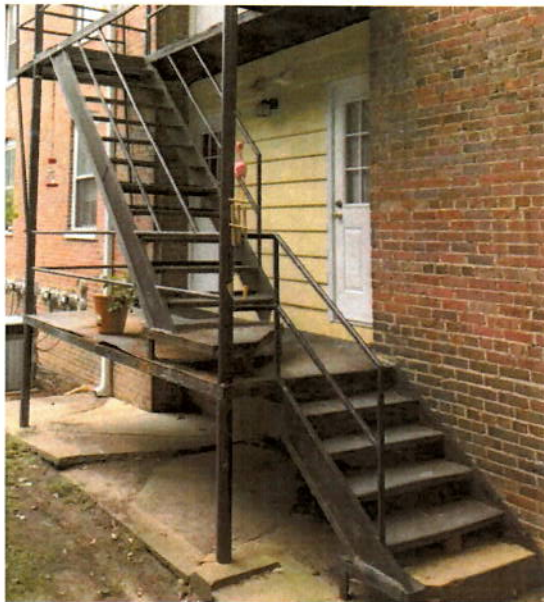
Photo 12

- No continuous handrail present, typical.
- No barrier under stringer, typical.
- Triangular riser & next riser encroaches on 36" clear width, typical.

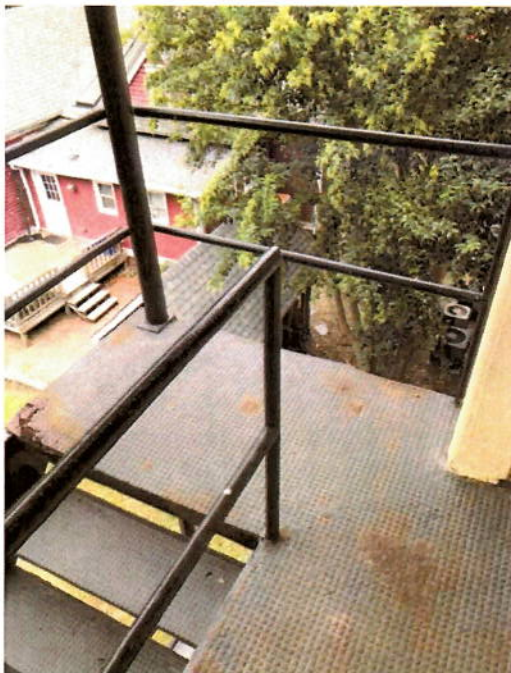
Photo 13

- Clear width of travel reduced at building corners, typ.
