### HDC-23-34

Historic District

211 GLENBURNIE ST  
CHAPEL HILL, NC 27514

RE: Fields - 211 Glenburnie COA Application Amendment

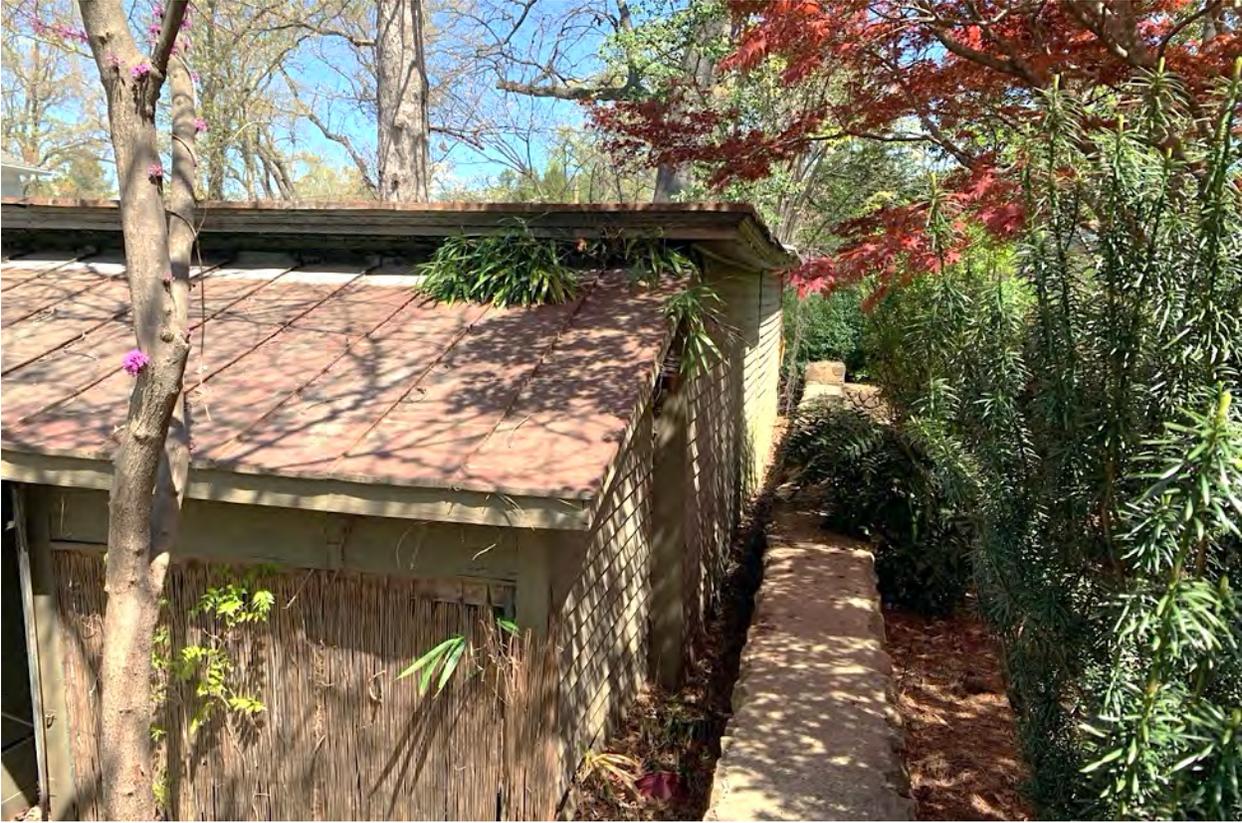
Rear (South) elevation of garage – Note: limited view is due to encroachment on neighboring property

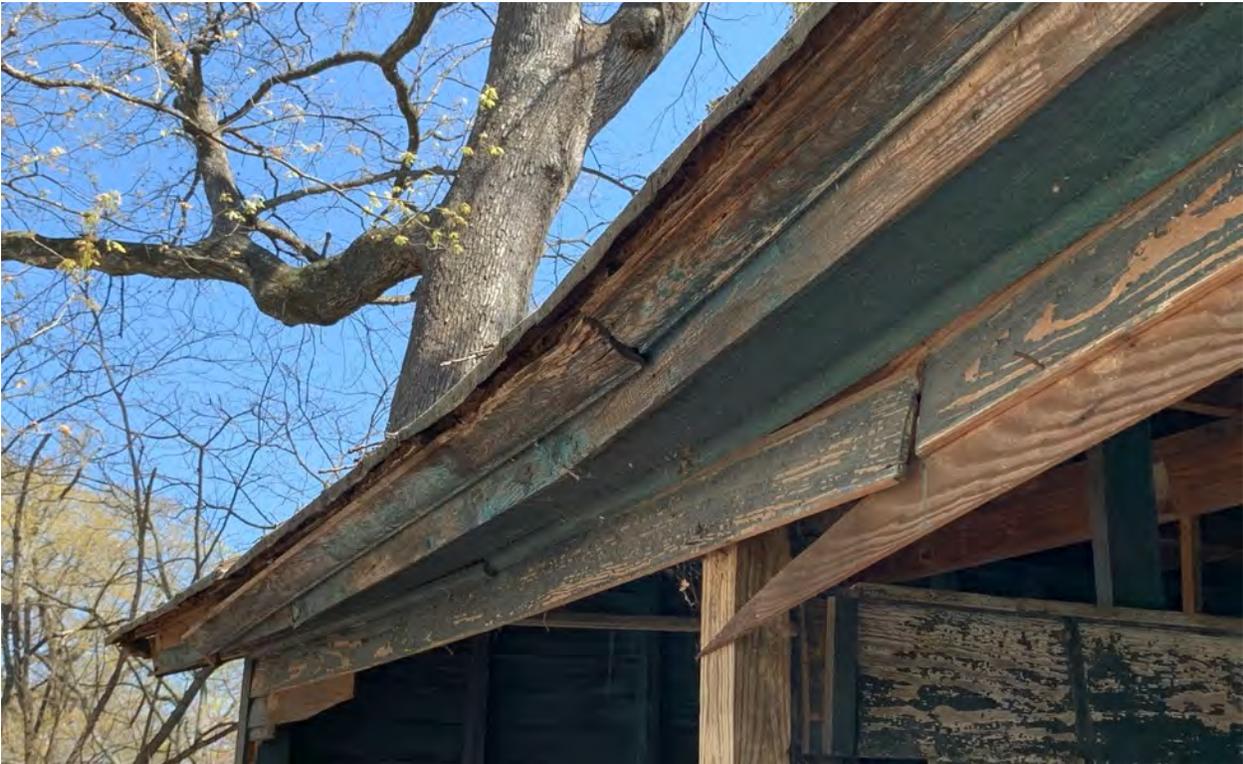
Failure of the standing seam metal roof has resulted in extensive water damage to roof framing, sheathing, and fascia.

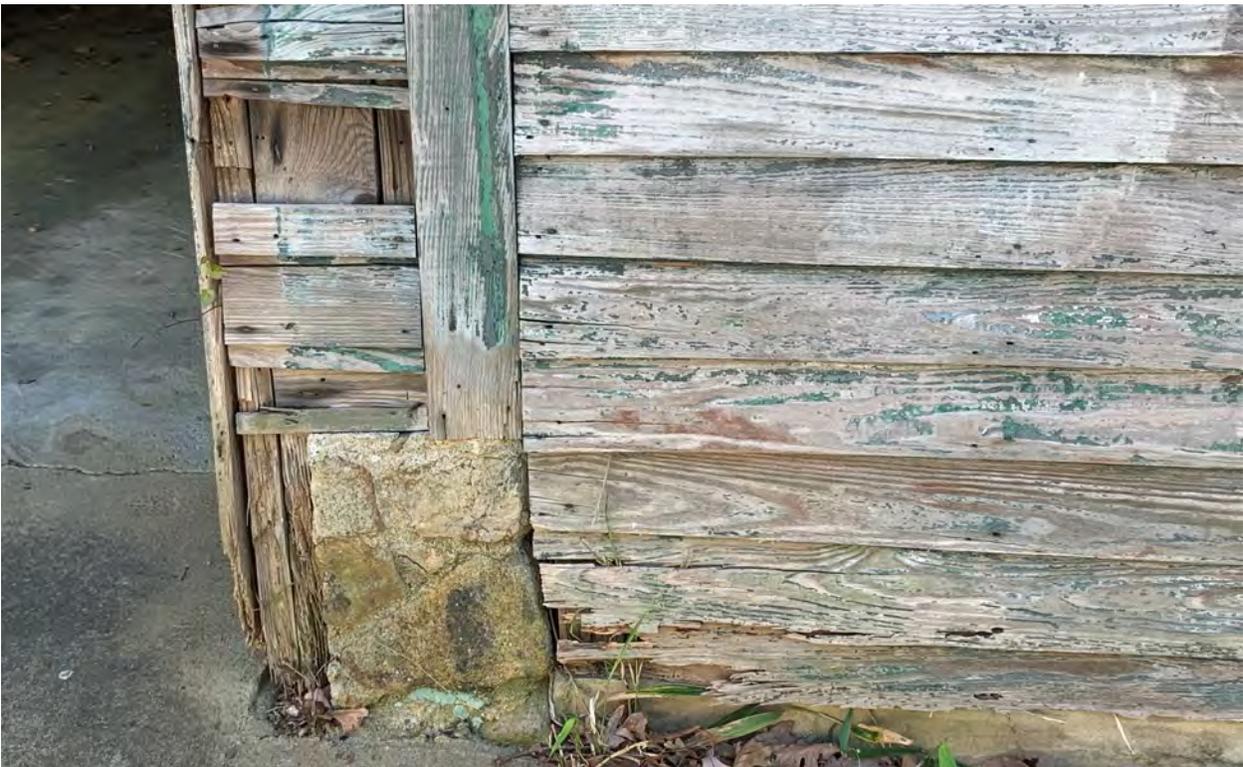
Water and termite damage is evident throughout the exterior wall framing and sheathing.

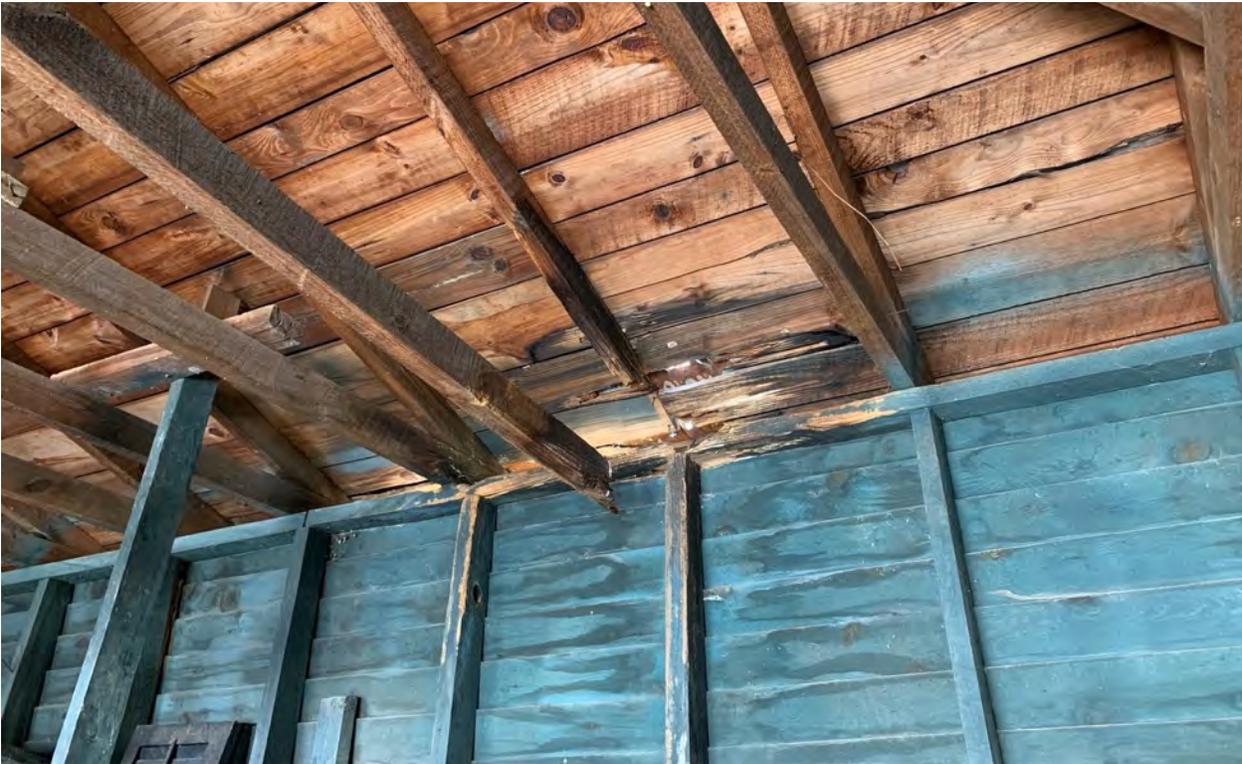
Framing and sheathing deterioration in Bay 1 (first bay from east)

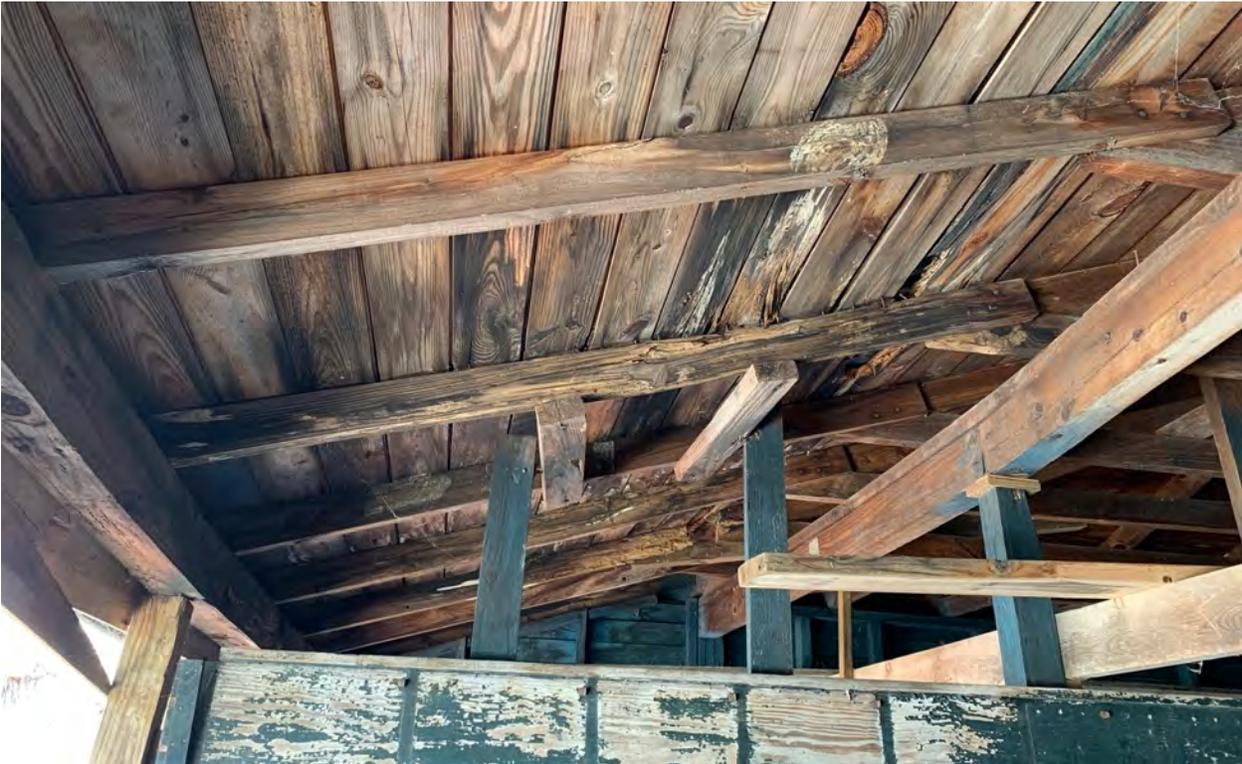
Framing and sheathing deterioration in Bay 1 and 2

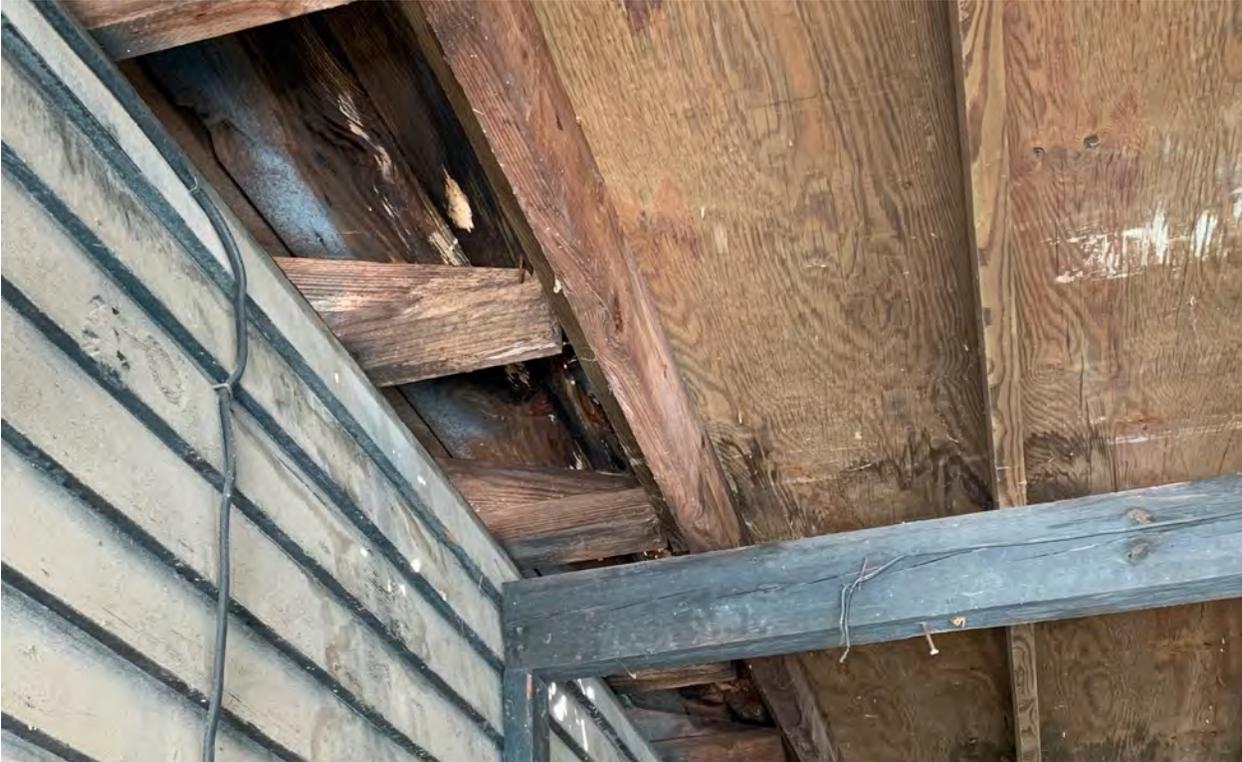
Framing and sheathing deterioration in Bay 3

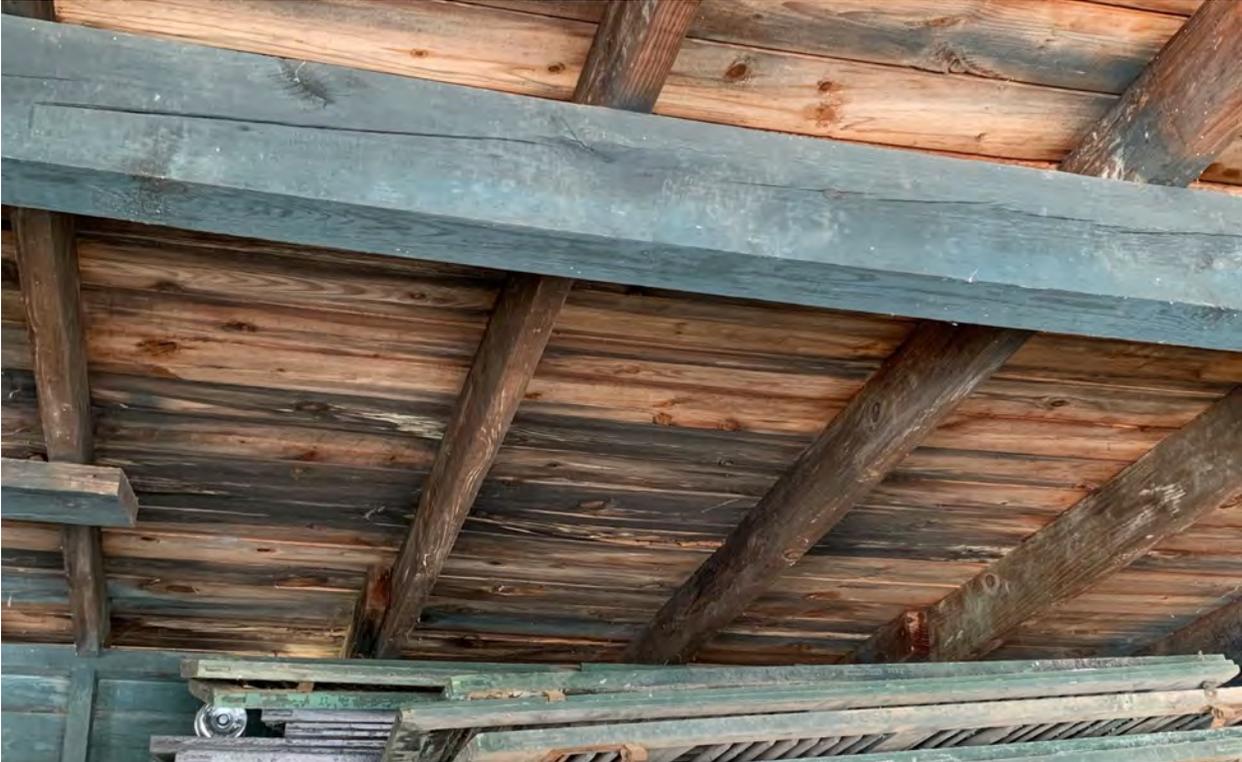
Framing and sheathing deterioration in Bay 4

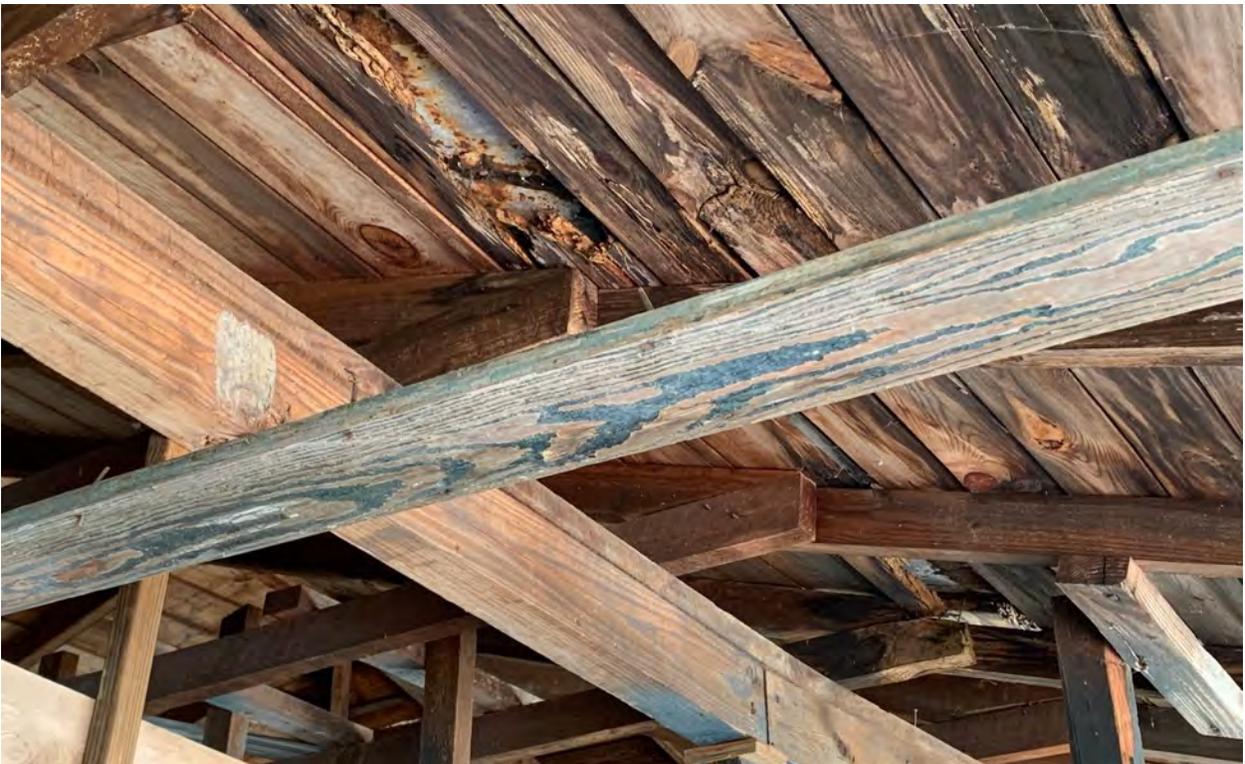
Much of the existing roof framing and sheathing was previously replaced.
