206 McCauley Street Certificate of Appropriateness Application-3/11/22

1) **WRITTEN DESCRIPTION**

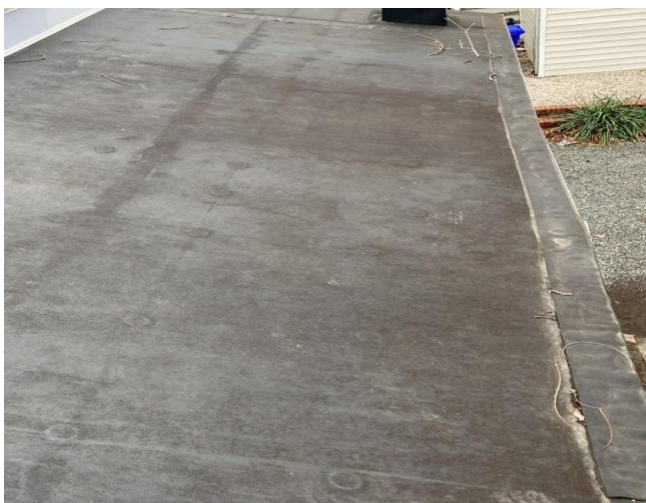
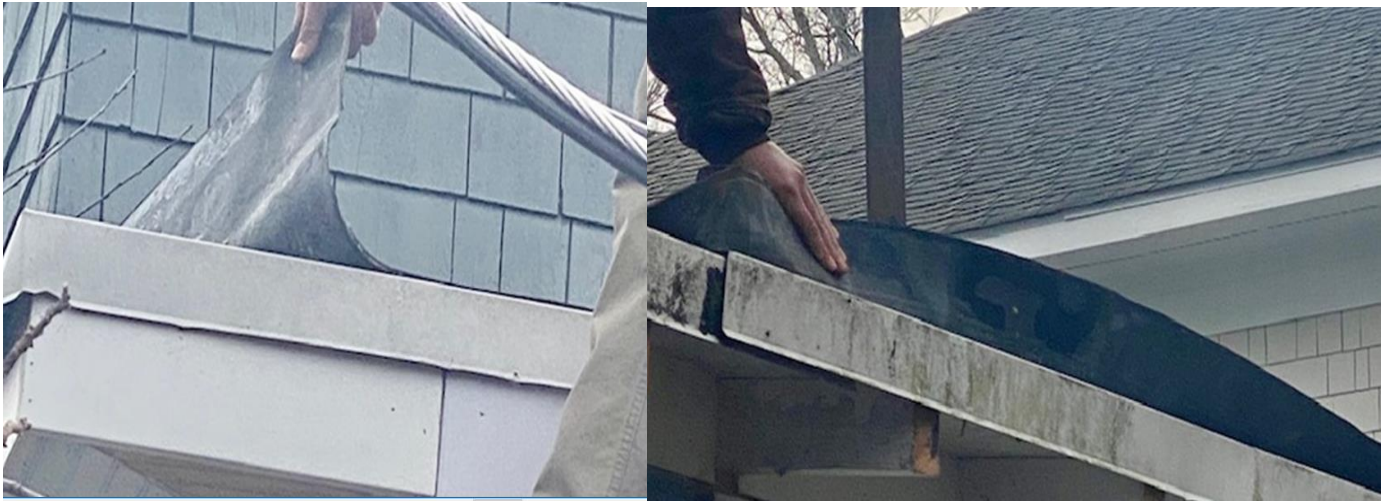
Existing rear flat EPDM roof is not sealed around seams and edges and allows water infiltration.

Views of Existing EPDM roof-current materials are not sealed around the perimeter nor on seams

Applicant proposes In-kind replacement of existing improperly installed and malfunctioning rear EPDM membrane flat roof.

Proposed roof replacement would be installed with like materials, design, color, etc. (see proposal below on page 26).

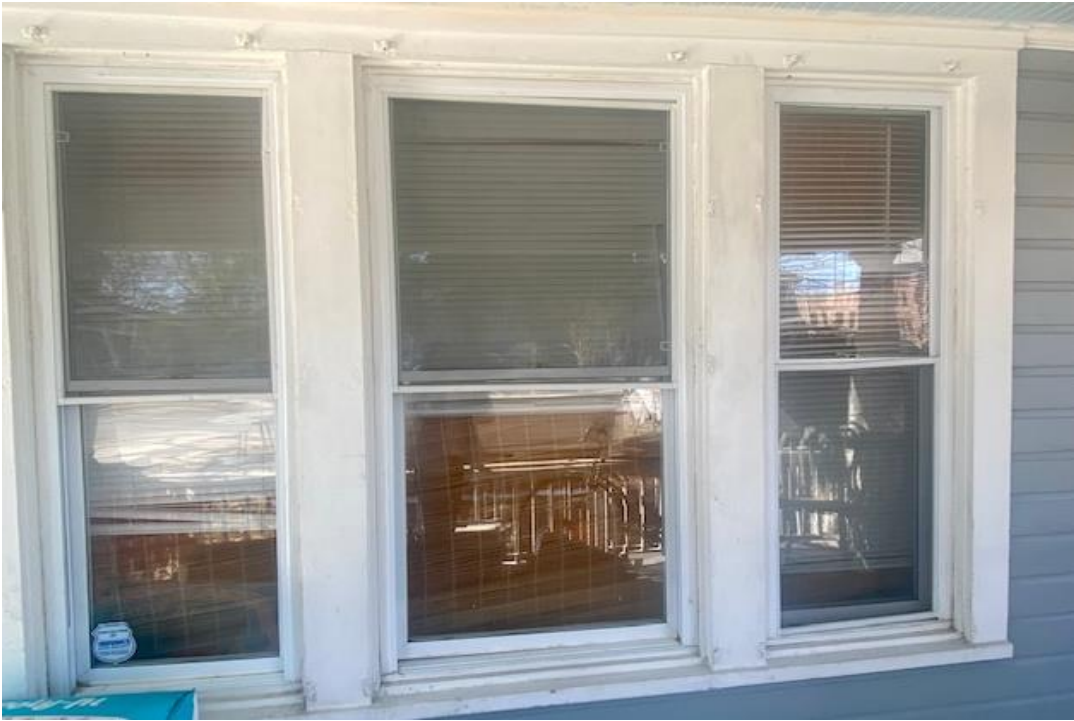
The original windows were replaced with vinyl sometime prior to current ownership. Existing vinyl windows are in poor condition. Owner is proposing fiberglass or aluminum clad since in kind replacement of vinyl windows is not permitted. We understand custom wood is preferred, but this option is much more expensive upfront and requires yearly maintenance and repainting. Our goal is to provide a solution that matches the aesthetic and quality of the original windows while protecting the building envelope, and in keeping with neighboring properties.

Closer view of existing vinyl windows-front of house

Replacement windows would be prefinished in white with no grid as are existing windows in subject property as well as several of the surrounding properties (see photos of neighboring properties above and proposals below for both fiberglass and aluminum wood clad). Windows are replacement windows so they are built in specific sizes to fit the openings on the home. With older homes like this one, stock sizes sometimes won't fit. Window contractor will be measuring each window opening and building the window to fit what is provided.

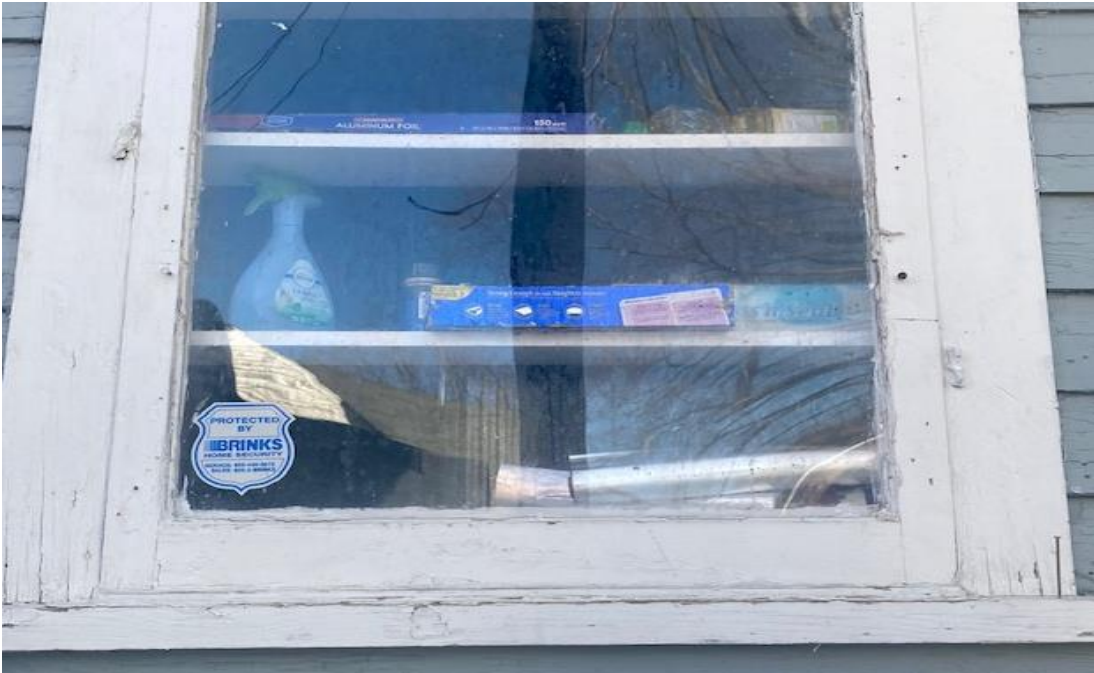
Existing window-east side (near side porch)-this one is not vinyl-perhaps original
