Town of Chapel Hill, NC

COA-22-10

Certificate of Appropriateness for the Historic District

206 McCauley Street Certificate of Appropriateness Application-3/11/22

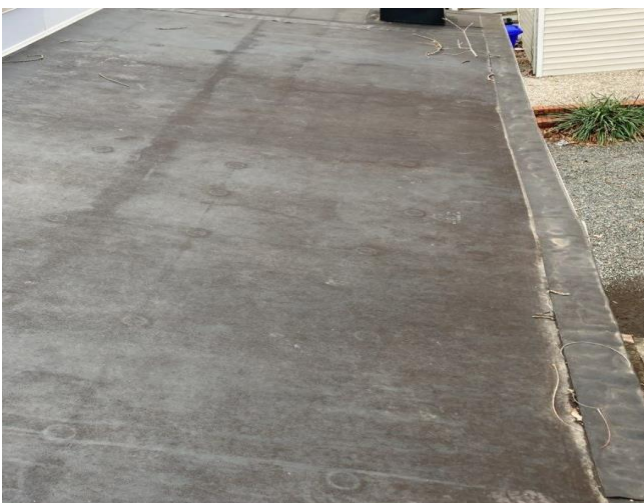
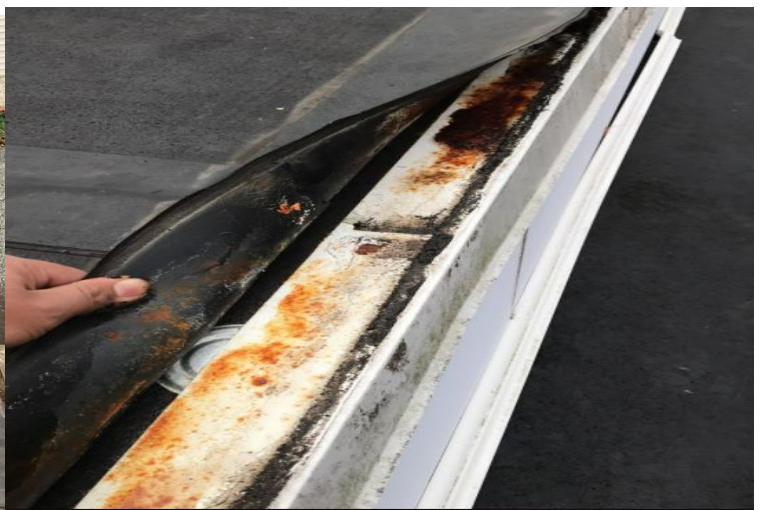
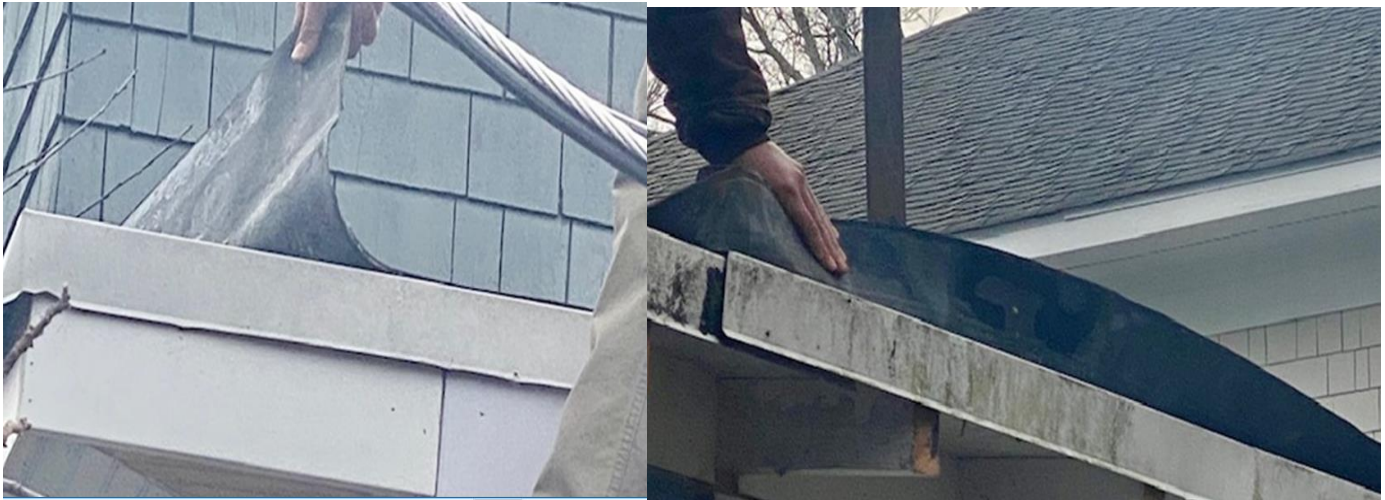
Existing rear flat EPDM roof is not sealed around seams and edges and allows water infiltration.

Views of Existing EPDM roof-current materials are not sealed around the perimeter nor on seams

Applicant proposes In-kind replacement of existing improperly installed and malfunctioning rear EPDM membrane flat roof.

Proposed roof replacement would be installed with like materials, design, color, etc. (see proposal below on page 26).

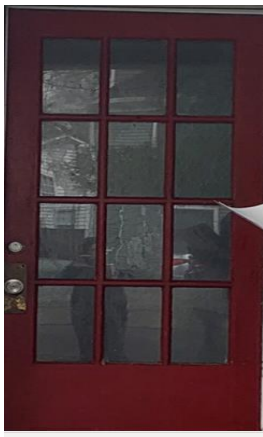
Exterior front door (red was recently painted navy)

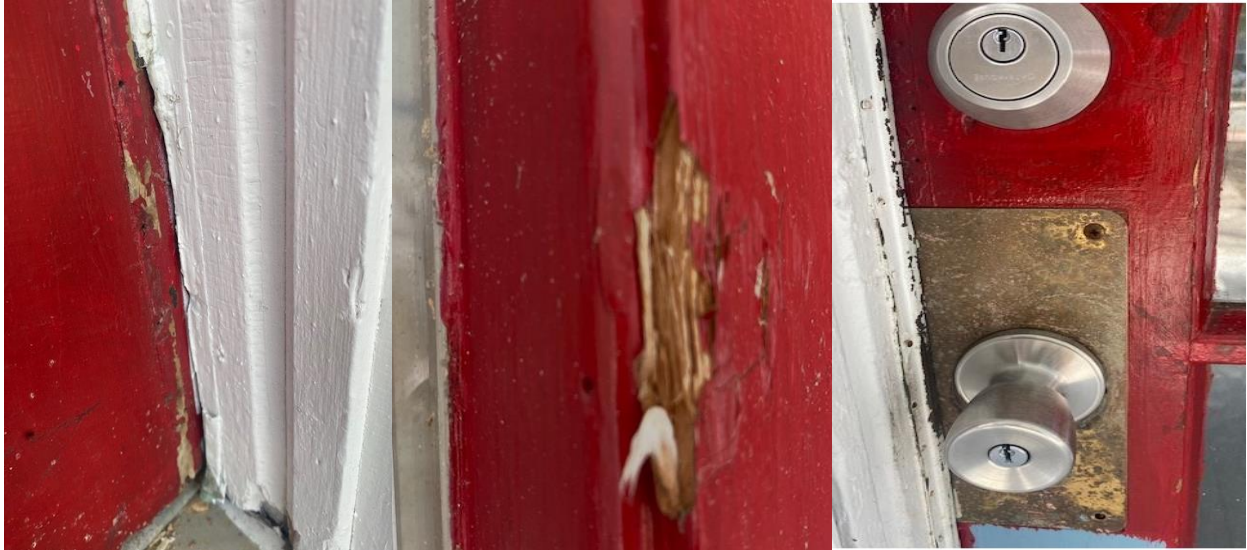
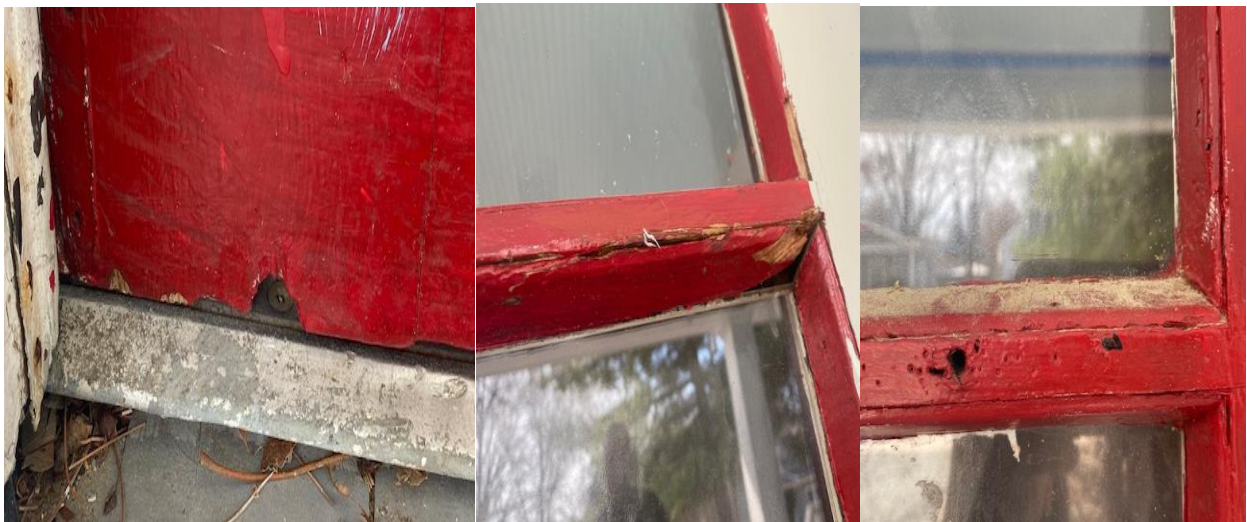
Poor conditions of existing front door

The applicant is requesting replacement with an in kind 12 light fir wood door in the same existing dimensions, in the event that restoration according to the standards is not possible.

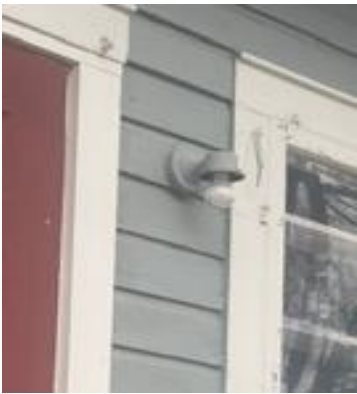
Existing side porch light

Applicant proposes in kind replacement of white front porch flush mount light with exact light in black as well as replacement of side porch and rear lights.

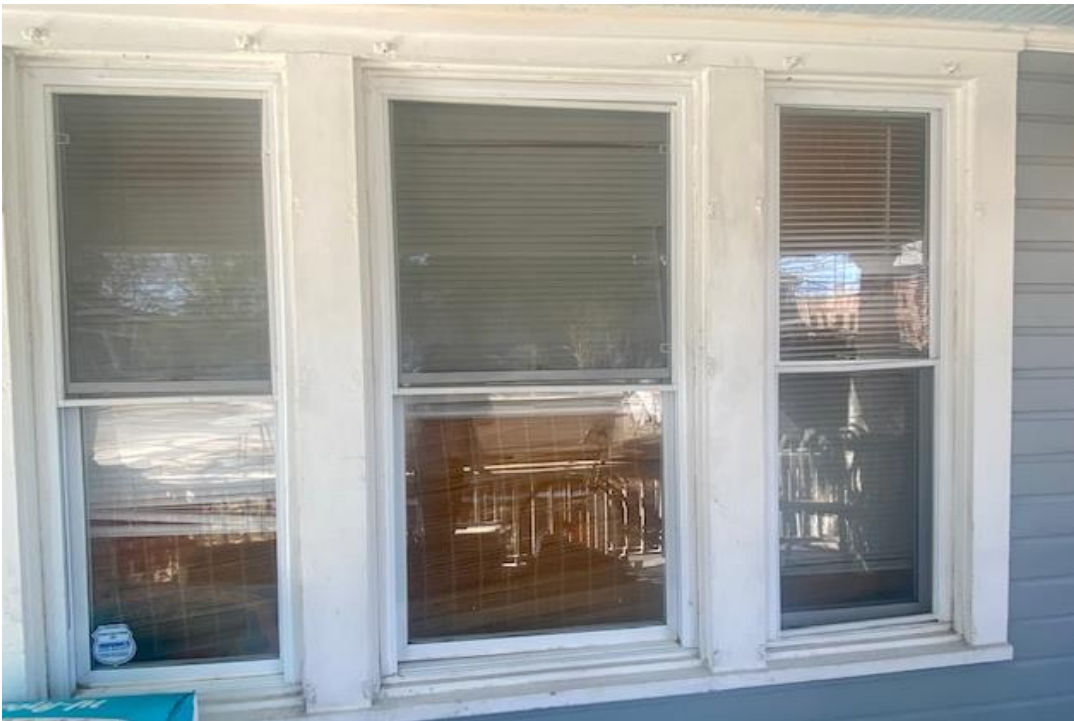
The original windows were replaced with vinyl sometime prior to current ownership. Existing vinyl windows are in poor condition. Owner is proposing fiberglass or aluminum clad since in kind replacement of vinyl windows is not permitted. We understand custom wood is preferred, but this option is much more expensive upfront and requires yearly maintenance and repainting. Our goal is to provide a solution that matches the aesthetic and quality of the original windows while protecting the building envelope, and in keeping with neighboring properties.

Closer view of existing vinyl windows-front of house

Replacement windows would be prefinished in white with no grid as are existing windows in subject property as well as several of the surrounding properties (see photos of neighboring properties above and proposals below for both fiberglass and aluminum wood clad). Windows are replacement windows so they are built in specific sizes to fit the openings on the home. With older homes like this one, stock sizes sometimes won't fit. Window contractor will be measuring each window opening and building the window to fit what is provided.

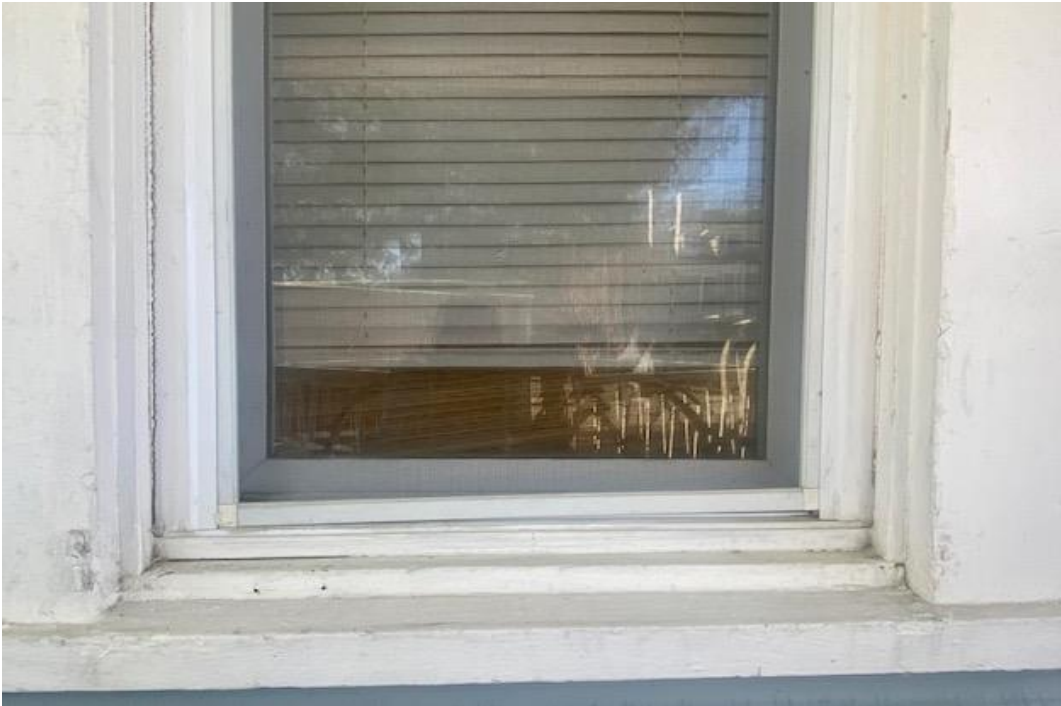
Closer view of existing vinyl window-front of house

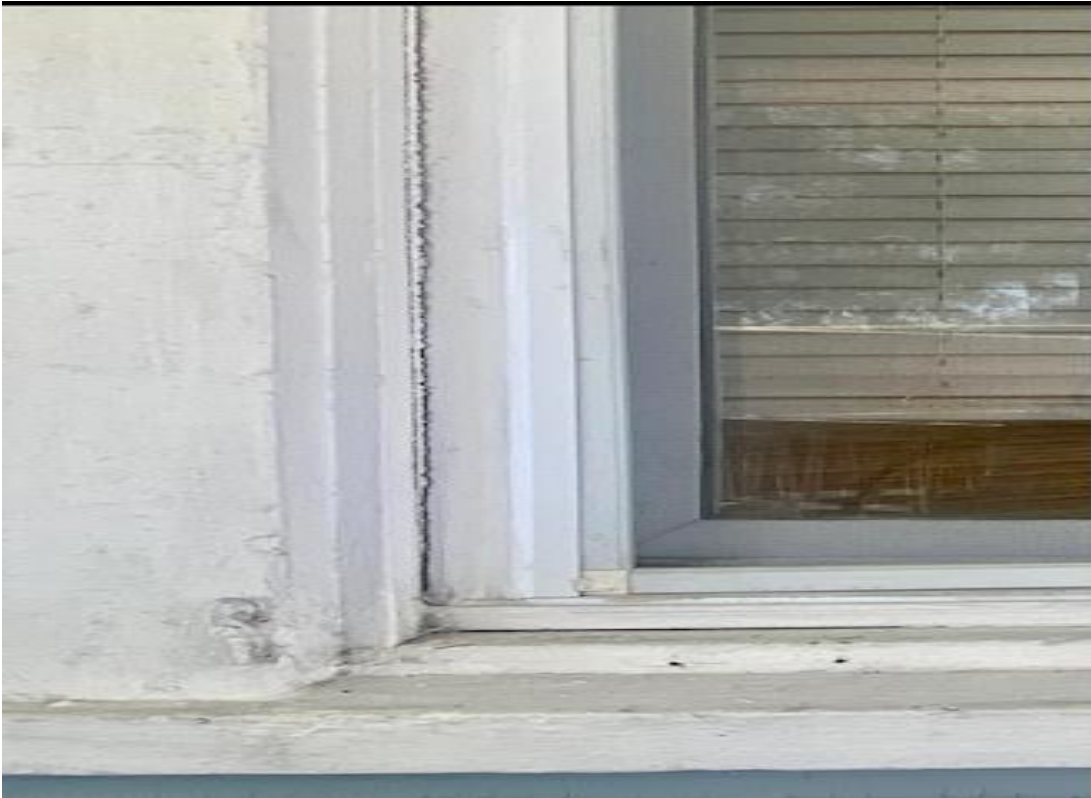
Closer view of existing vinyl windows-front of house

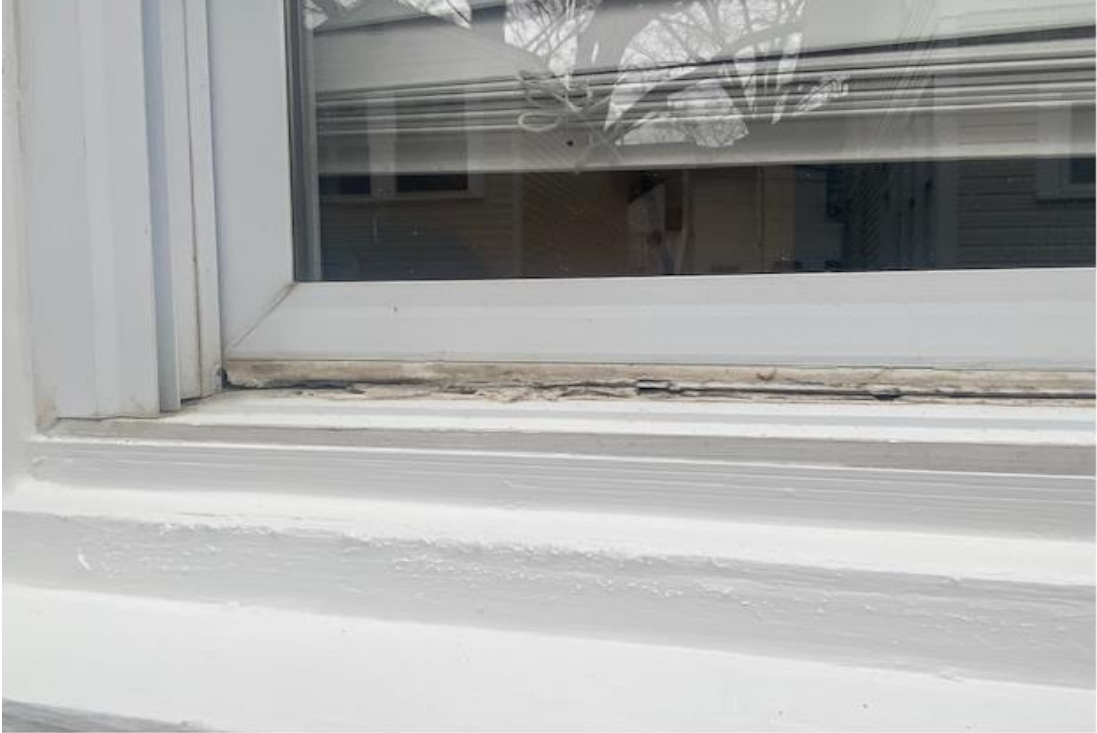
View of existing window-west rear side

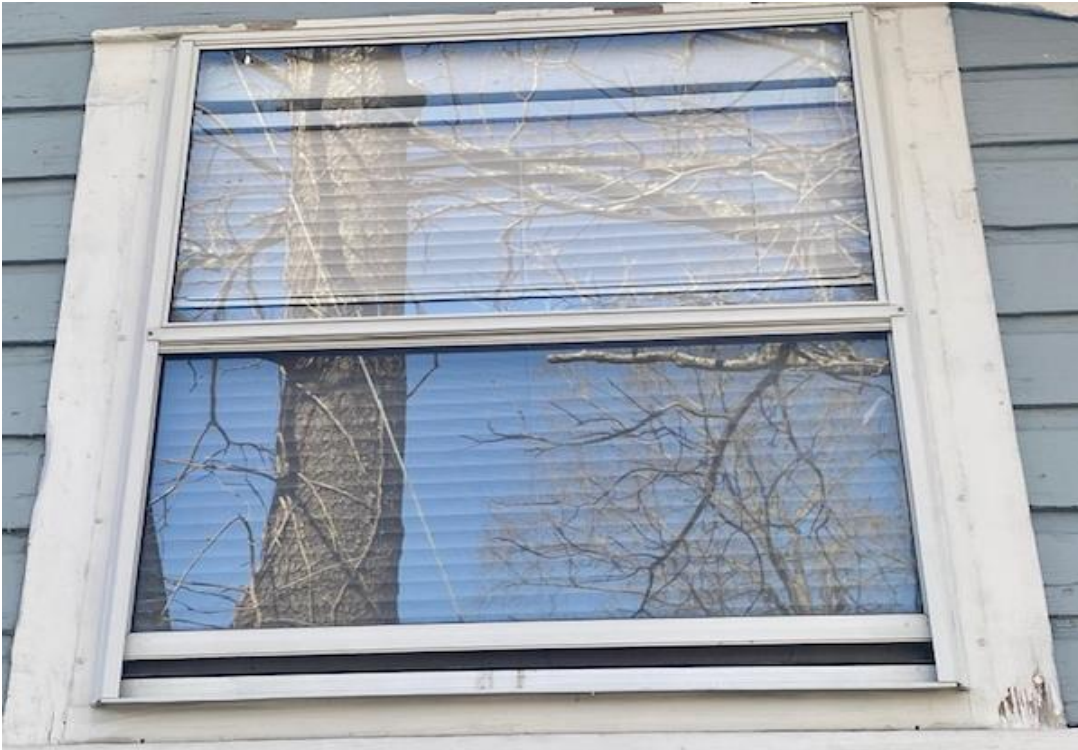
Existing window-east side

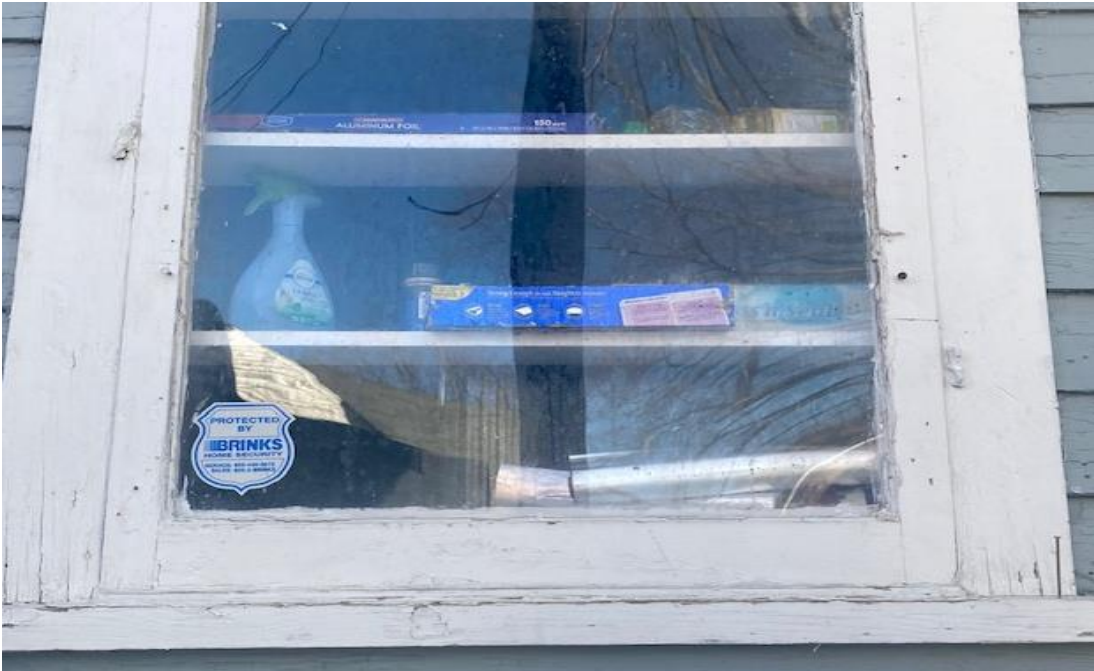
Existing window-east side (near side porch)-this one is not vinyl-perhaps original
