Petition: Overhaul the Door Zone Bike Lane on Country Club Road and correctly place Shared Lane Markings as described in the attached paper.

Door Zone Bike Lane on Country Club Road and misplaced Shared Lane Markings

February 16, 2022

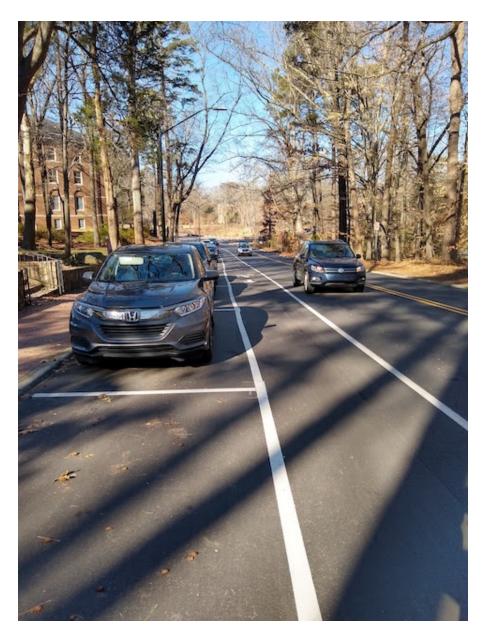
Image 1. The parking lane on Country Club Road is 8' wide, the Door Zone Bike Lane is 6', and the travel lane is just 10'.

Parked vehicles can abut the parking limit line. Opened doors can extend 3.5', leaving just 2.5' of Bike Lane clear space. Bicyclists are 2.5' wide but need 4' of clear operating space plus shy distances. Trucks, buses, and landscape trailers are 8.5' wide not including mirrors, and can abut the Bike Lane.

This design is fatally flawed. Bicyclists should not have to tightrope, staying far left in the Bike Lane to defend against opened doors on their right while being skimmed on the left by close passing motor vehicles.

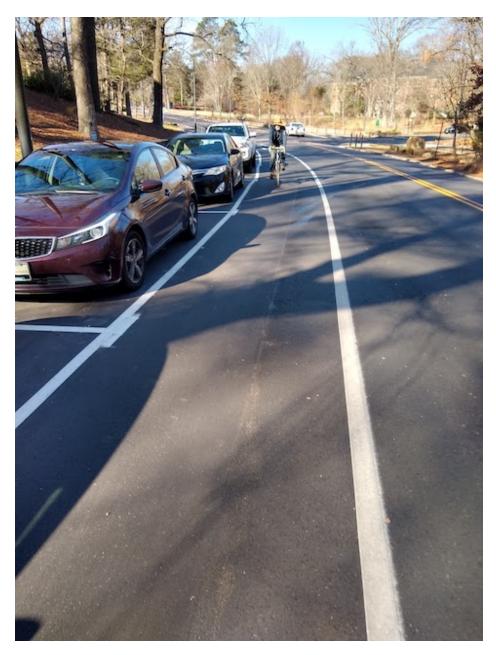
Image 2. A random bicyclist within the Door Zone.

Bicyclists are shepherded into the Bike Lane, while motorists are kept out of the Door Zone by the Bike Lane.

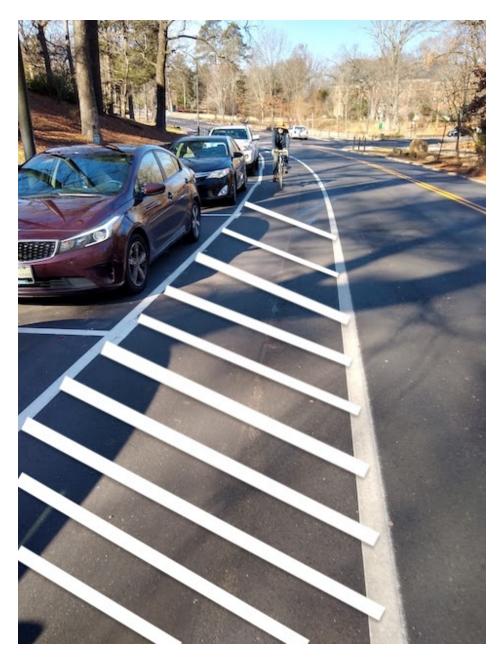
Image 3. Rather than a Bike Lane, it should be a buffer showing the area to avoid.

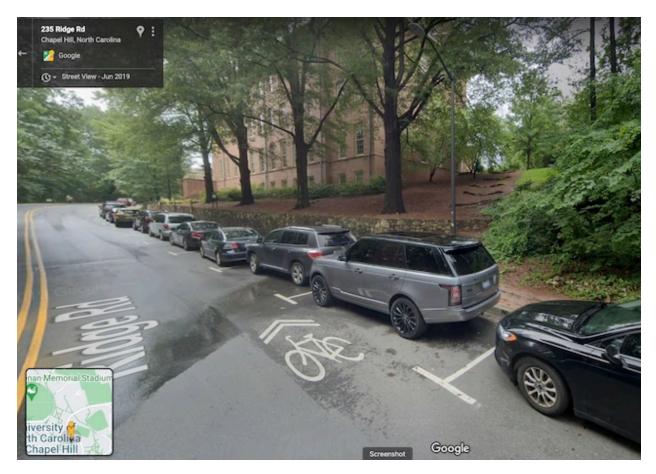
Image 4. Shared Lane Marking in the Door Zone on Ridge
Road.

This and similar others are willful miseducation; they should be at lane center.

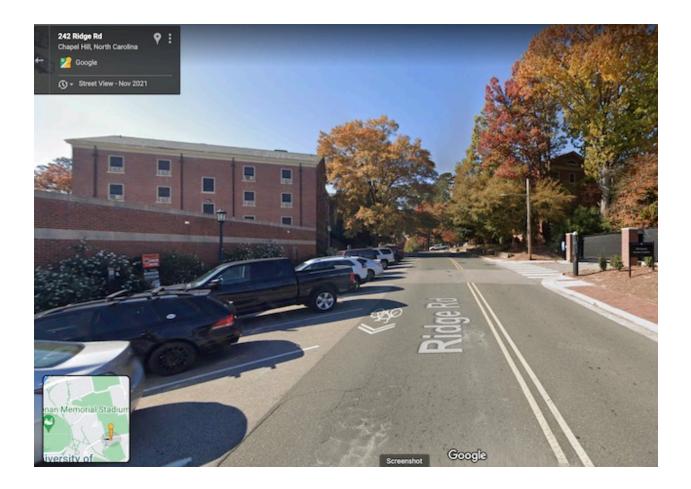
Image 5. Shared Lane Marking placed too close behind angled
parking on Ridge Road.

Bicyclists riding over the markings are screened and vulnerable to backing vehicles.
