Historic District Certificate of Appropriateness

**HDC-22-5**

234 MCCAULEY ST CHAPEL HILL, NC 27516

Remove malfunctioning shingles on low pitch areas of roof. These roof areas include the front porch, back dormer and back porch.

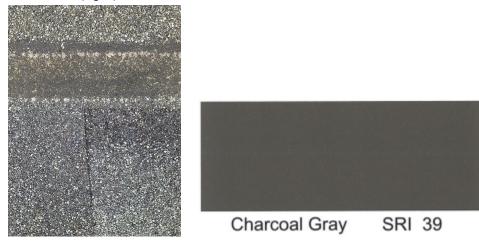
#### **Existing Material, color-matched new material**

New material will be non-straited standing-seam metal, 16" wide with a 1" seam and hidden fastener system. The material is Galvalume, 26 gauge. The paint is factory applied Kynar. The manufacturing company is Metal Panels Inc. The color will match the existing shingles as closely as possible. Please see below for pictures of current shingle color (left) and color of proposed material (right).

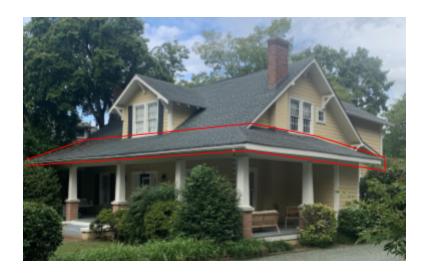
Photo of front/side of 234 McCauley Street subject property. Area outlined in red will be replaced with proposed roofing material.

Replace the failing shingles in the aforementioned areas with non-straited standing-seam metal, 16" wide with a 1" seam and hidden fastener system. The material is Galvalume, 26 gauge. The paint is factory applied Kynar. The manufacturing company is Metal Panels Inc. The color will match the existing shingles as closely as possible.

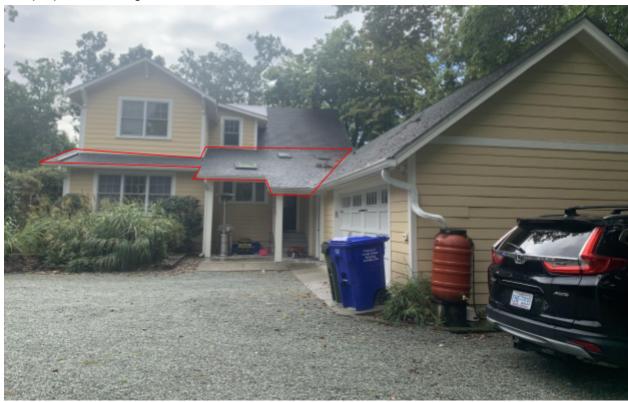
Photo of back of 234 McCauley Street subject property. Area outlined in red will be replaced with proposed roofing material.

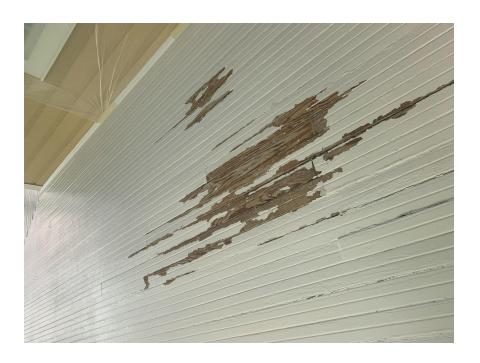
- Roof shape will not change. Roof materials will only change in areas where this is absolutely necessary due to failing shingles.
   We have tried replacing shingles to repair roof on multiple occasions, but each year we have new leaks in low pitch areas. Our roofer Mark Stith informed us the only way to prevent new leaks is to replace the shingles in low pitch areas with metal roofing material.

Damage to front porch ceiling of subject property.

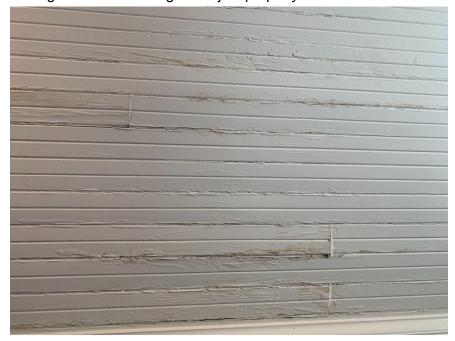
Damage to interior ceiling of subject property.
