Written Description of Physical Changes Proposed

Addition & **Renovations to** The Battle House

203 Battle Lane Chapel Hill, NC 27514

HISTORIC DISTRICT **COMMISION REVIEW**

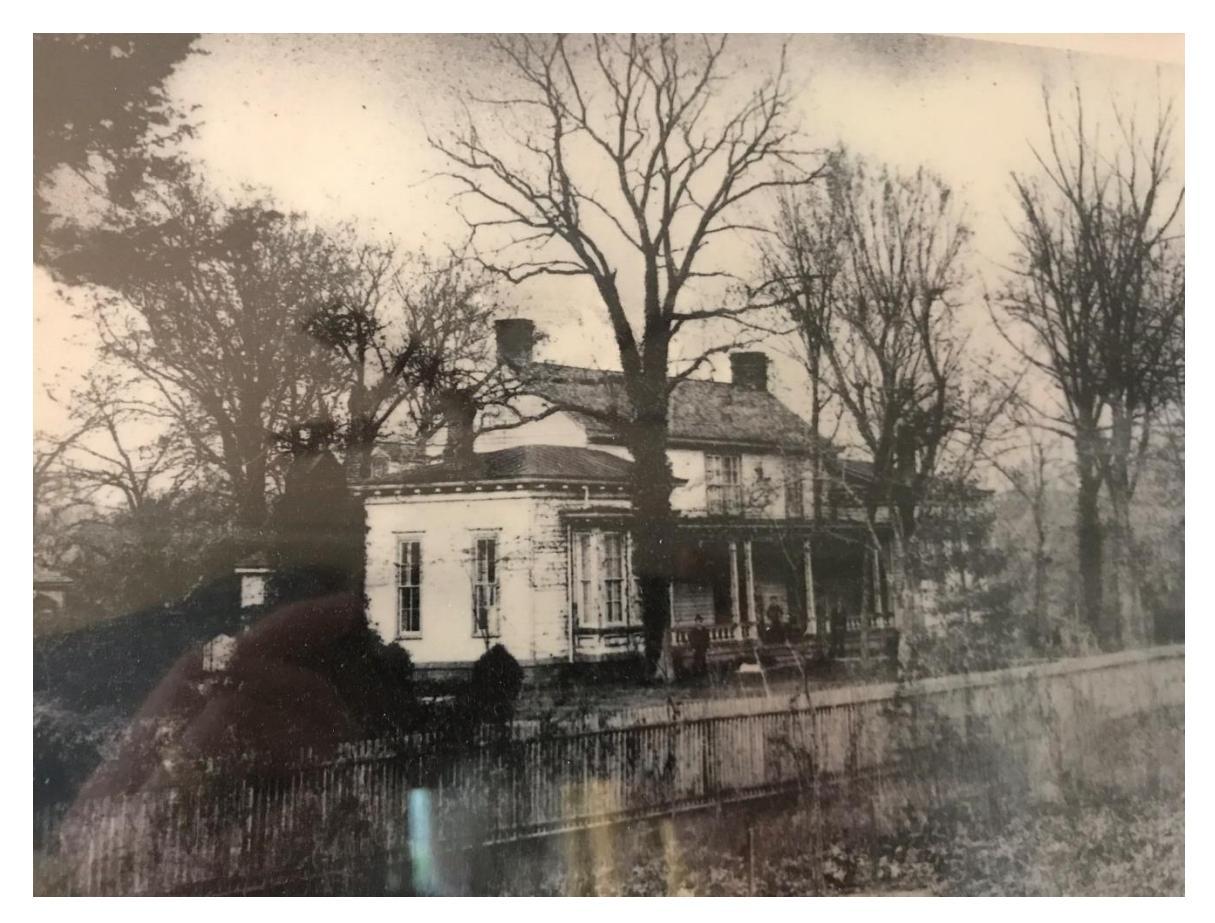
Photo, date unknown, showing circa 1876 Italianate-style renovation. Upper roof appears to be wood shingle while the roof the over one-story wings appears to be metal. Italianate, double columns can be seen on the porch.

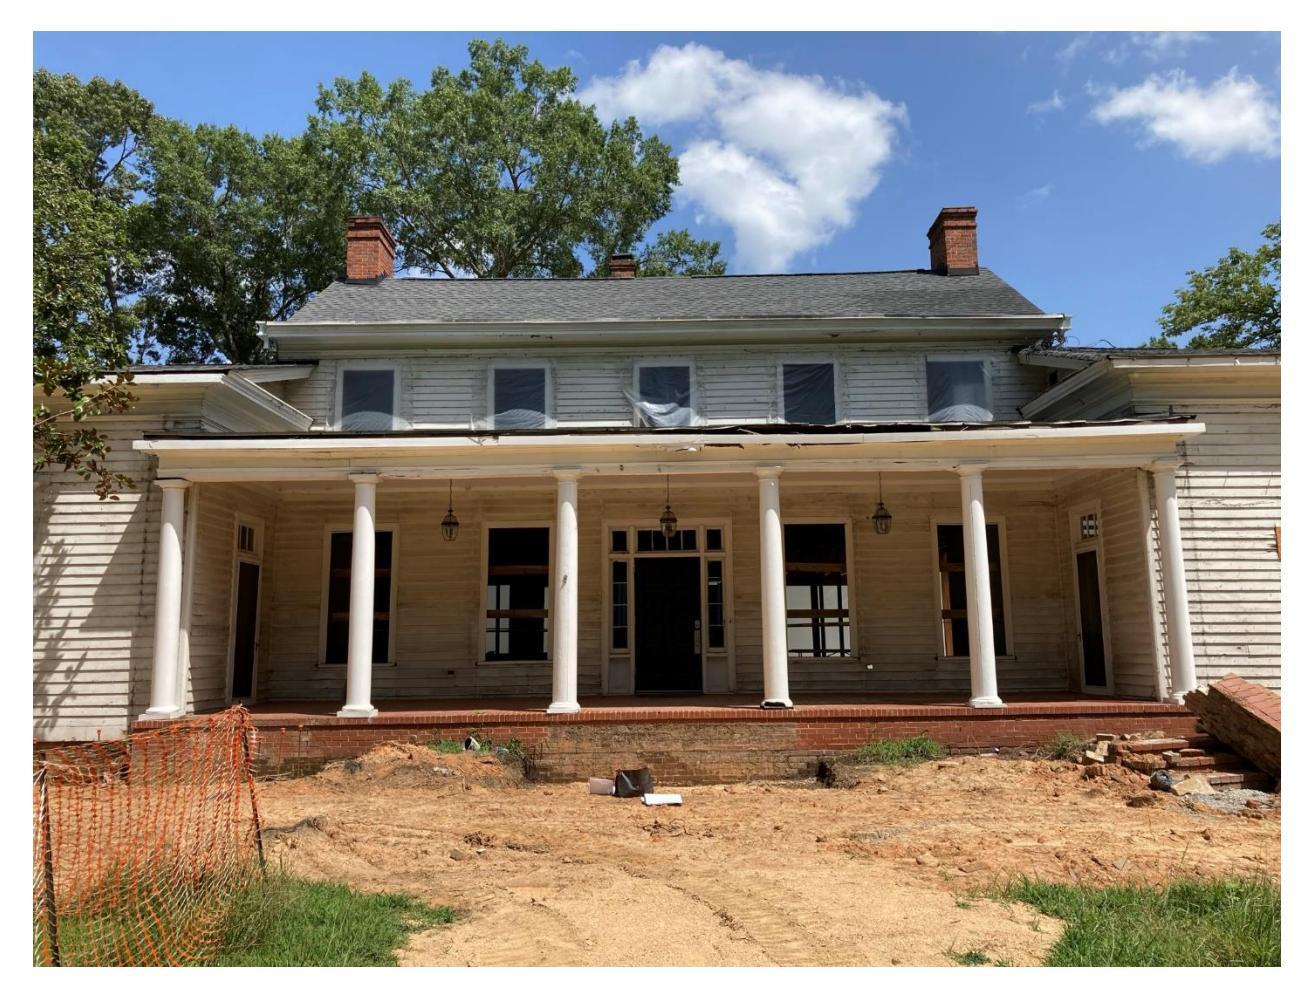
West elevation today, during renovation. The house was renovated in the 1920's in the colonial revival style, and the Italianate double columns were replaced at that time with classical-order single columns. Columns, for the purpose of this application, are numbered from left (north) to right (south): N3, N2, N1, S1, S2, and S3.

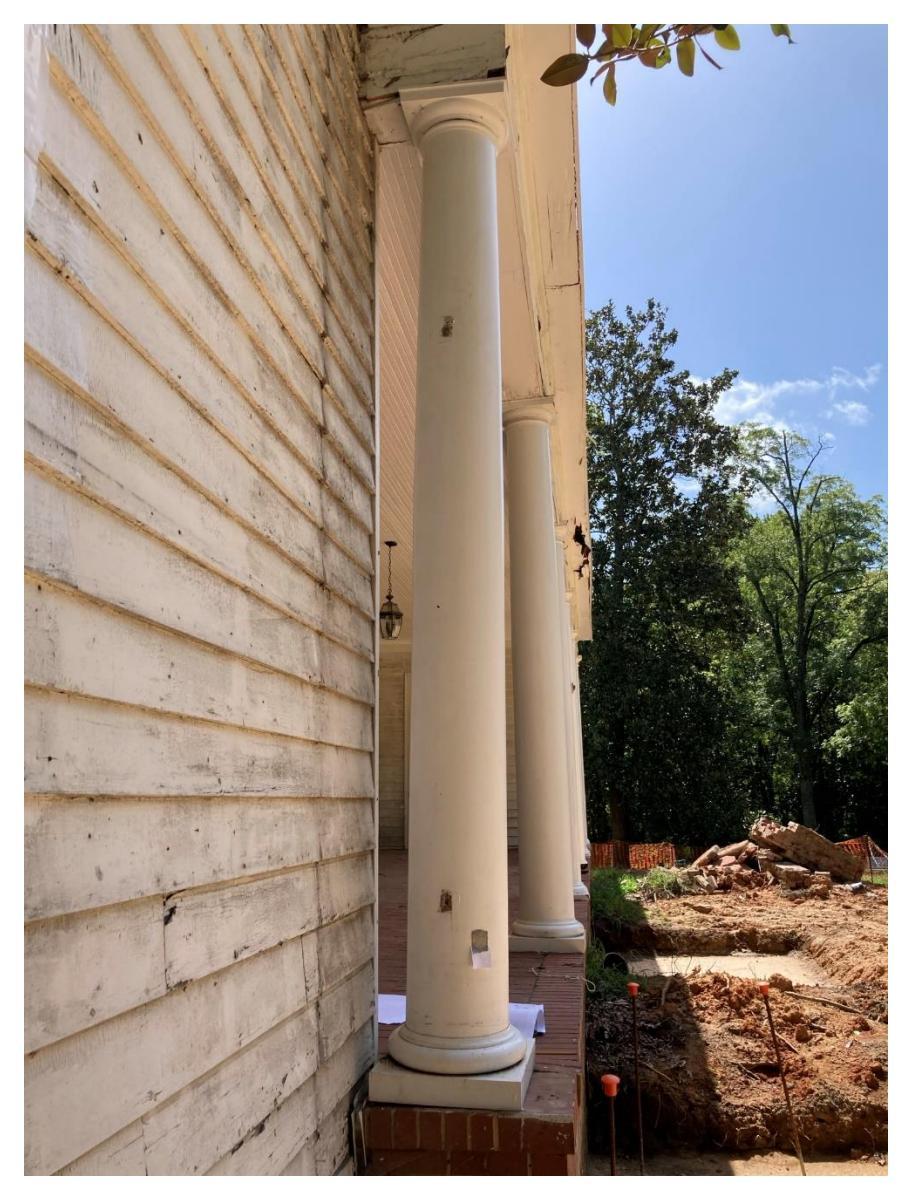
Column N3. Non-original replacement column. Shaft is fiberglass/concrete composite and base and capital are furniture-grade structural foam.

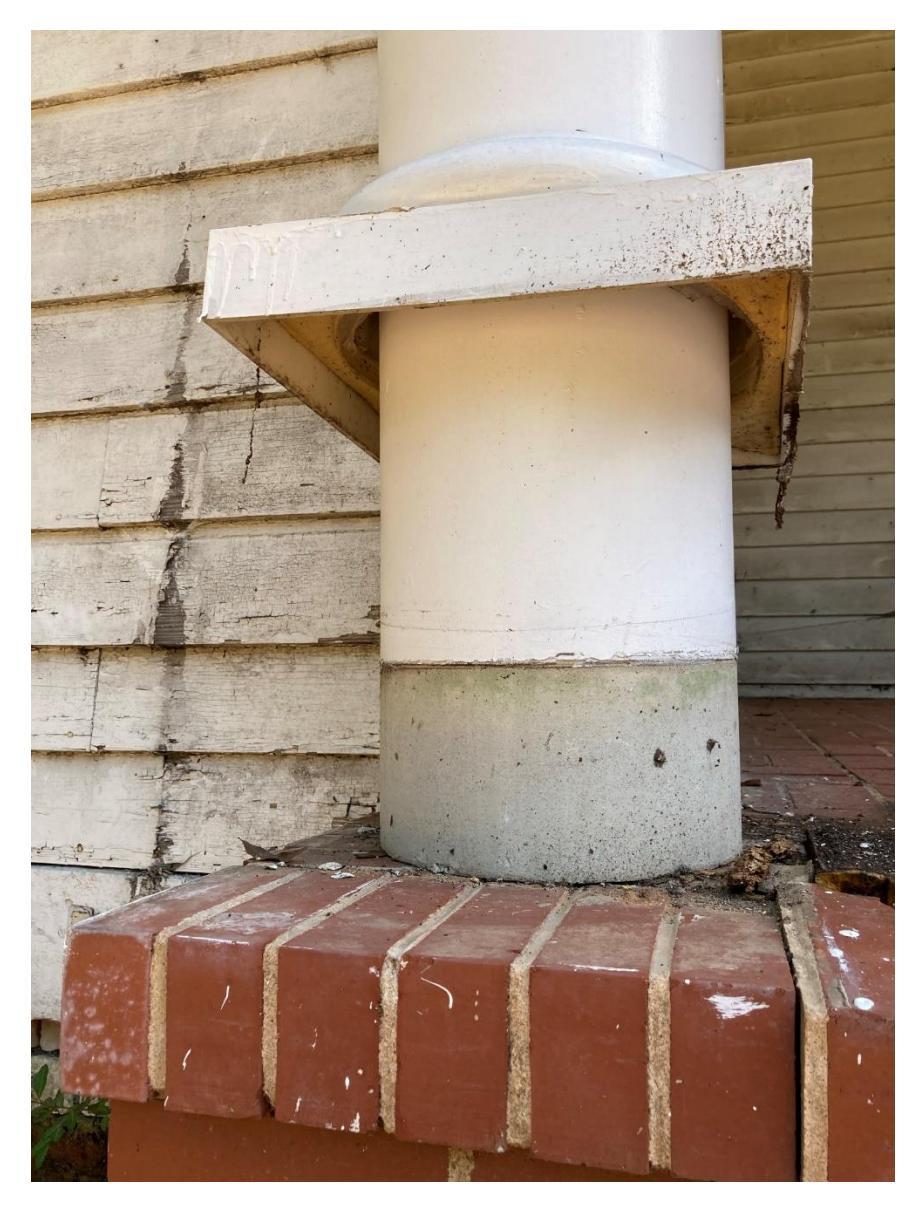
Column N3 base. Furniture-grade structural foam base, lifted up to show how it slides onto shaft.

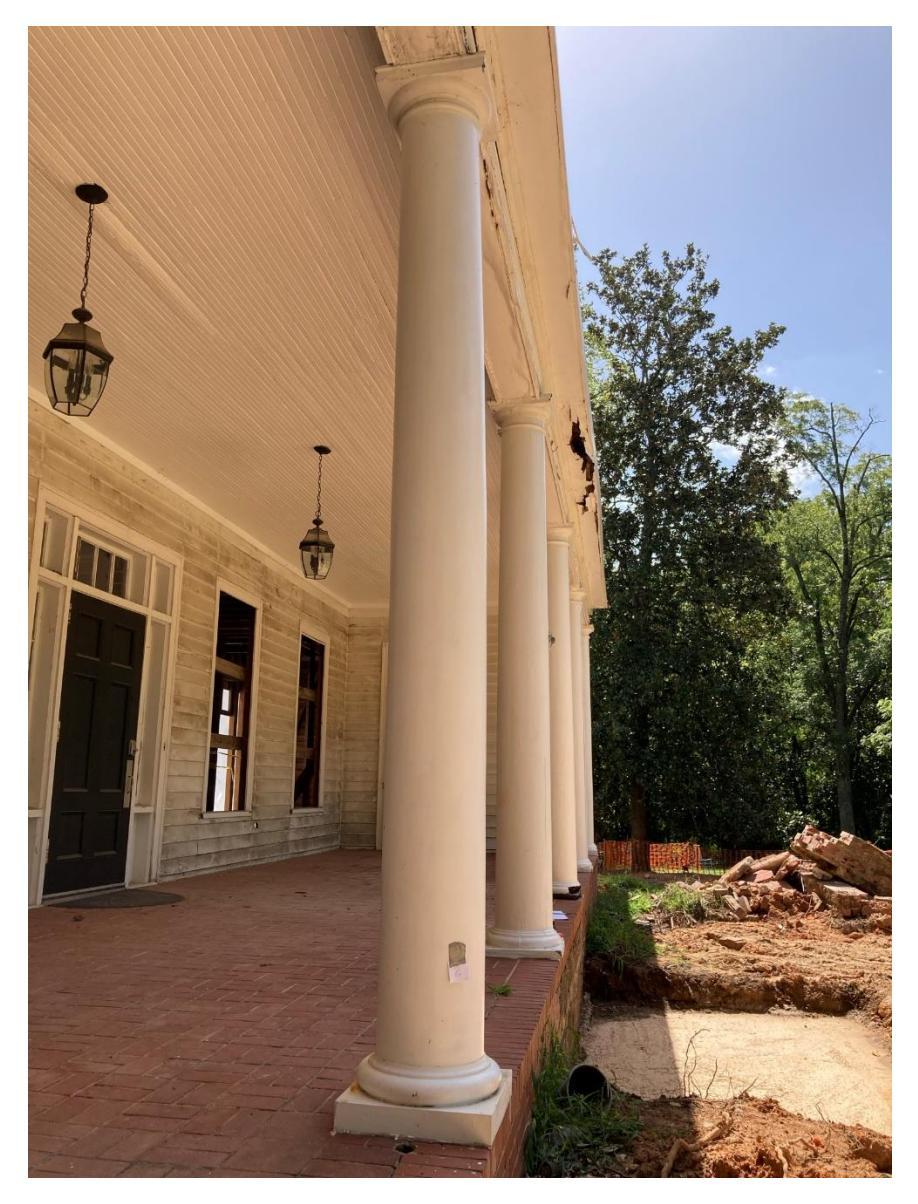
Column N2. Non-original replacement column. Shaft is fiberglass/concrete composite and base and capital are furniture-grade structural foam.

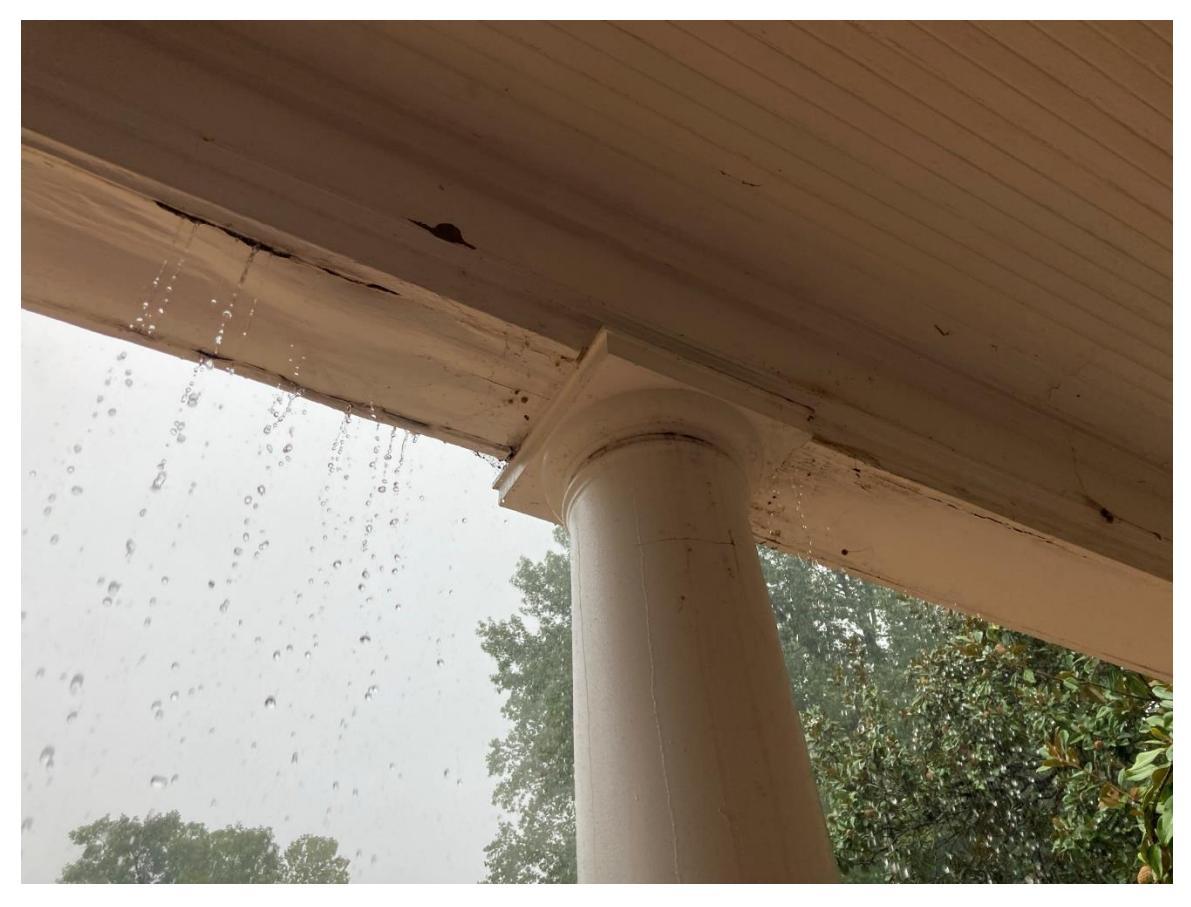
Column N2 capital. Furniture-grade structural foam capital and base do not show any indication of needing repair.

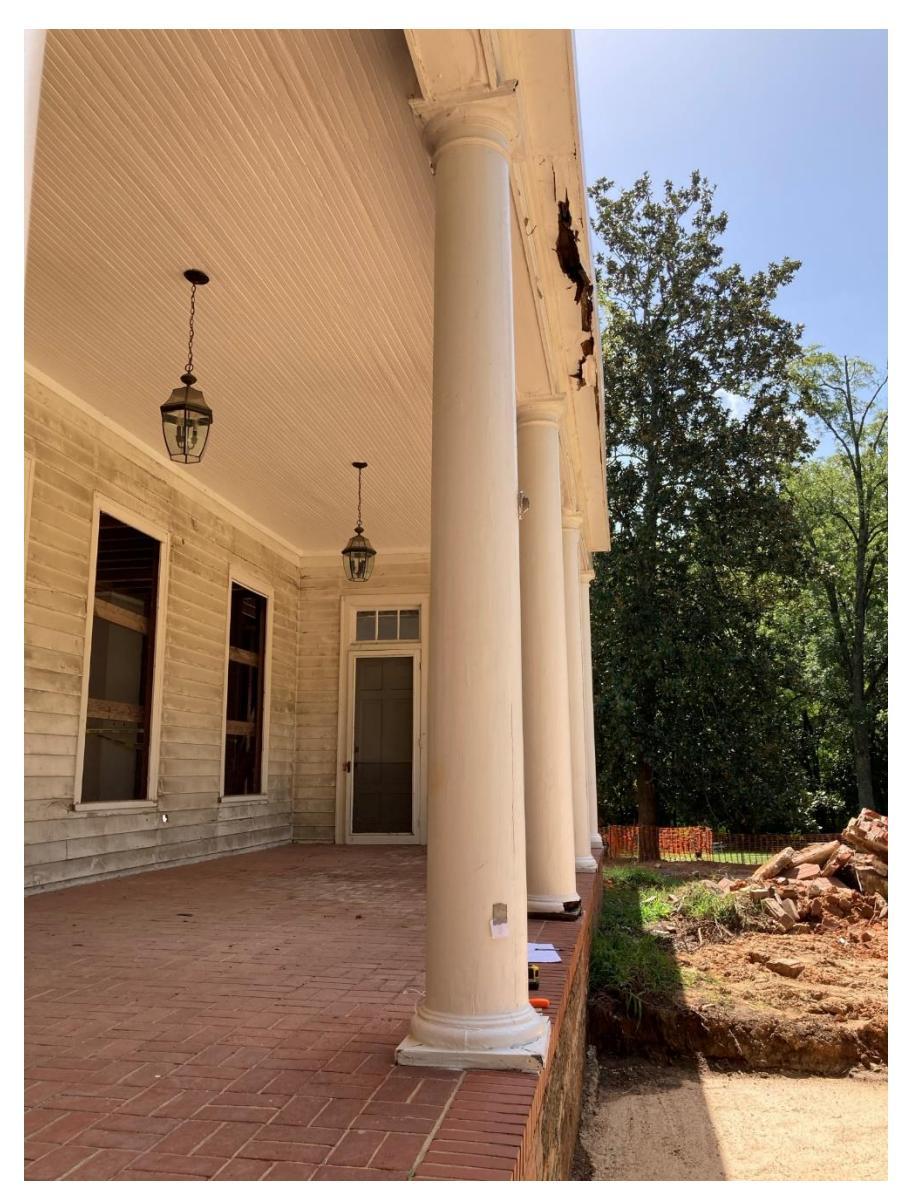
Column N1. Likely an original column from the 1920's renovation. All wood.

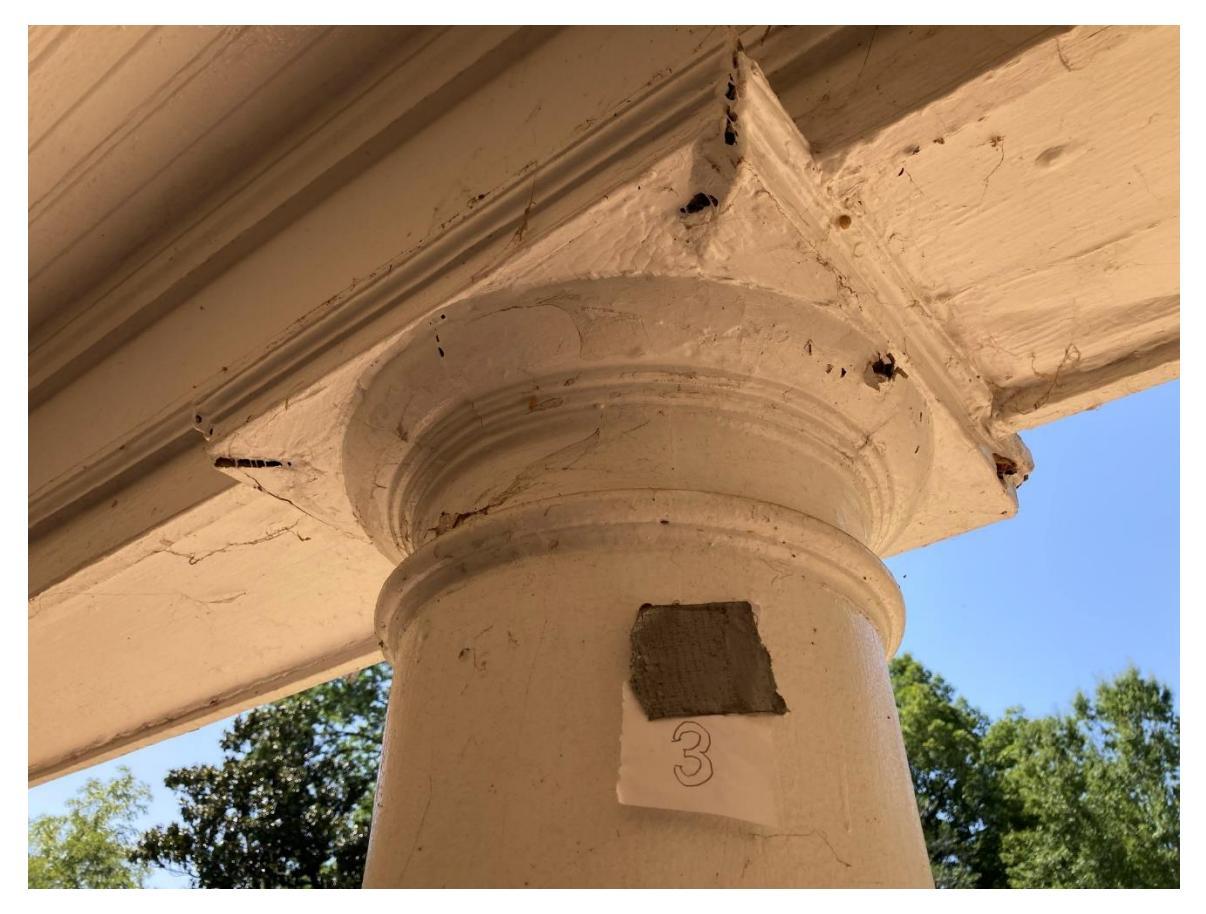
Column N1 capital. Holes in capital indicate where screw-driver probe test was performed and where significant rot was discovered.

We propose to replace six existing columns on the front of the house with fiberglass/concrete composite columns made by HB&G. The columns we propose to replace include: (3) all-wood columns, likely original to a 1920's renovation; (2) replacement fiberglass/concrete composite columns; and (1) column with a wood shaft and wood capital, both of which may or may not be original to the 1920's renovation, and a furniture-grade structural foam base. The six new columns we propose are HB&G's round tapered "PermaCast" columns, made of fiberglass-reinforced concrete shafts and furniture grade- and structural foam bases and capitals. Their details, dimensions, and profiles are of the simplified doric order (referred to as "Tuscan" by the product literature), and the profiles and dimensions of their base and cap are very similar to those of the existing wood columns. The product cut sheets, provided as part of this application, demonstrate their similarity to the details of the existing all-wood columns. The proposed columns' base diameter (11.6") is less than an inch less than the average of the three existing all-wood columns (12.5"), and their upper diameter (9.4") is only slightly more than an inch less than the upper diameter of the existing all-wood columns (10.6").

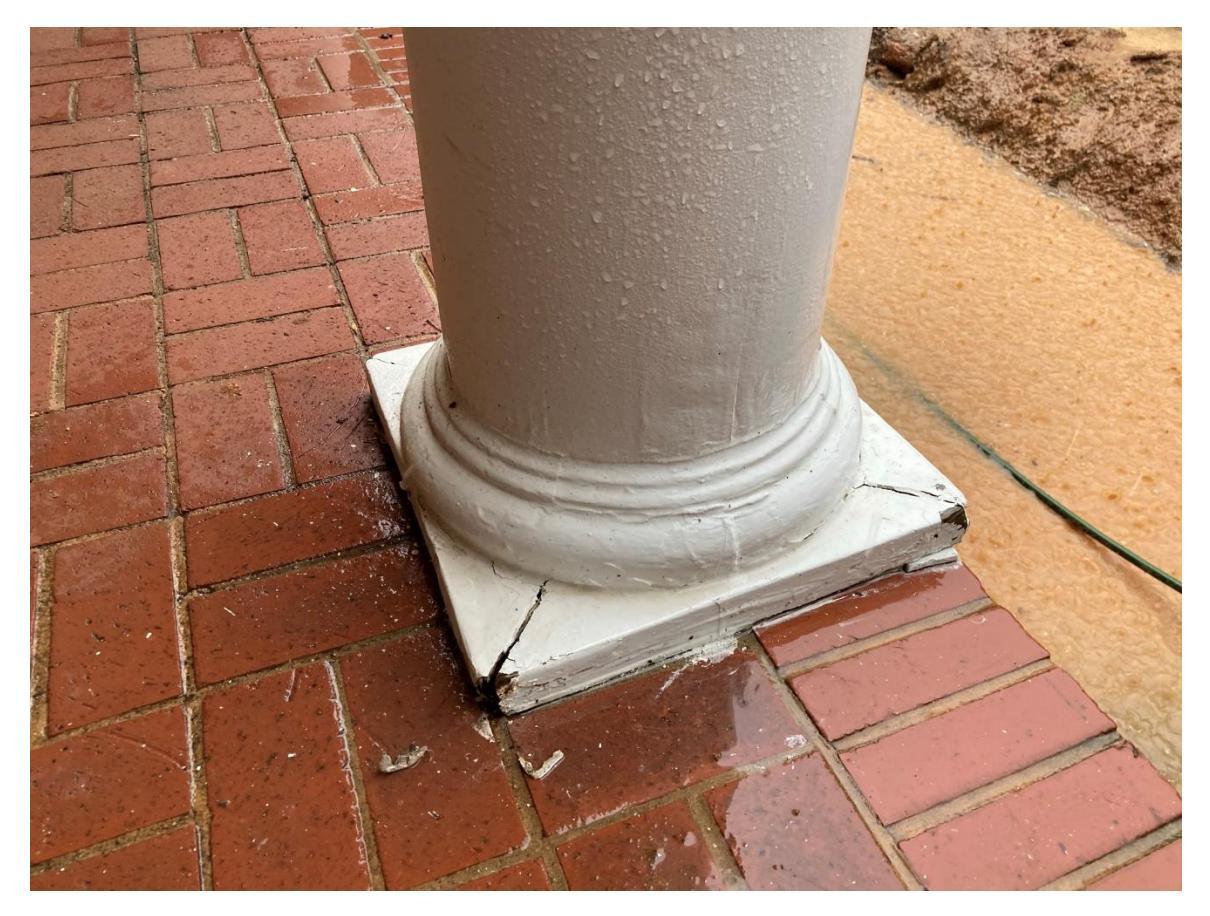
Column N1 base. A screwdriver was able to be pushed well into the wood at the bottom left corner of the base.

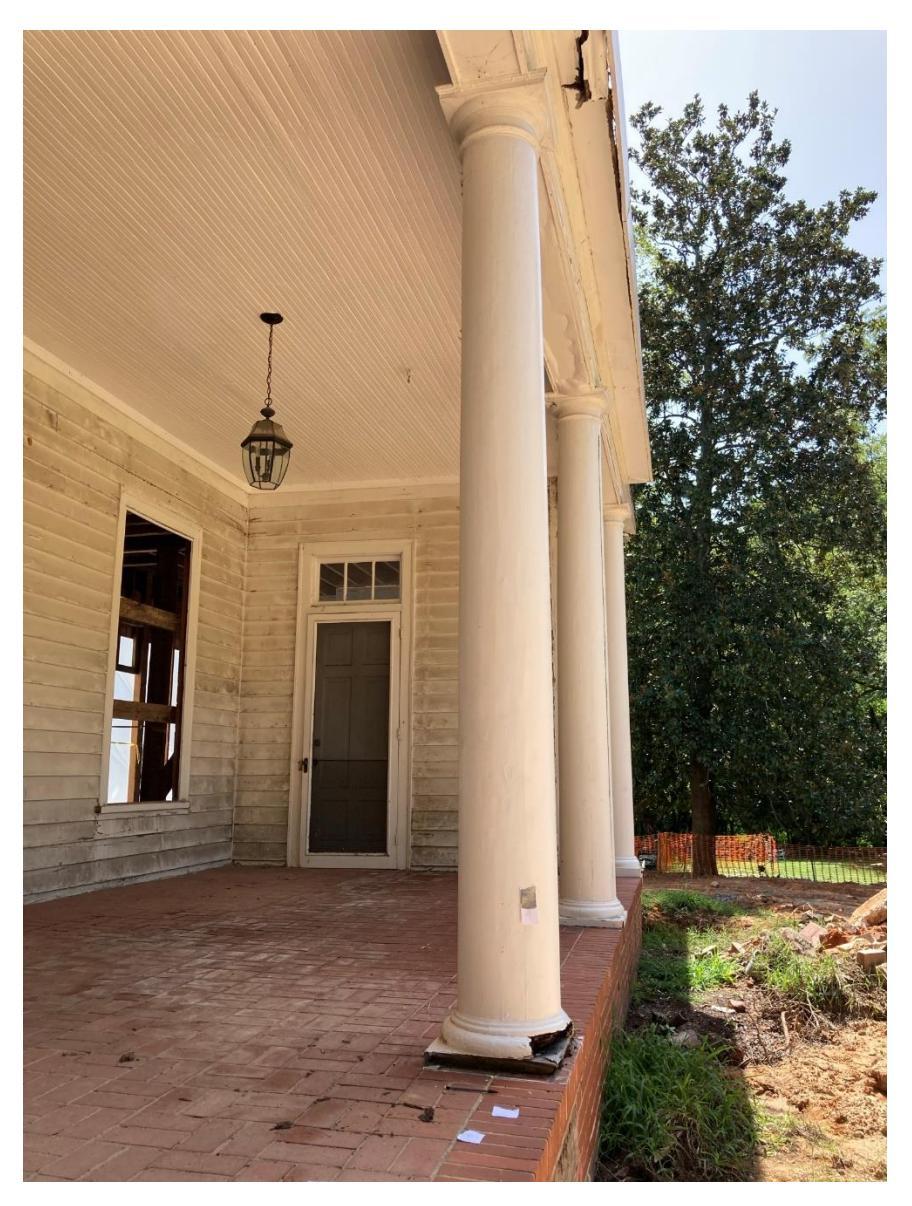
Column S1. Likely an original column from the 1920's renovation. All wood.

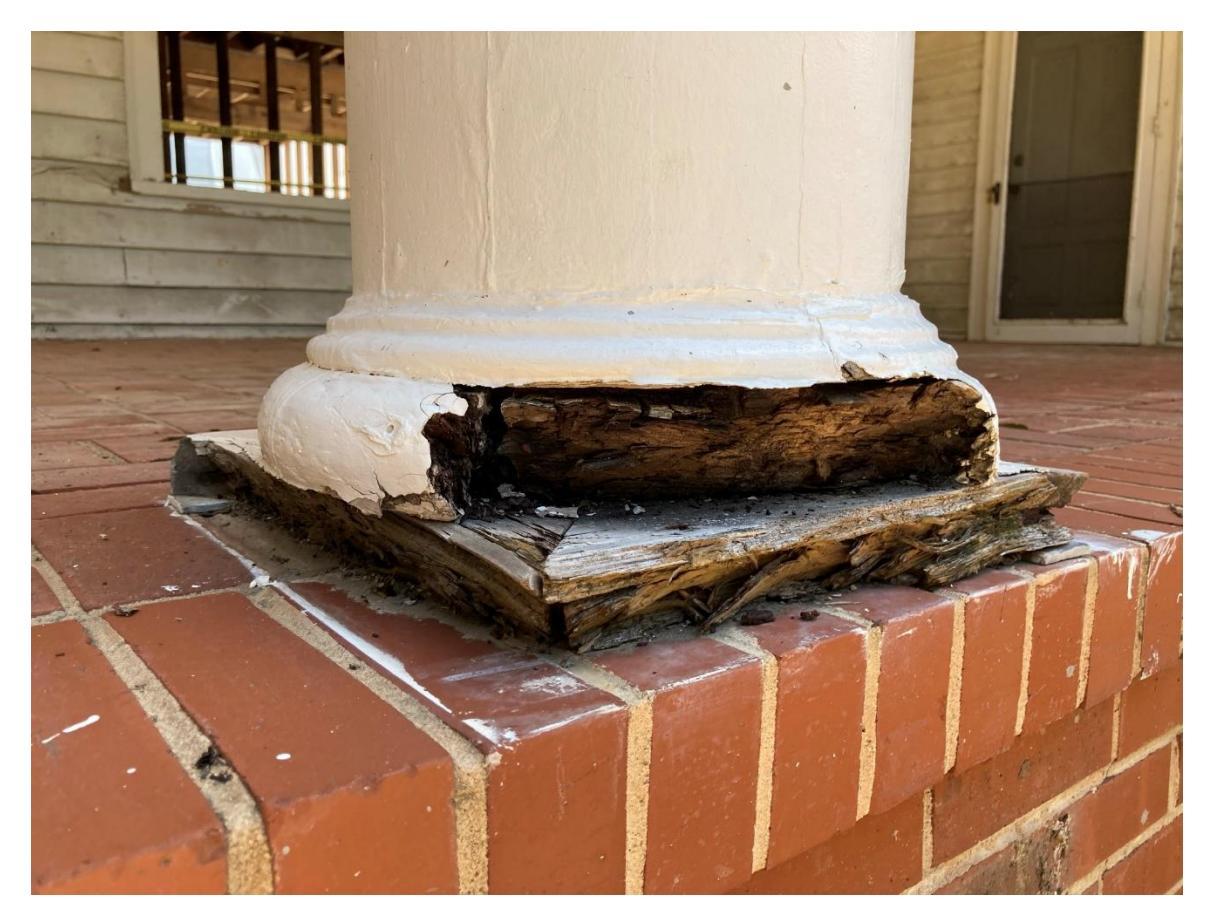
Column S1 base. Shows significant water damage. Metal standoffs, at the four corners of the base, were employed at some point in the past in an attempt to allow air and water circulation under the base.

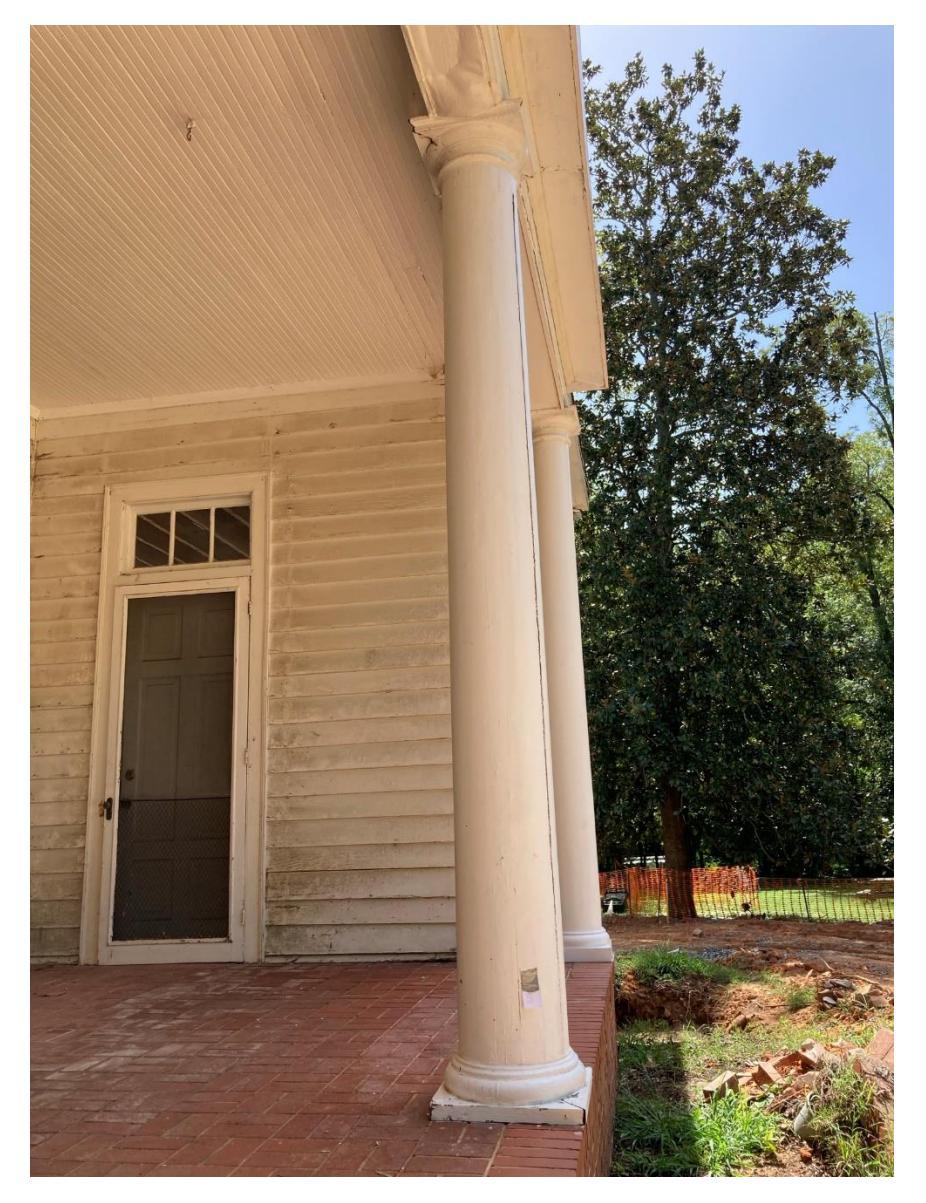
Column S2. Likely an original from the 1920's renovation. All wood. A large split in the finger-jointed wood of the shaft can be seen on the right edge of the column.

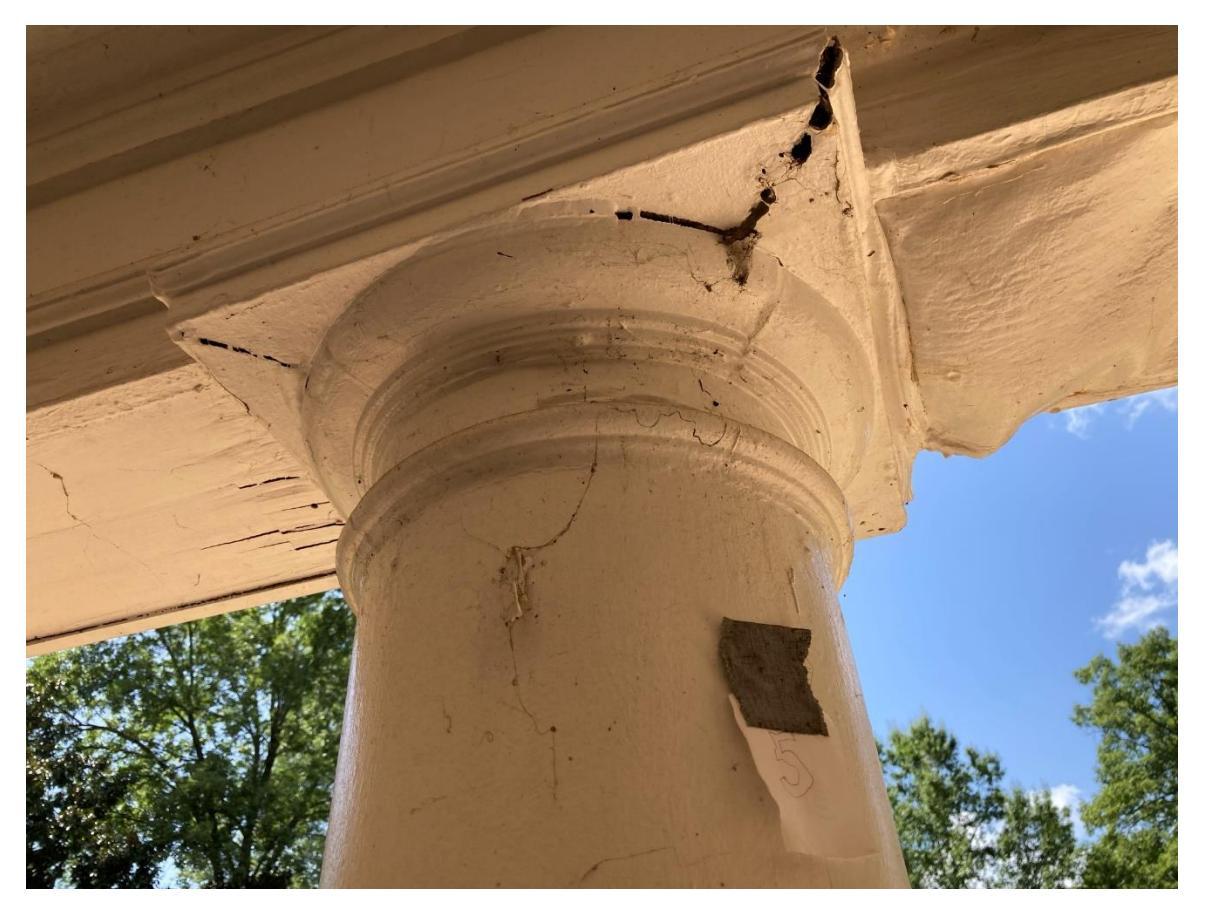
Column S2 capital showing water damage.

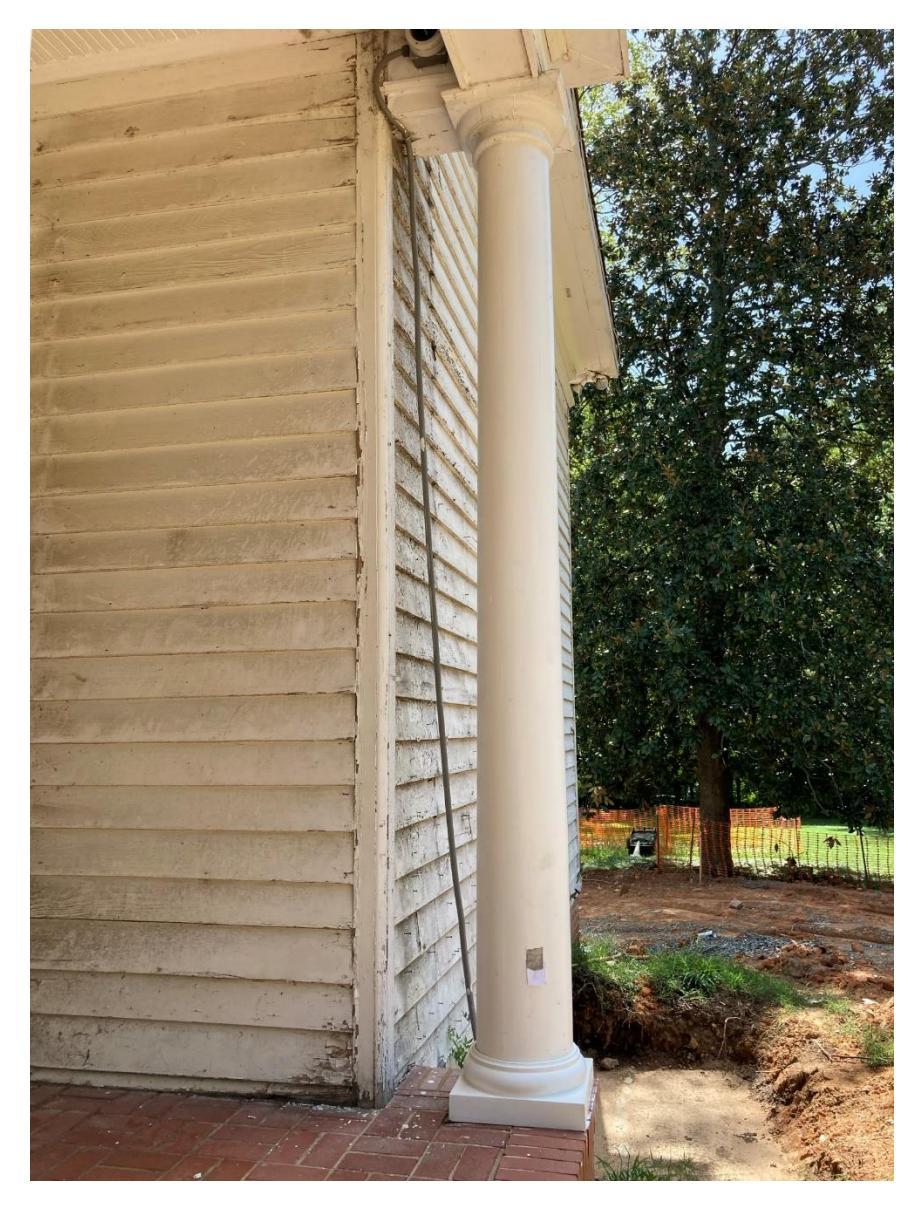
Column S3. Perhaps an original from the 1920's renovation, however wood shaft is narrower than other wood shafts, capital is wood; the base is a replacement furniture-grade structural foam base.
