# COA for 207 W Cameron Ave.

Roof – Gutters – Cornice

Chris Cook – Baker Roofing – September 12, 2023

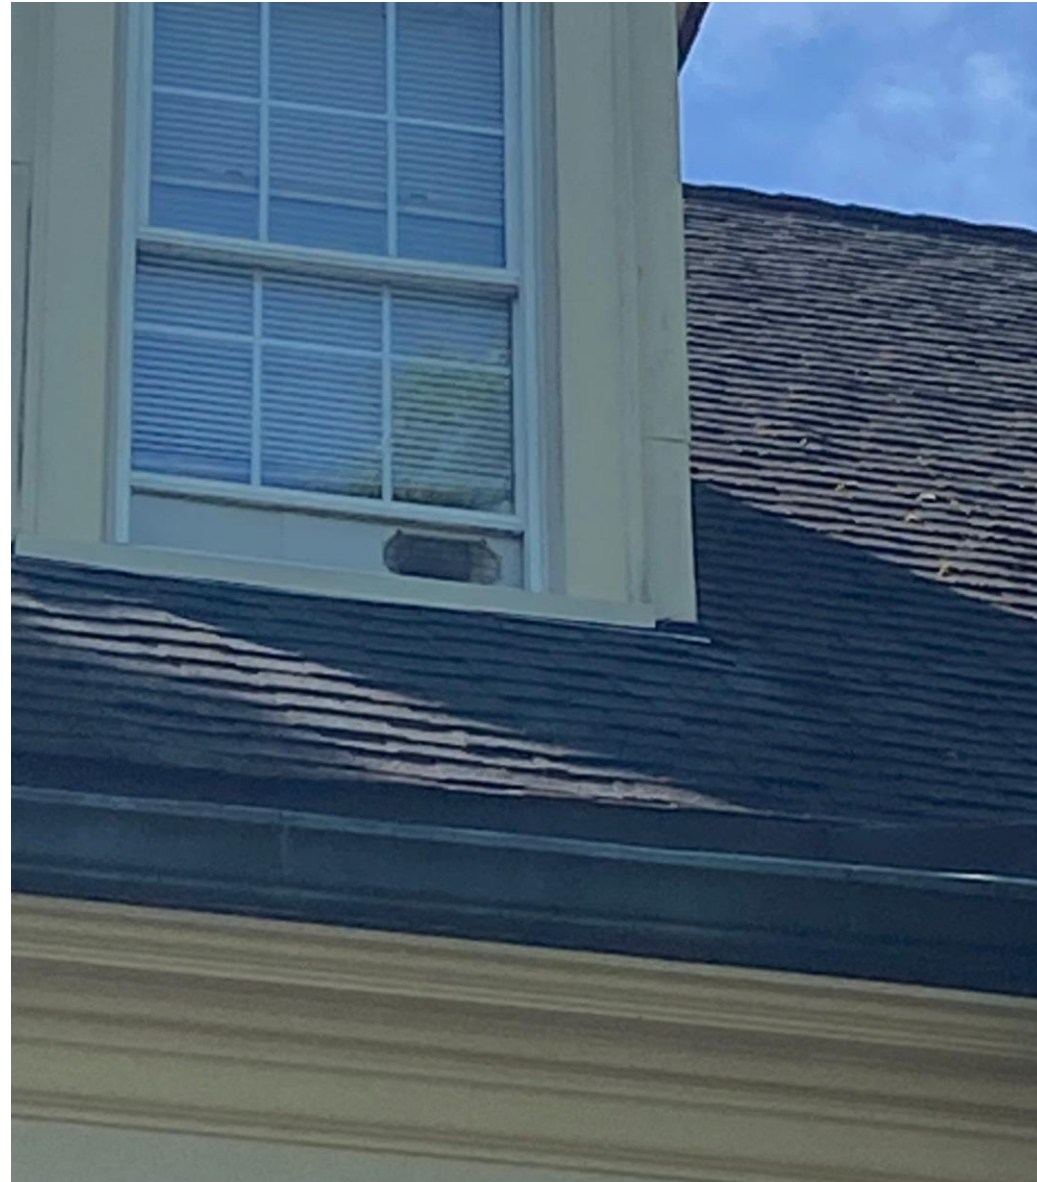
# Single Roof

- Original architectural shingles to be replaced with new/similar color
- CT Landmark Pro
  - Similar color
  - Algae and streak resistant
  - Keep original profile and reveal
  - Replace all flashing/add where needed
    - Drip edge – Berger F8
    - Step flashing
    - Apron flashing (no exposed fasteners)

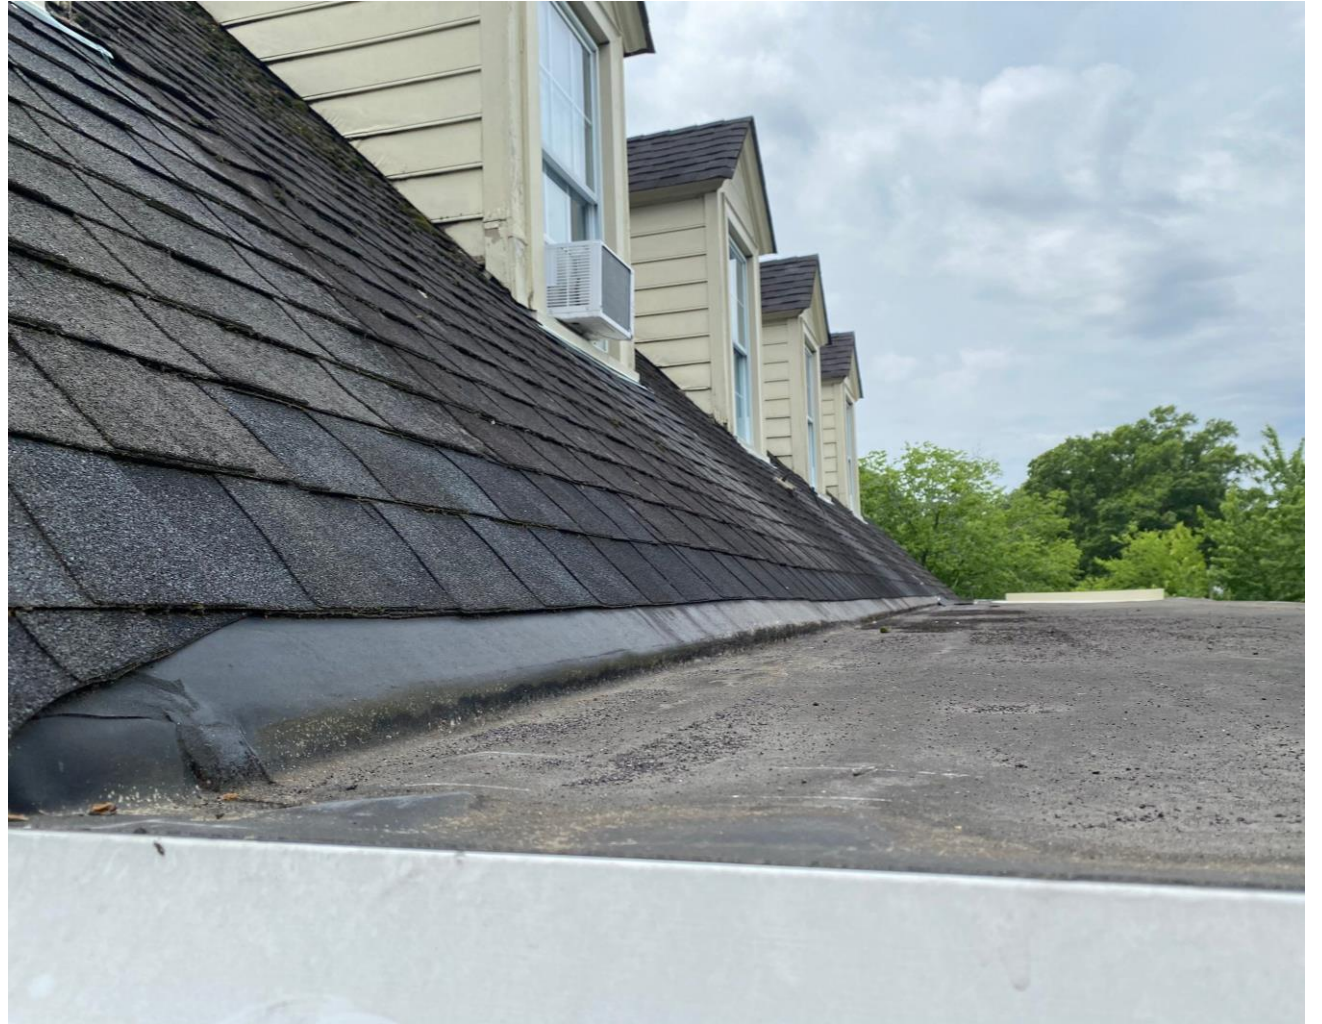
# Flat Roof

- Replace with new EPDM
- Install transition slip sheet to protect from abrasion and chemical breakdown

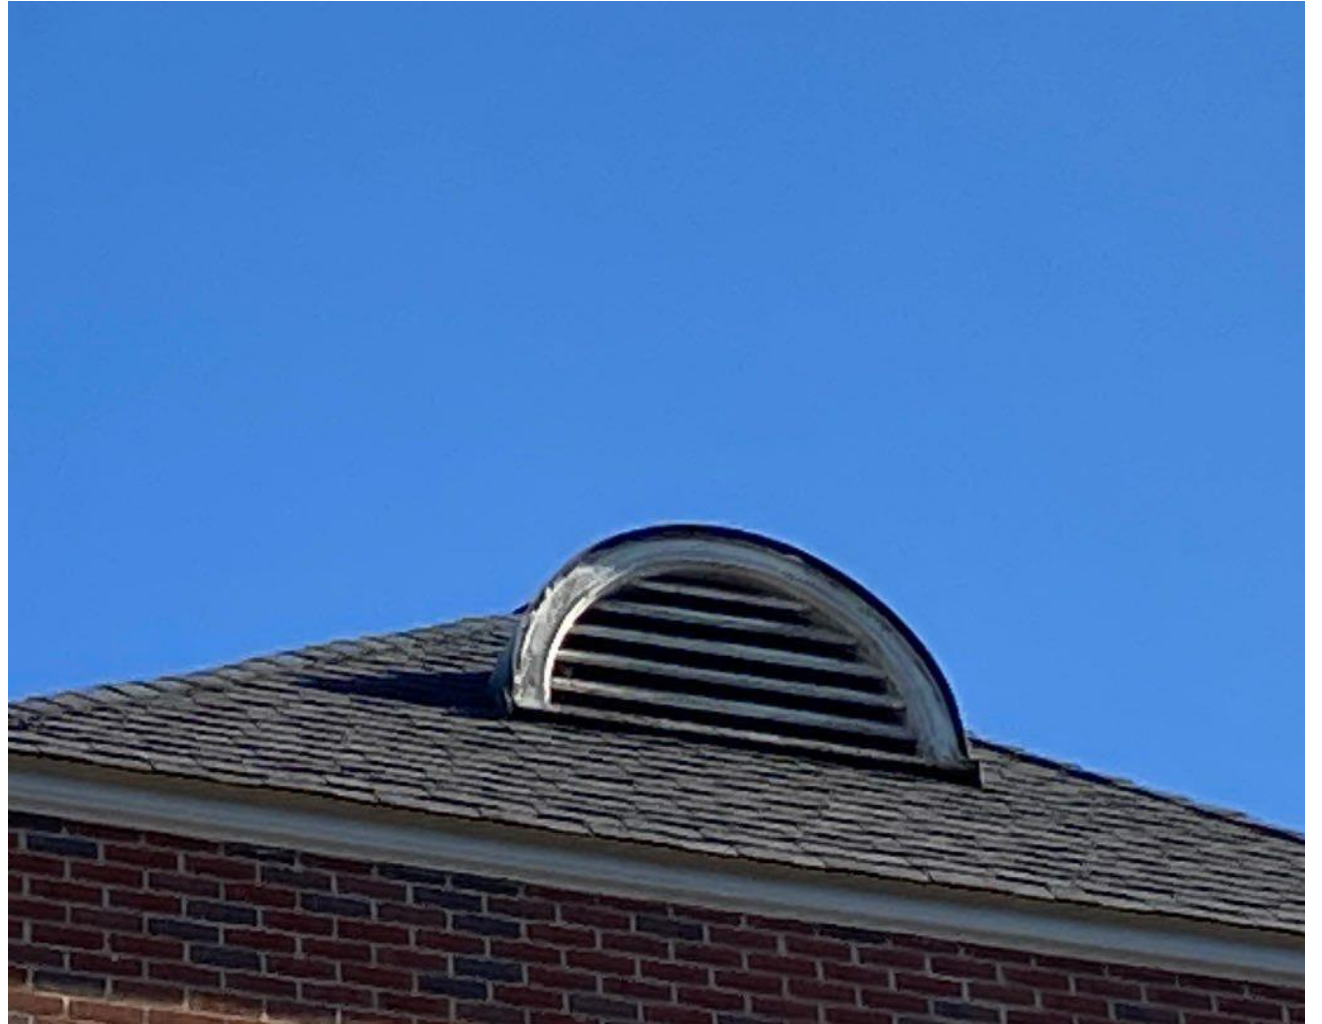
# Louvered Vents

- Replace Copper cover with 16 oz copper

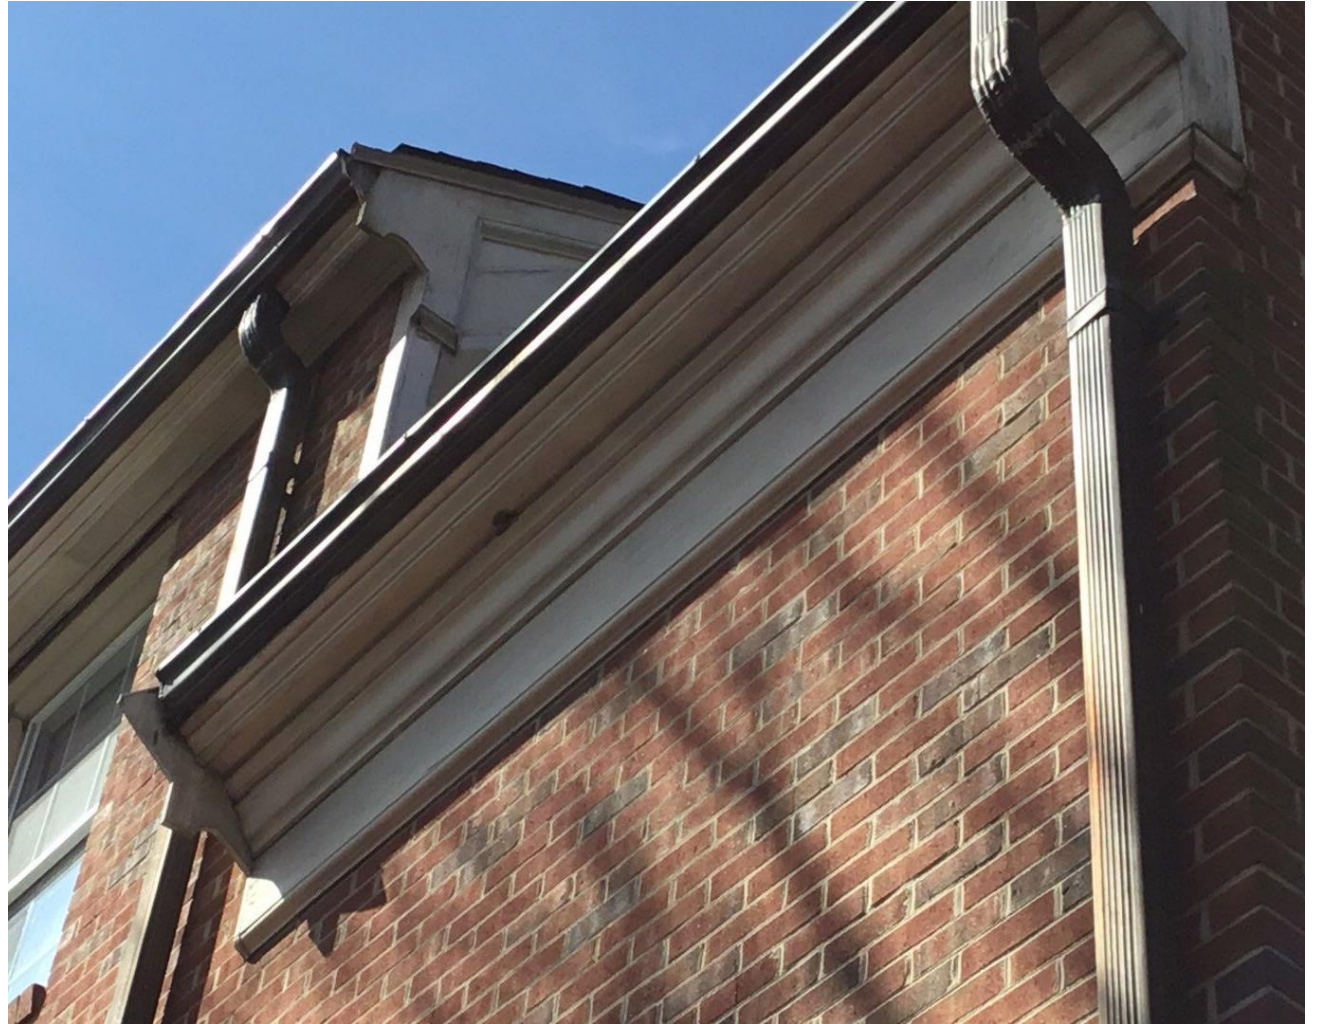
# Gutters and Gutter Guards

- 6" K-style Profile
  - 3"x4" downspouts
- Raindrop Gutter Guards

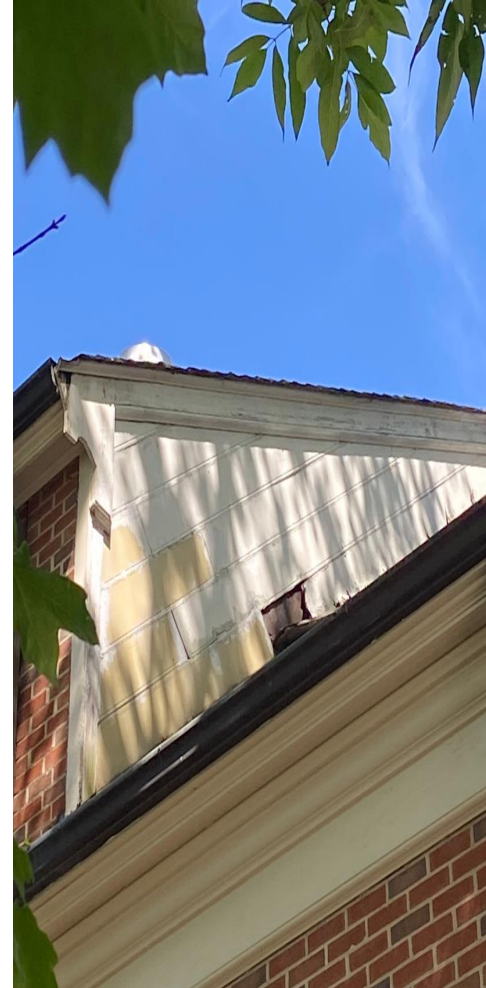
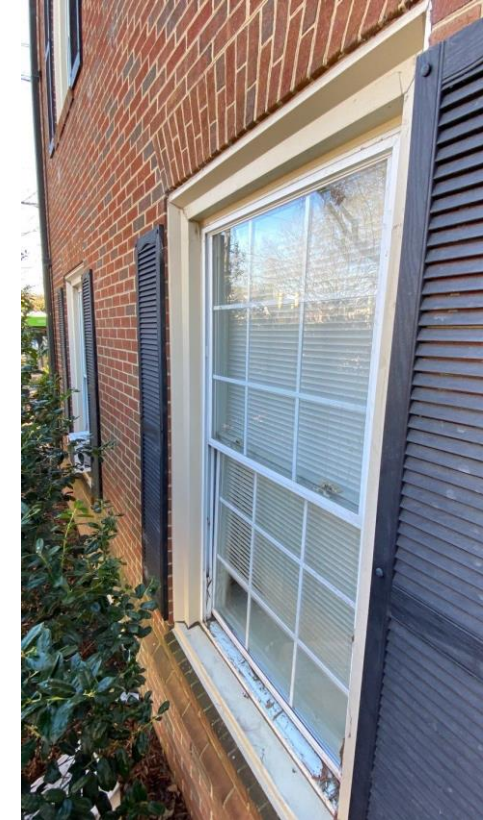
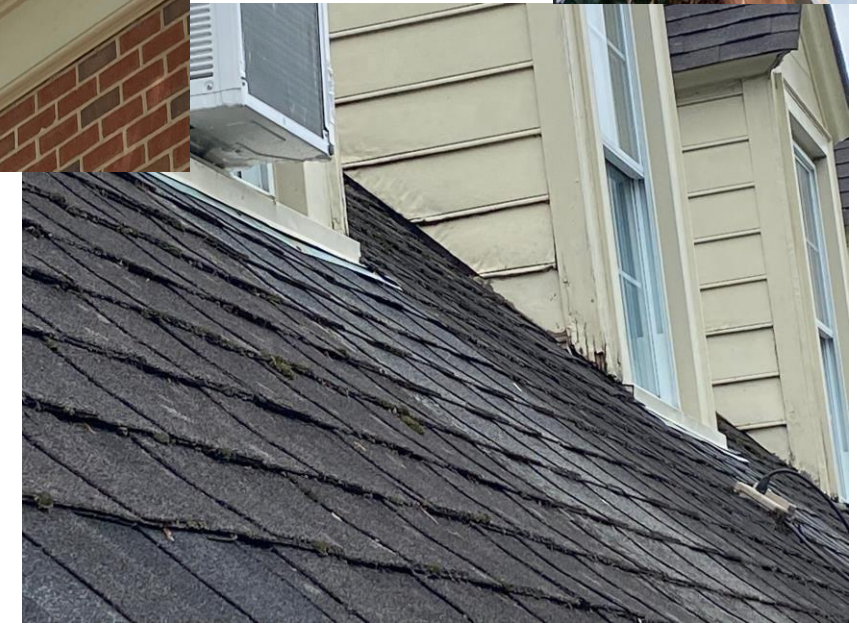
# Items for approval

- Replace siding, trim, and flashing on dormers and rear wing walls with similar profile, James Hardie lap siding
- Remove existing window trim wrap and install new aluminum of similar color
- Metal will be color matched and all items will be painted to match existing

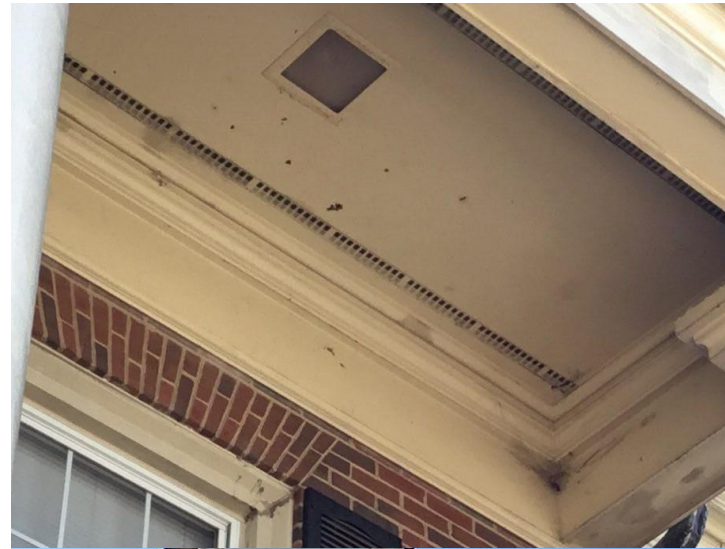
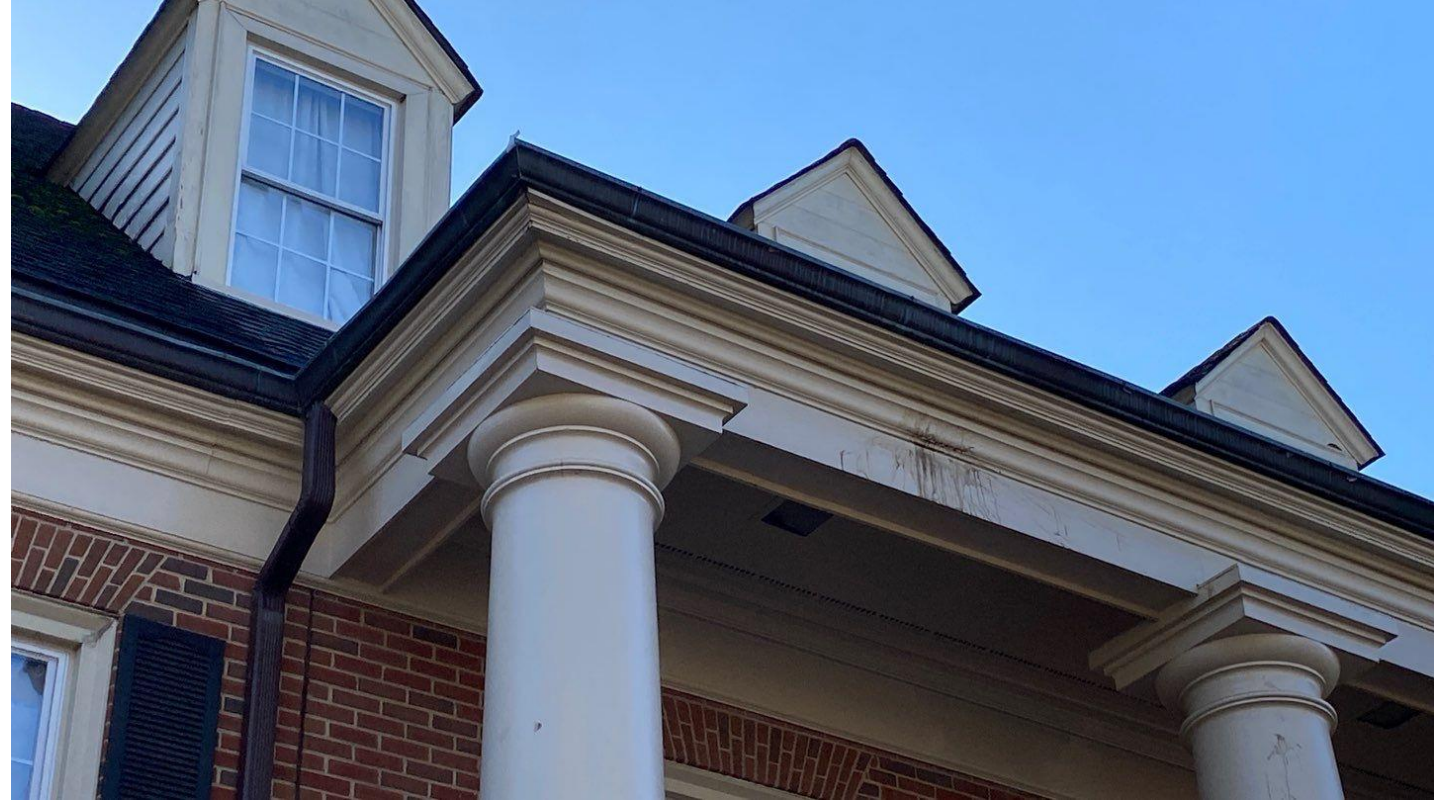
# Items For Approval Continued

- \* Remove existing front entry ceiling panels, replace with new James Hardie panels, installing new similar style soffit vents

- \* Replace existing wood trim cornice with non-rot James Hardie trim, using PVC for decorative details

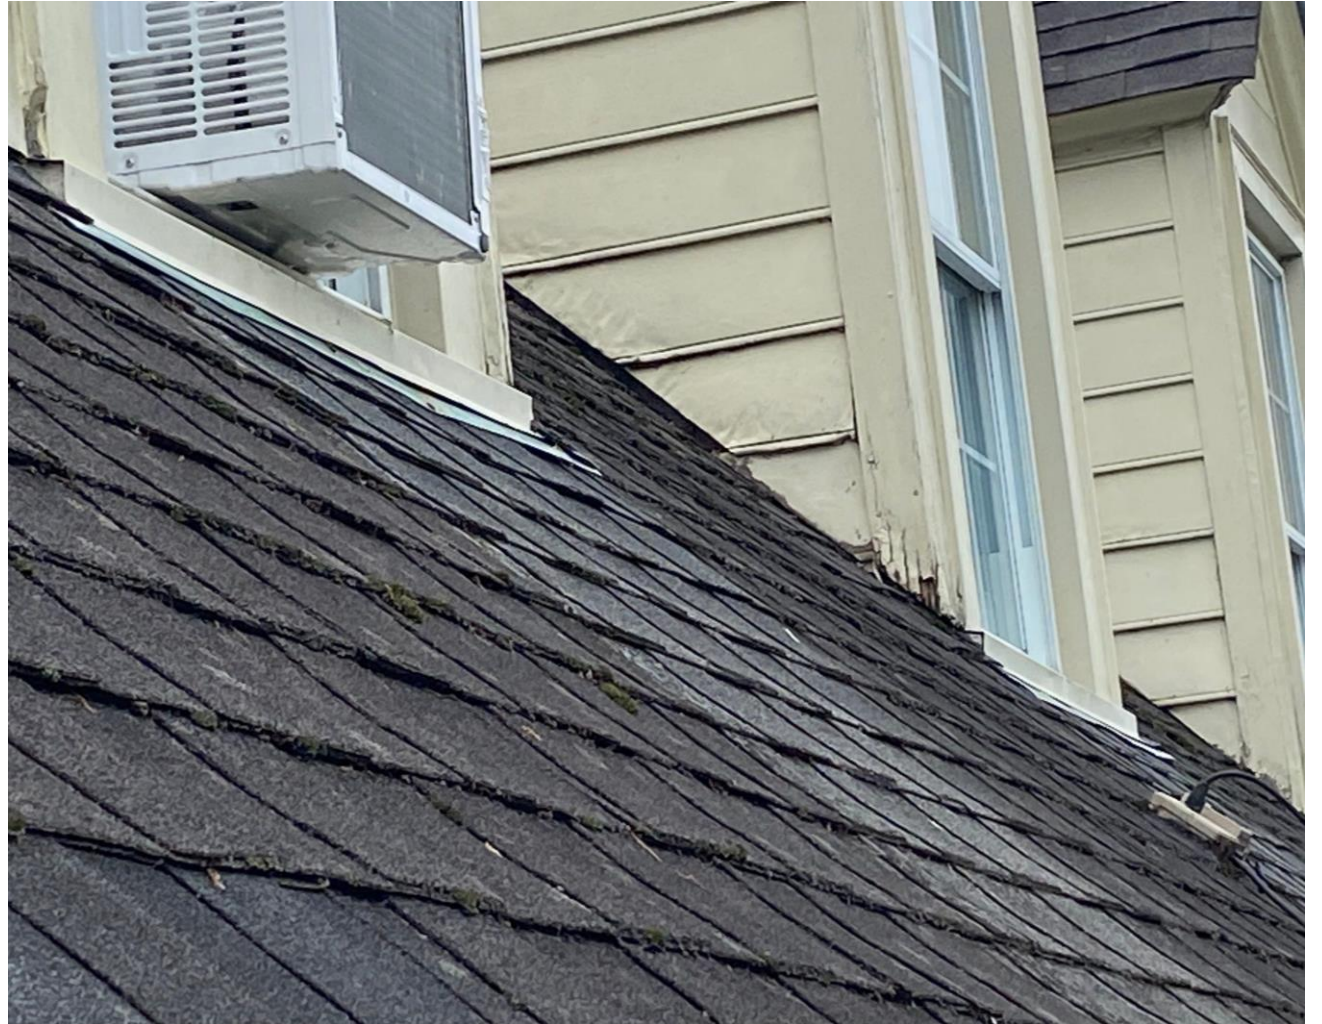
# Dormer Repairs

- Siding shows signs of water damage
- Corners will be replaced with James Hardie 5/4 trim
- Lap siding will be replaced with JH 8-1/4" lap
- Moulding replaced with similar profile PVC
- Window trim wrapped with new metal
- Painted to match

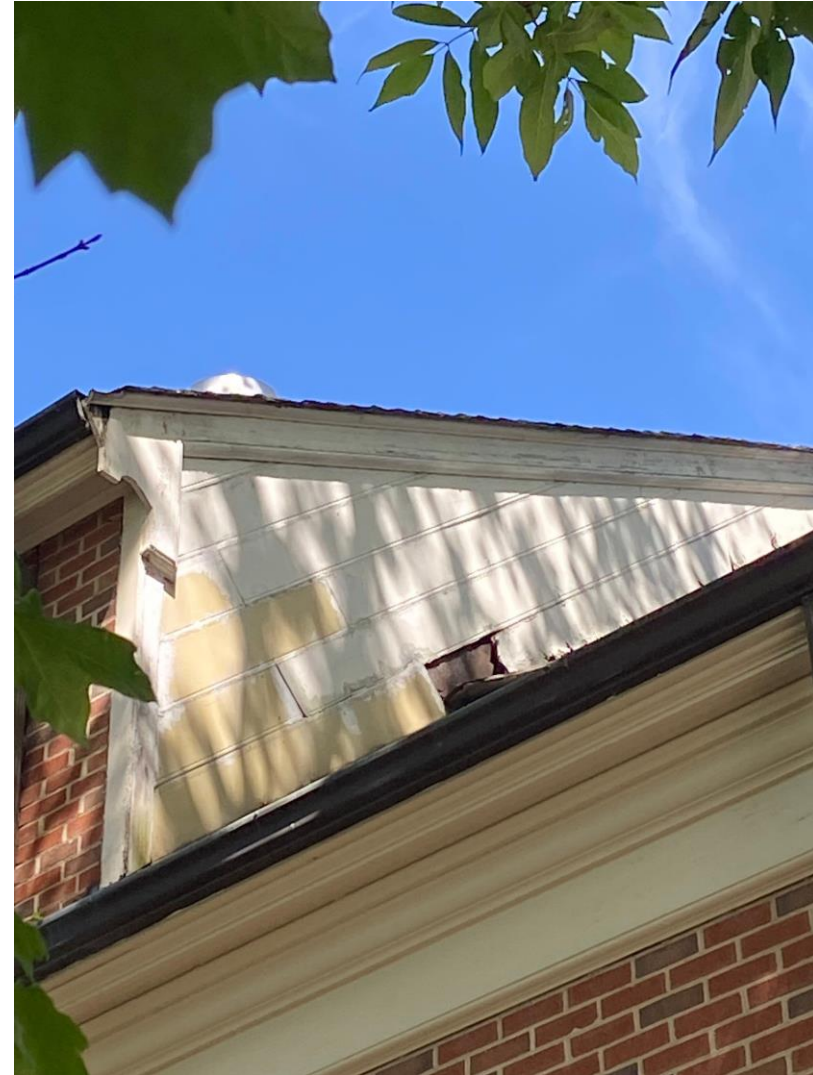
# Rear Wall Siding

- Improperly repaired siding will be corrected with repairs
  - Slanted installation without proper laps has caused degradation and water infiltration
- Water resistant barrier will be installed over wall sheathing
- Siding will be installed horizontally, vertically laps matching front dormers
- This installation will meet current James Hardie installation best practices

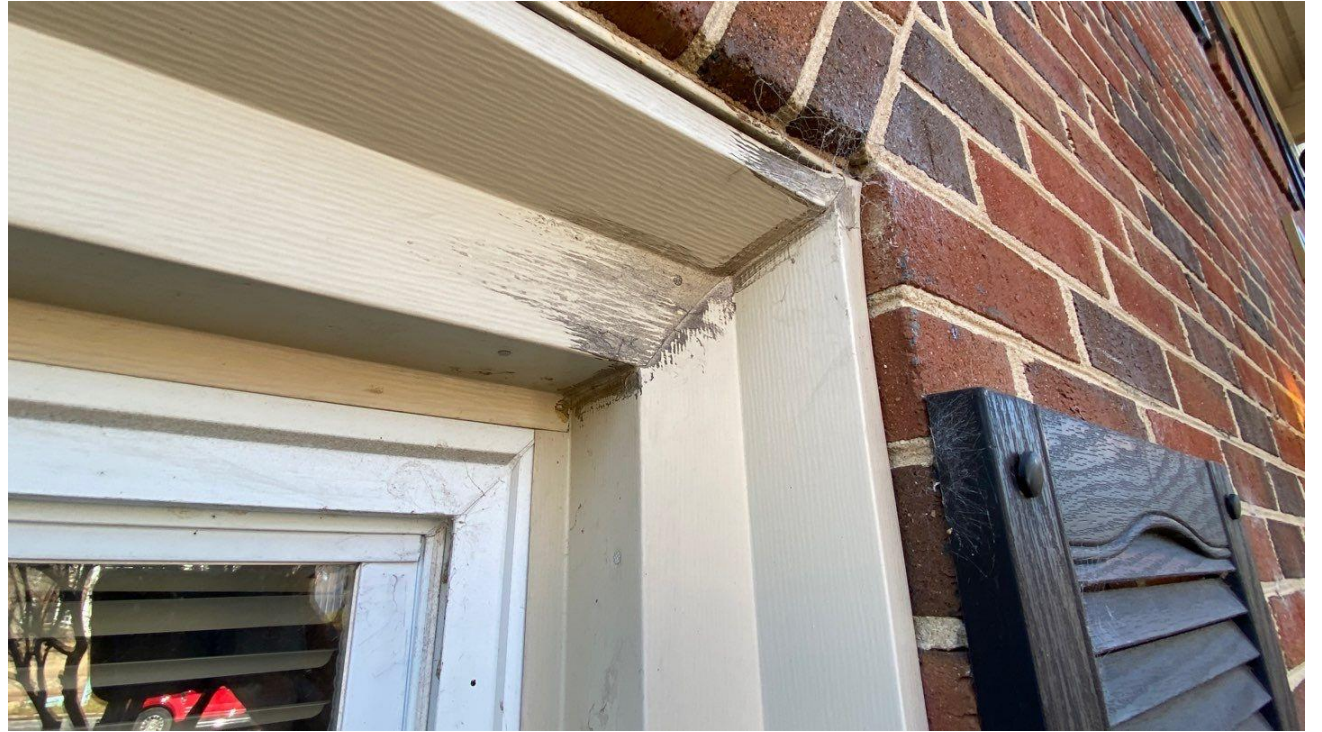
# Window Trim Wrap

- Improper installation has caused deterioration of caulk and metal
  - This has resulted in water infiltration and an overall unsightly appearance
- New aluminum will be properly integrated, with proper laps.
- New caulk will match metal

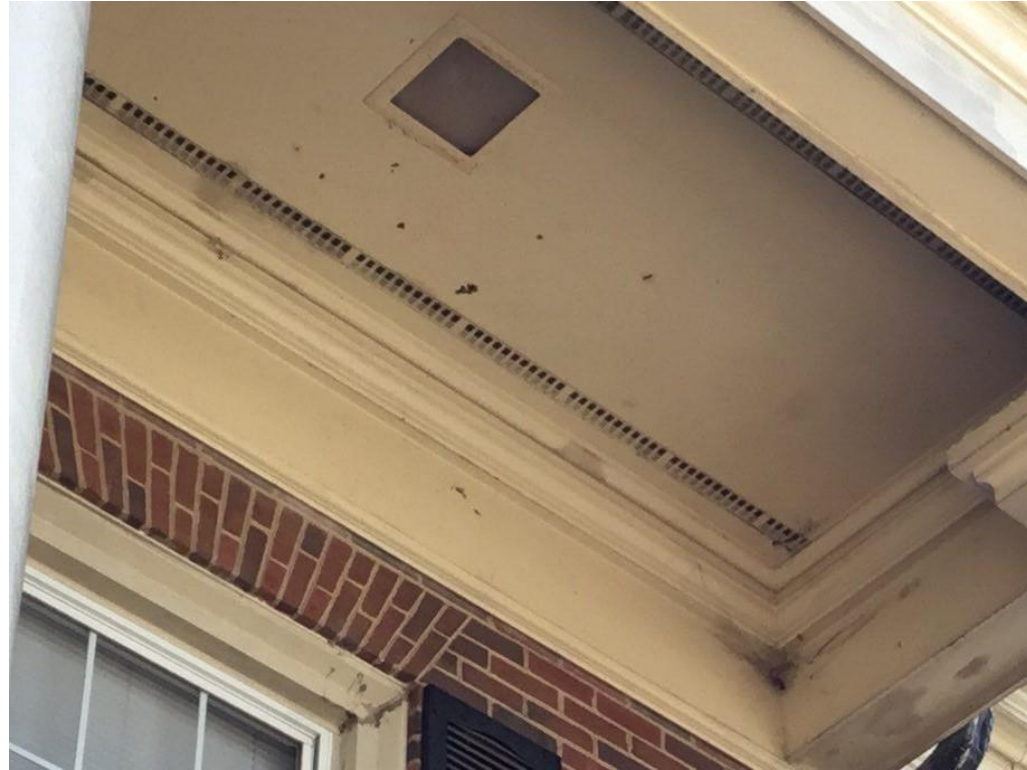
# Front Entry Ceiling

- Shows signs of water staining
- Areas where ventilation is compromised with paint
- Deteriorated Paint
- New vents will be installed
- Paneling will be replaced with James Hardie panels
- Trim replaced with combination of JH and PVC

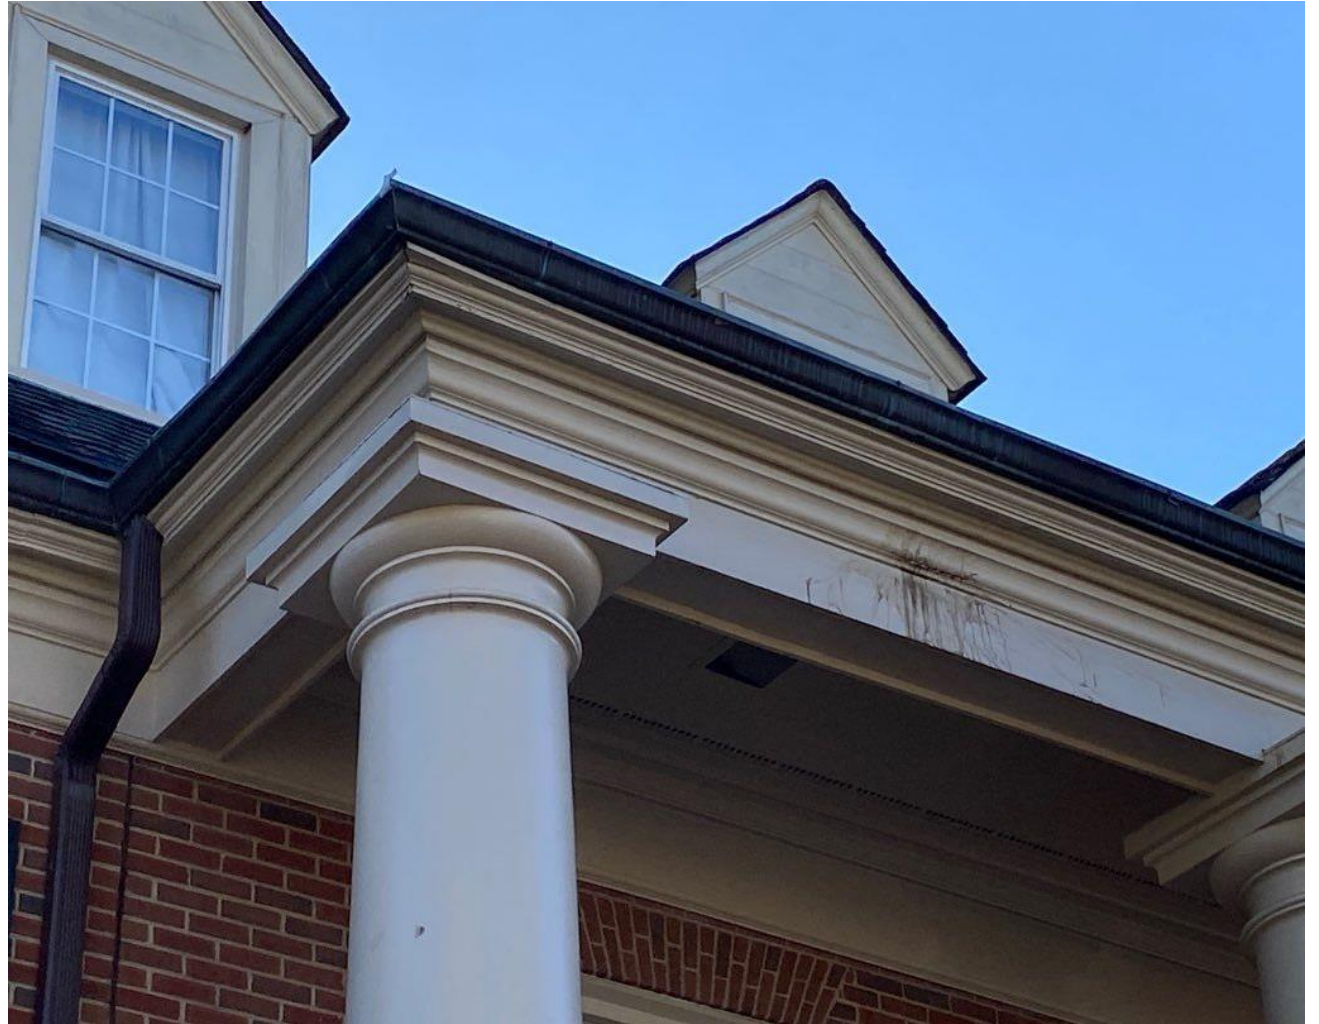
# Cornice Trim

- Staining and deteriorated wood to be replaced with combination of James Hardie and PVC
- PVC will only be used for detailed areas not available in JH
- New flashing will be added to prevent future water infiltration
  - Tops of columns
  - Gutter shelf
