Staff Report

*Report prepared by Town of Chapel Hill Staff
June 7, 2019*

Proposed Interim Remedial Measures with Coal Combustion Products (CCPs) Location and Cover Evaluation

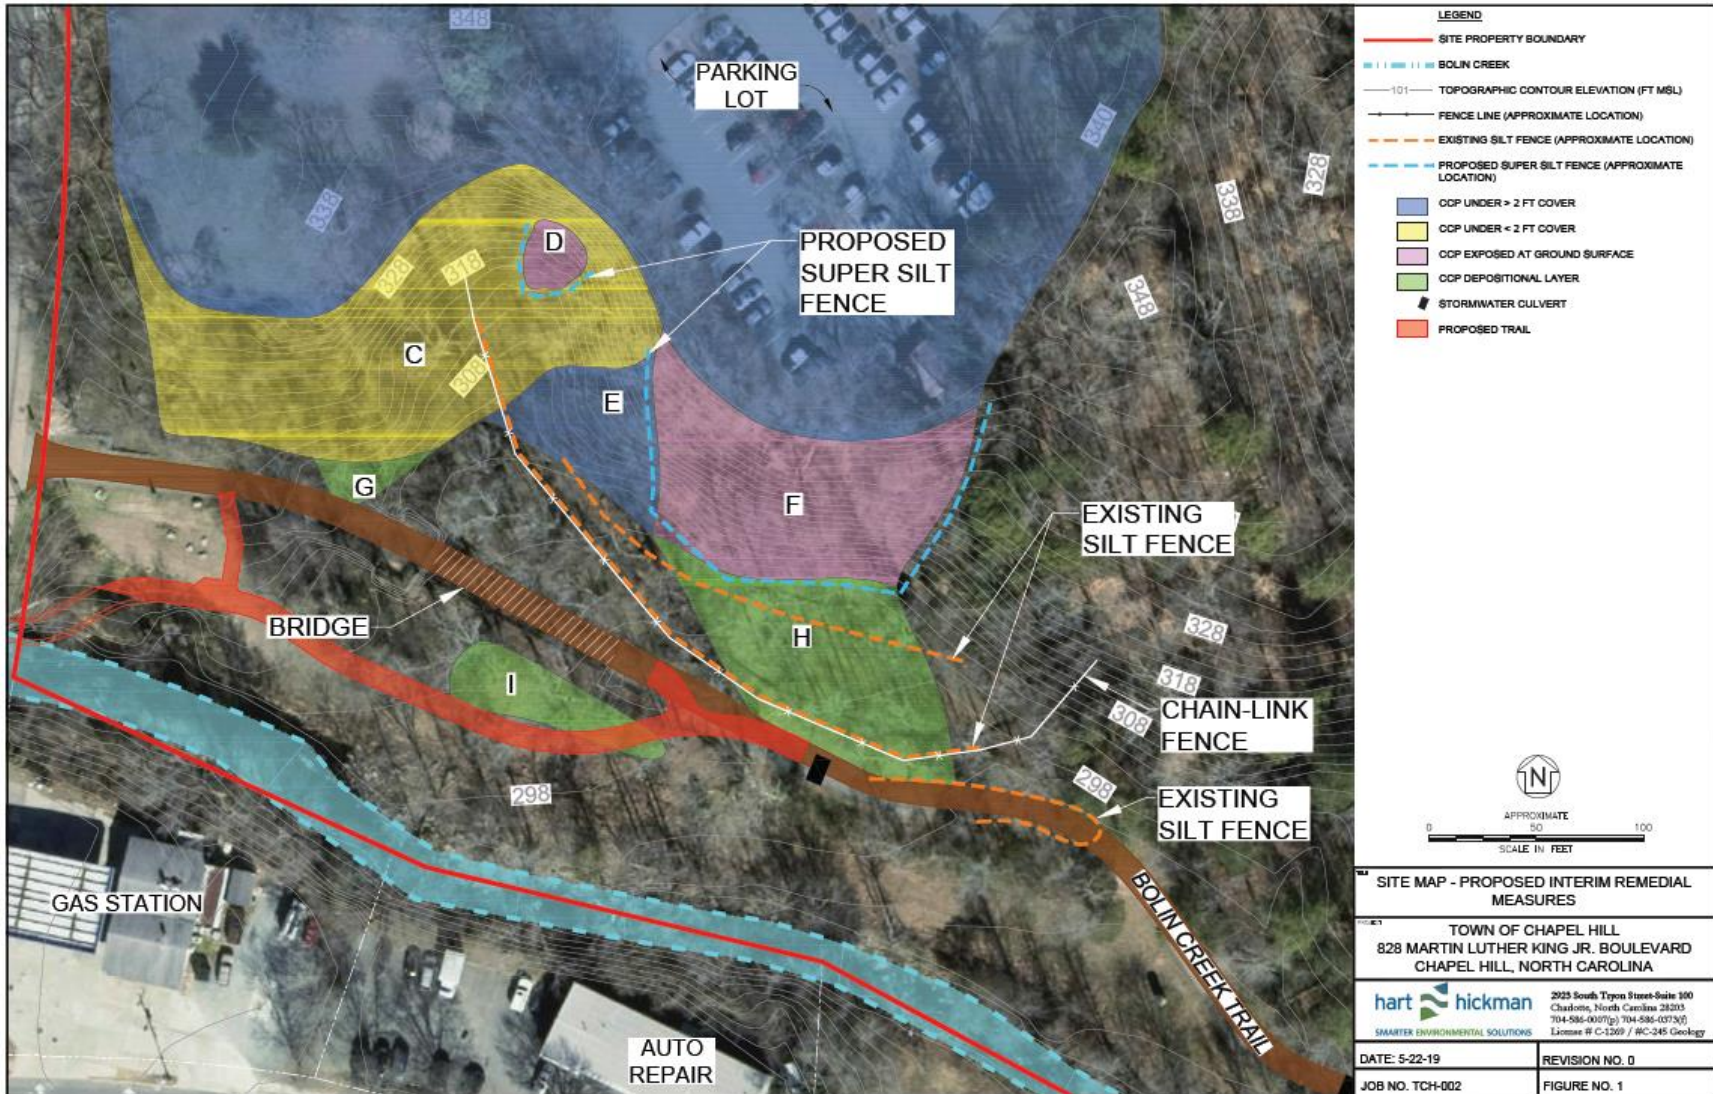
Remove deposits of CCPs and contaminated soil in the areas next to the trail and the creek (see green areas on map below). This work includes the removal of approximately 6-12" of CCPs and contaminated soil. The materials will be transported to a facility that is permitted to receive them. For the purpose of evaluating post-removal risks, soil samples will be collected after CCPs and contaminated soils are removed. We will then have clean soil brought in to replace the amount that was removed.

Repair existing silt fence (see orange dashed lines on the map below) and add additional silt fencing to help control erosion from the embankment (see blue dashed line on map below). Currently, there are two layers of silt fencing on the site – one at the base of the embankment and another at the base of a black chain link fence that separates the Bolin Creek Greenway from the embankment. The silt fencing would be monitored and repaired as needed.

Hydroseed the areas of the embankment where CCPs are currently exposed (see the pink areas on the map below). Hydroseeding is the process of adding a concentrated liquid of seed, mulch, and nutrients to quickly establish grass or another vegetative cover. The goal of this measure is to reduce the likelihood of CCP erosion and further contamination of the soils next to the trail and the creek. Due to the steep slope of the embankment, our consultants recommend that we evaluate this technique by first testing a small area.
