Discuss Budget Proposal for Interim Measures to Begin Addressing Coal Ash Clean-up and Monitoring

May 15, 2019

Coal Ash Disposal Site Remediation Project

Bolin Creek Trail Risk Assessment

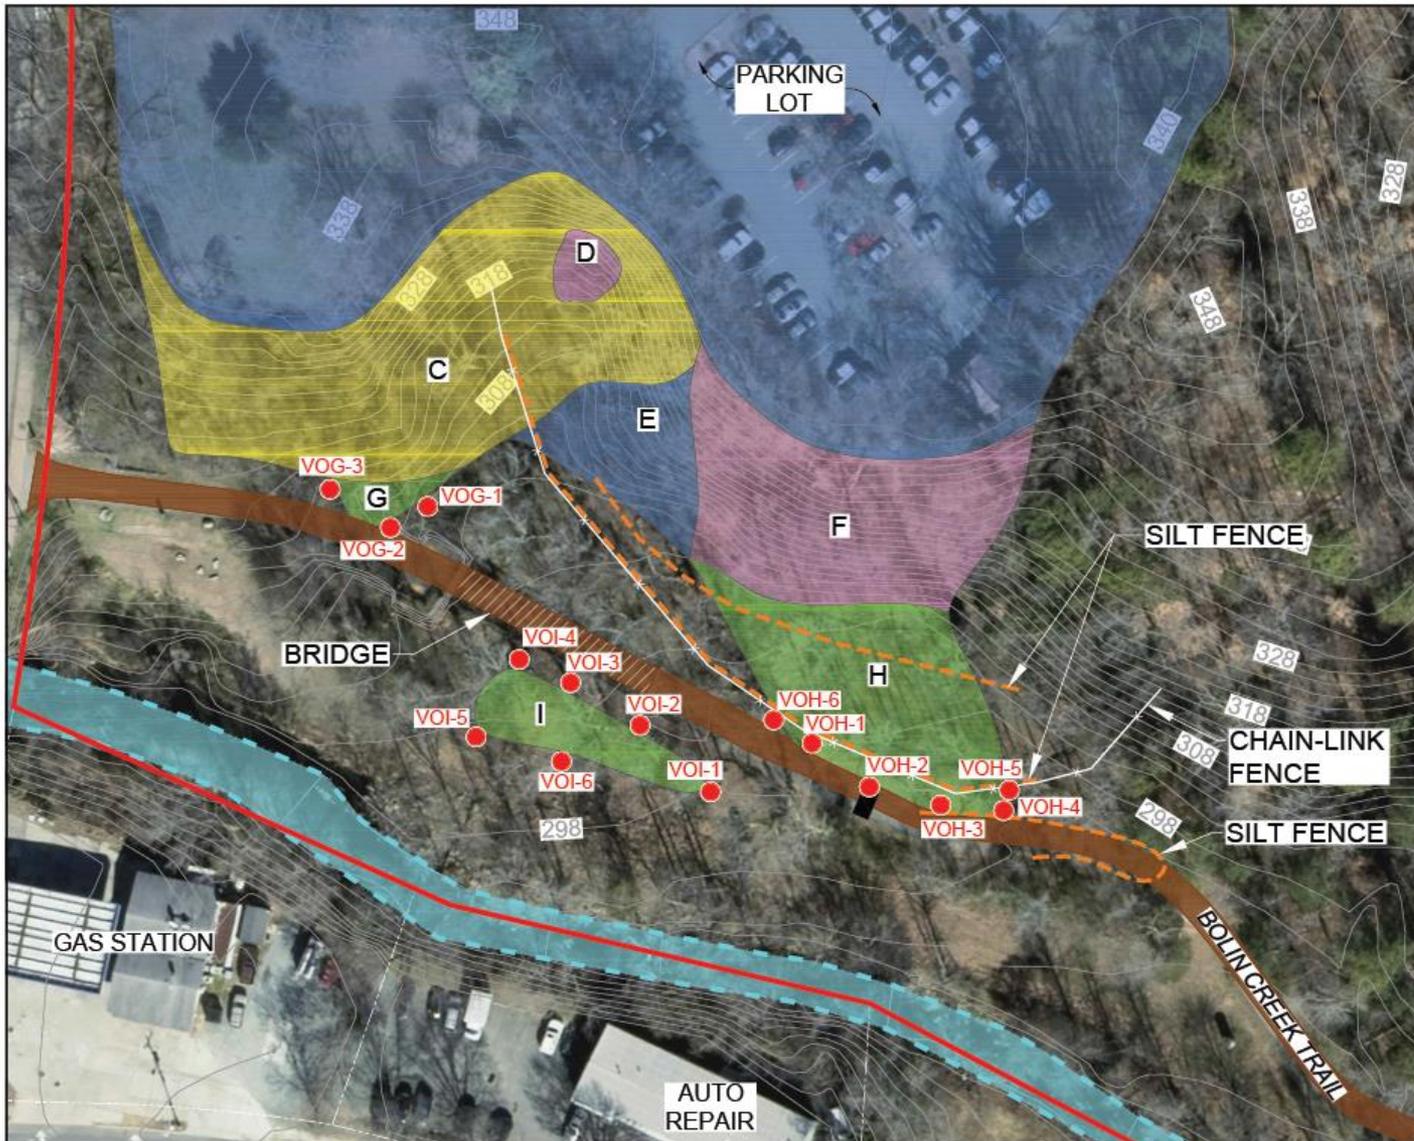
DATE: 5-10-19	REVISION NO. 0
JOB NO. TCH-003	FIGURE NO. 1

SITE MAP - EXISTING CONDITIONS

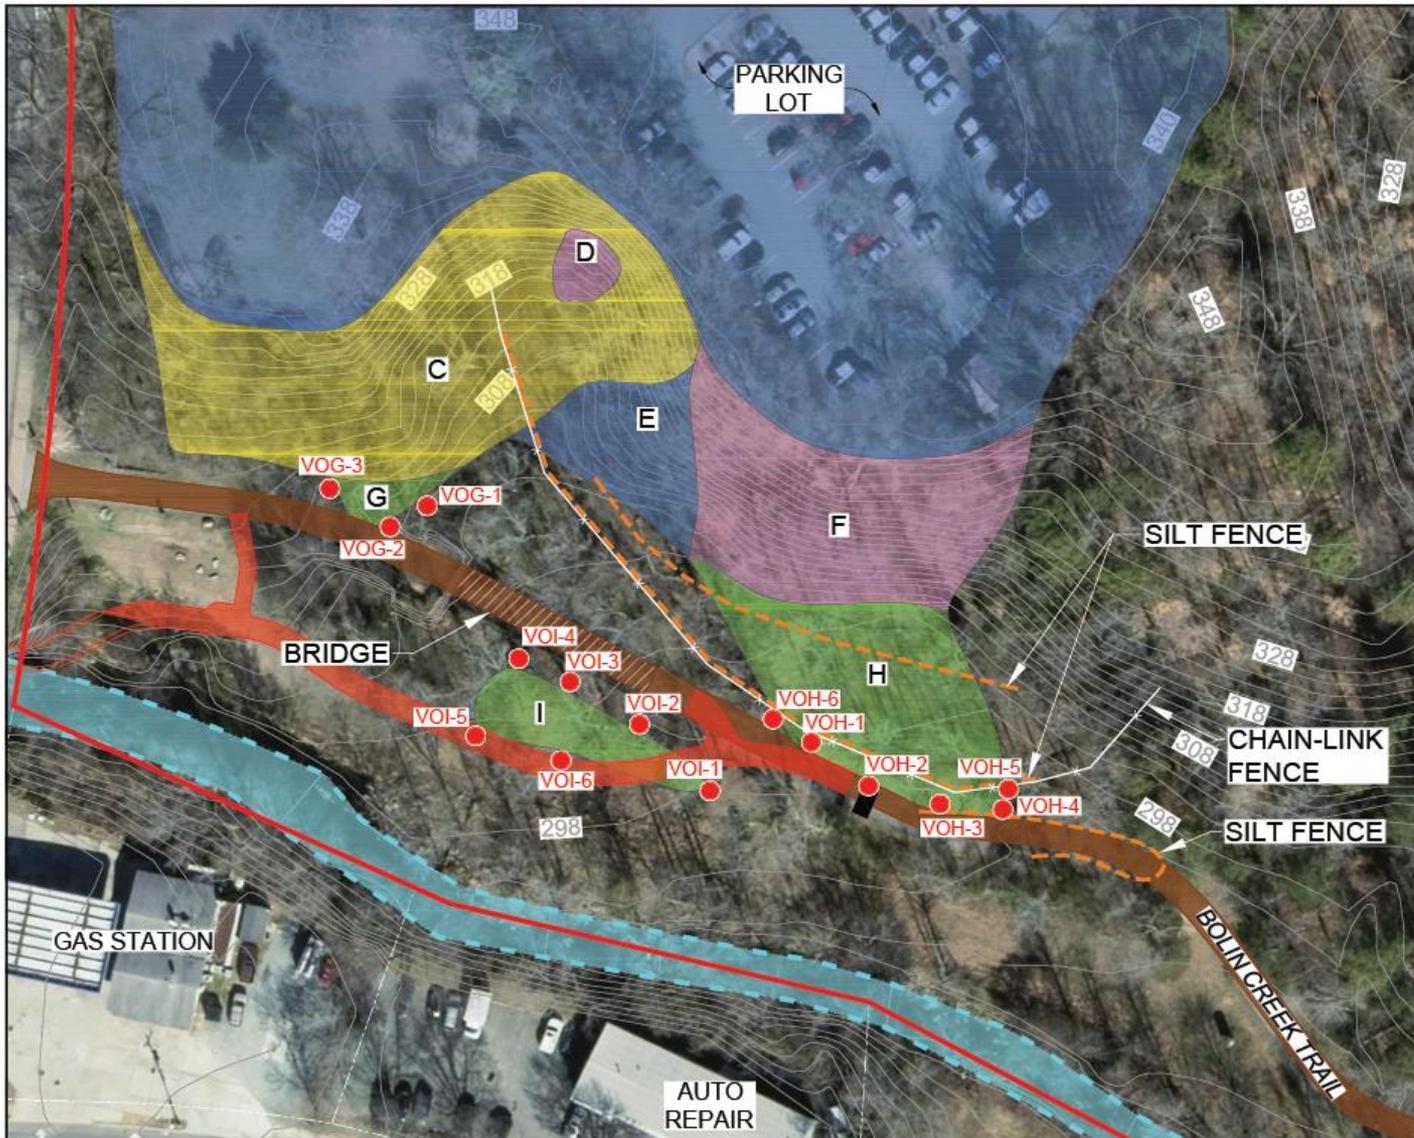
DATE: 5-10-19 REVISION NO. 0
JOB NO. TCH-003 FIGURE NO. 2

SITE MAP - PROPOSED TRAIL LOCATION
