# **KIM LEVELL DESIGN**

# 510 Hopper Lane | Certificate of Appropriateness

Version 1.0 – Issued 13th May 2021

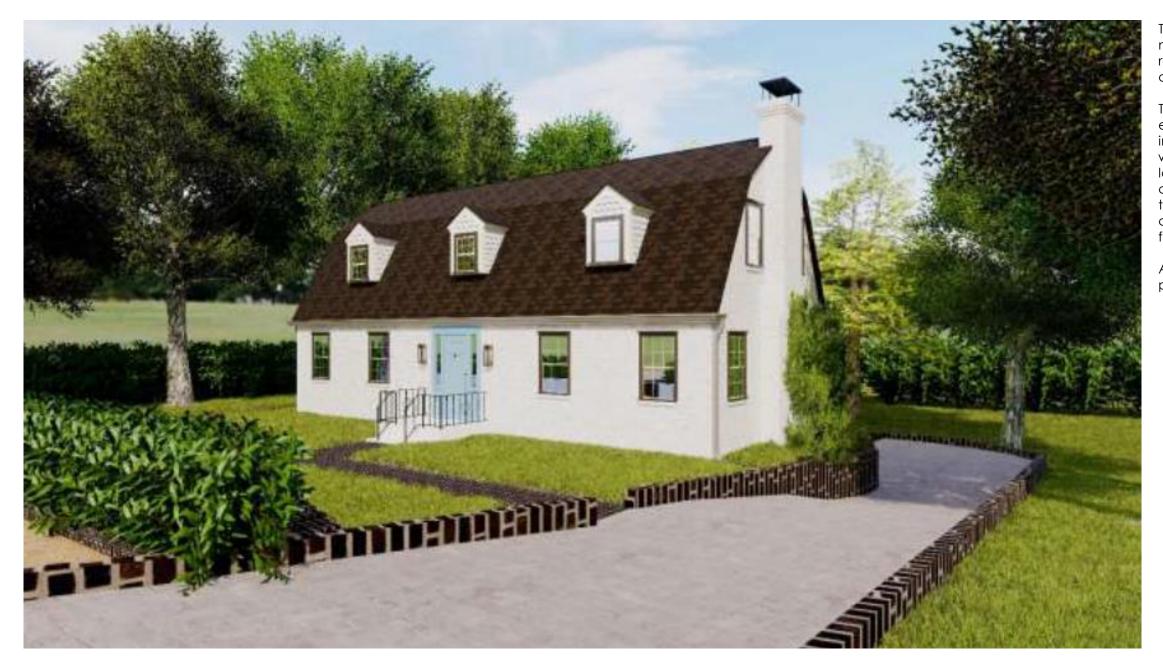
Project Overview

The scope of the project includes minor modification of the existing landscaping and restoration of original architectural features of its design.

The project scope is comprised of demolition of an existing brick parking pad and concrete slate, installation of a semi-permeable brick paver walkway, semipermeable chapel hill gravel landscaping area, installation of a reinforced concrete block wall with new drainage system to the front entrance, change finish, replace gutters, change roof tiles, add lighting and landscaping features.

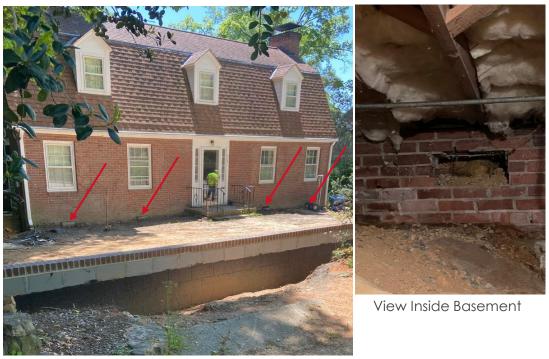
Drains that was Installed on front wall to allow stormwater inside the building into the basement (Red Arrows)

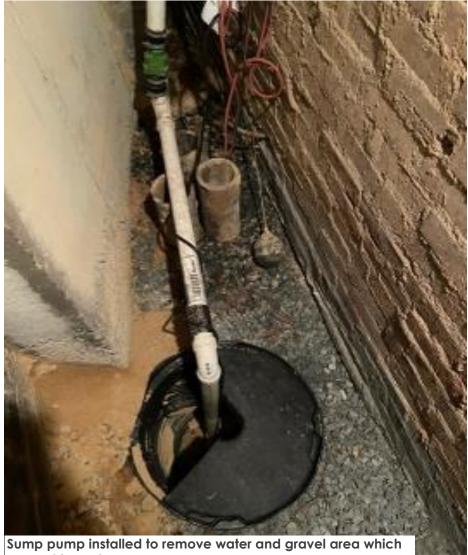
Area where soil is collapsing - Water runs into the space during every storm and is heavy during heavier times. It is now just starting washing in.

never dries out.
