510 Hopper Lane | Certificate of Appropriateness

Version 2.0 – Issued 10th June 2021

Project Overview

The purpose of this presentation is to provide clarification on the necessity of performing minor and major works on the property situated at 510 Hooper Lane, located within the boundaries of the Franklin-Rosemary Historic District of the Town of Chapel Hill, to preserve the structural integrity of the building allowing it to be maintained and preserved as an important historical asset to the local community and to its residents.

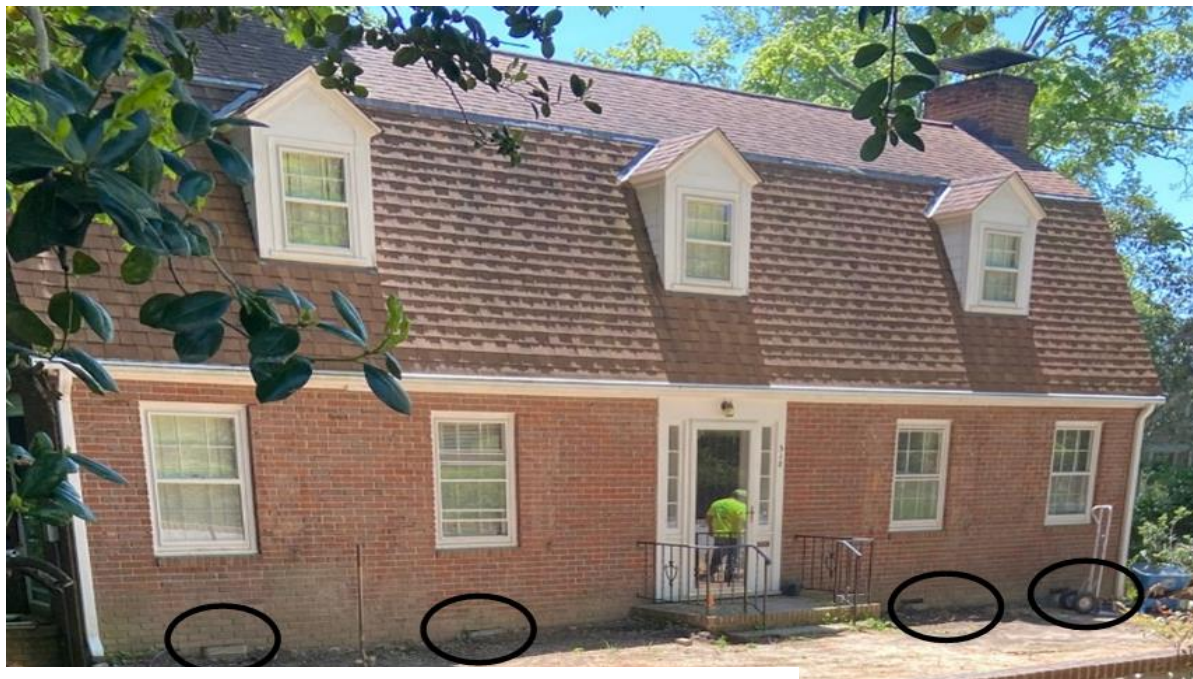
Image 2 | Cleared Front Yard – Basement Vents

- Plantings and Landscaping Blocking Vents;
- Soil washing through vents;
- Previous Measures taken;
- Current Conditions: Excess Humidity, Efflorescence, Soil Slide & Mold Growth.

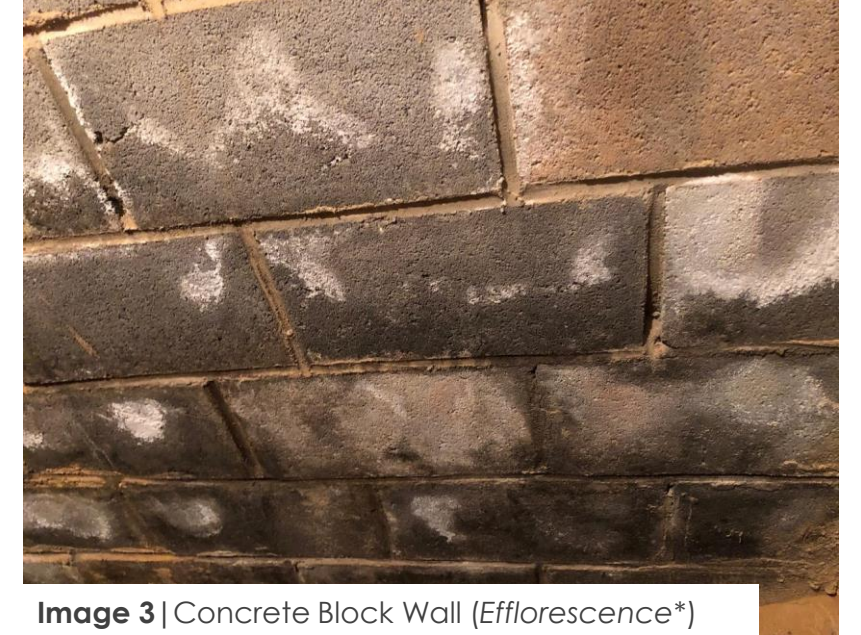
Image 3 | Concrete Block Wall (Efflorescence*)

* **Efflorescence** (which means "to flower out" in French) is the dissolved salts deposited on the surface of a porous material (such as concrete or brick) that are visible after the evaporation of the water in which it was transported. The moisture that creates efflorescence often comes from groundwater, but rainwater can also be the source. Efflorescence alone does not pose a major problem, but it can be an indication of moisture intrusion, which may compromise the structural material.

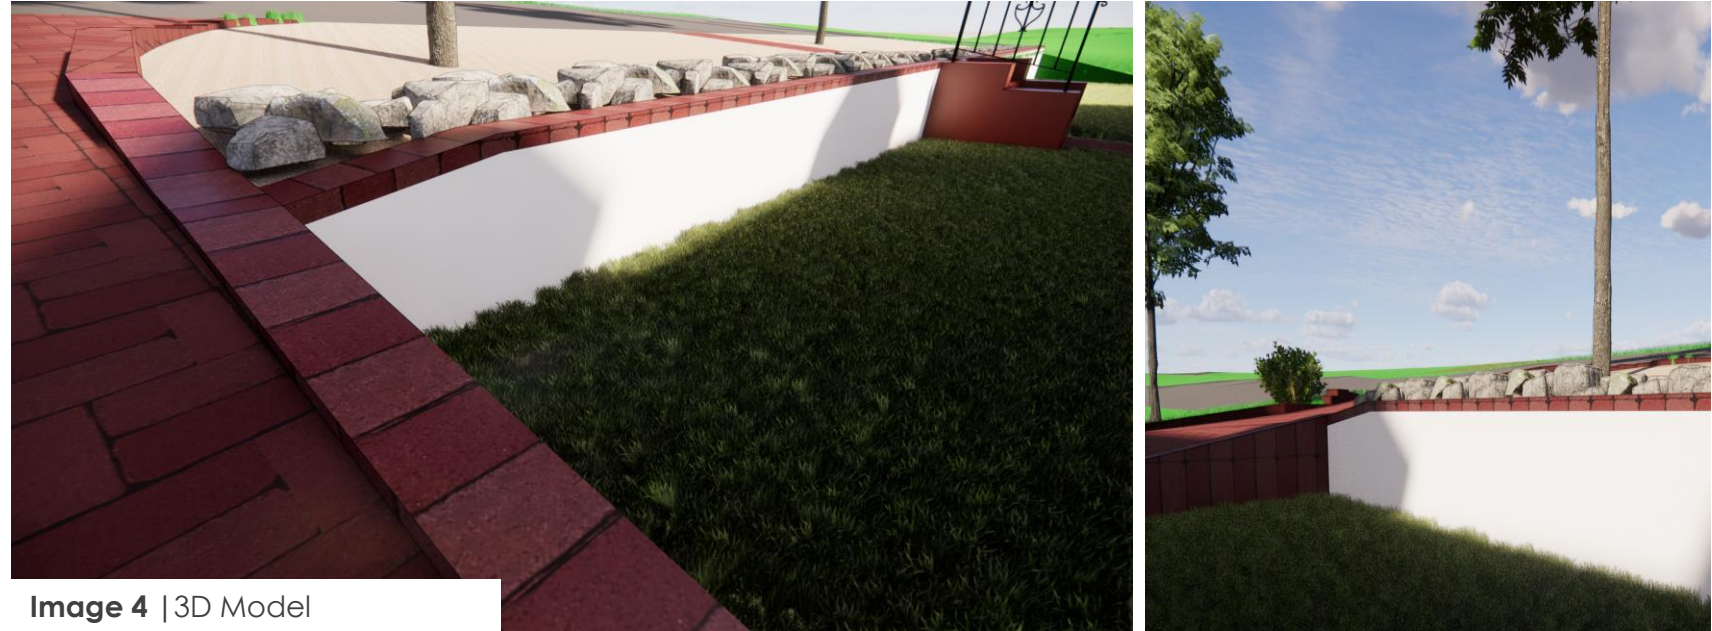
Image 4 | 3D Model

- The brick cap on the new wall was designed to match with the brick wall of the driveway to make it seem part of the property and not just a new element that does not fit.
- The brick cap will also not be visible from the street and any sign of the wall will be covered by the reintroduction of a fieldstone wall.
- The wall received a stucco treatment and white paint on its interior side). The white paint was relevant to the site as it matches with overall colors of the property, and it is not visible from any angle outside the property.
- The new steps are constructed with same brick of brick cap to match with existing driveway and brick wall on its edges.

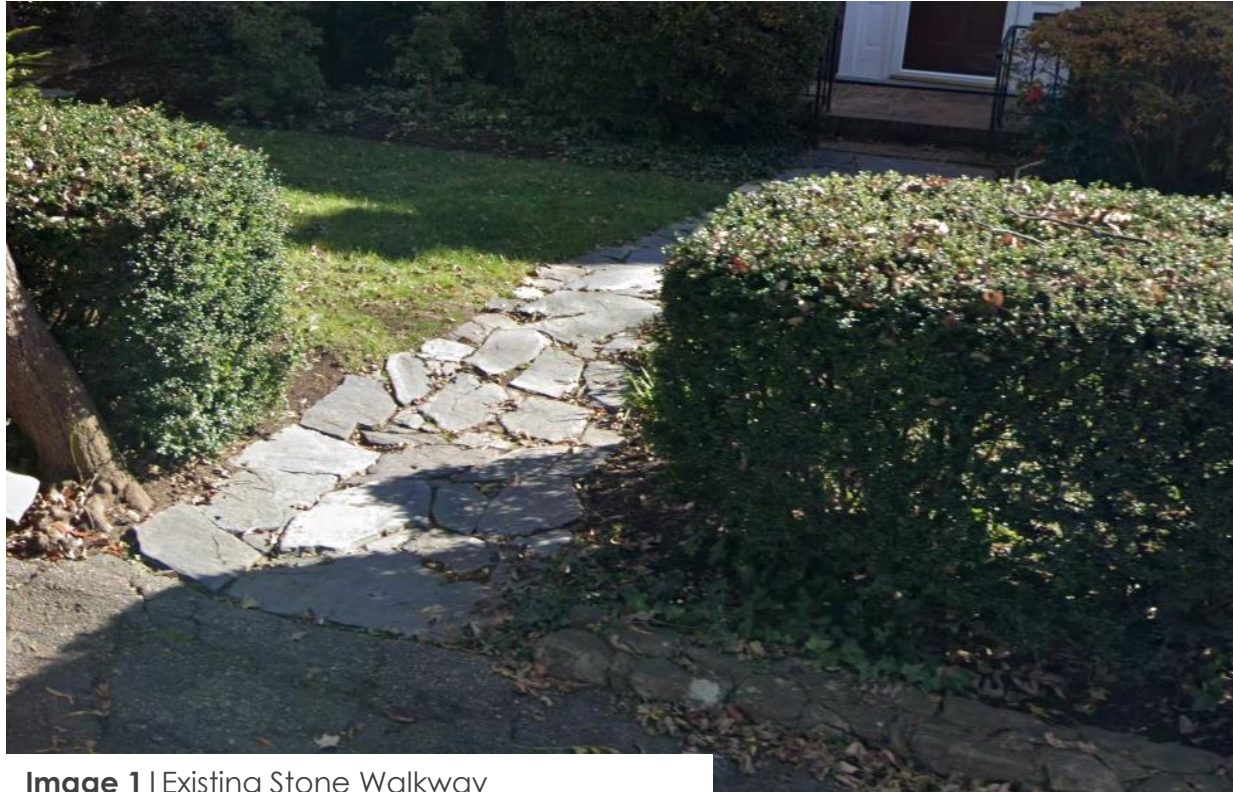
Image 1 | Existing Stone Walkway

- The previously installed stone walkway (Figure 70), as previously suggested, was installed sometime between 2008/2010.
- The stone walkway was deteriorated and presented a safety risk because of its configuration, setting and roughness.
- The walkway did not match with any finish or color of other walkways in the site or adjoining properties and did not provide a safe or pleasant walk, which is required as functionality for the main and only path with access to the front door.

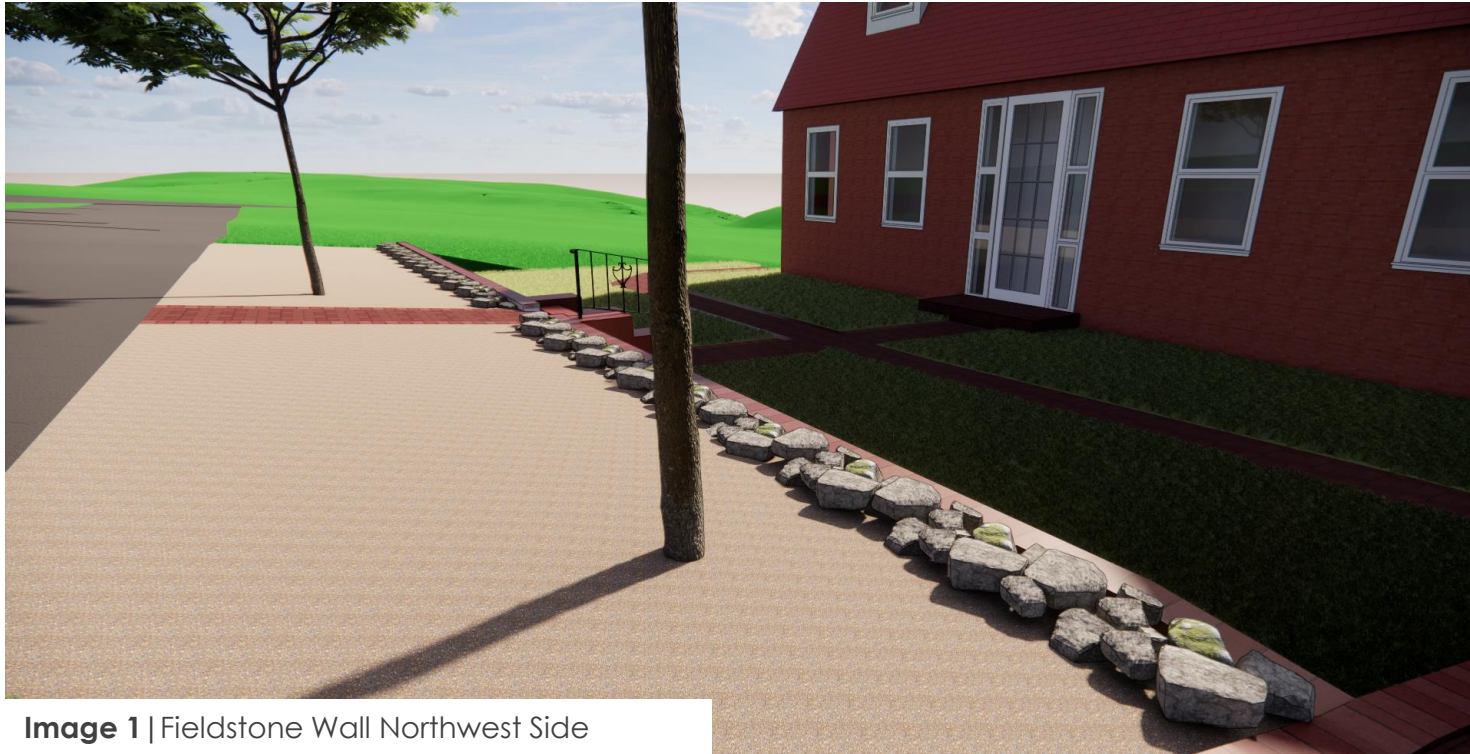
Image 1 | Fieldstone Wall Northwest Side

- With the change of slope of the front yard the original 6" high fieldstone wall had to be removed.
- Similar material will be used to replicate the original look of the wall, size and shape as well as covering any signs of newly installed retaining wall and its brick cap.
