Staff Report

Coal Combustion Products (CCPs) Location and Cover Evaluation Map

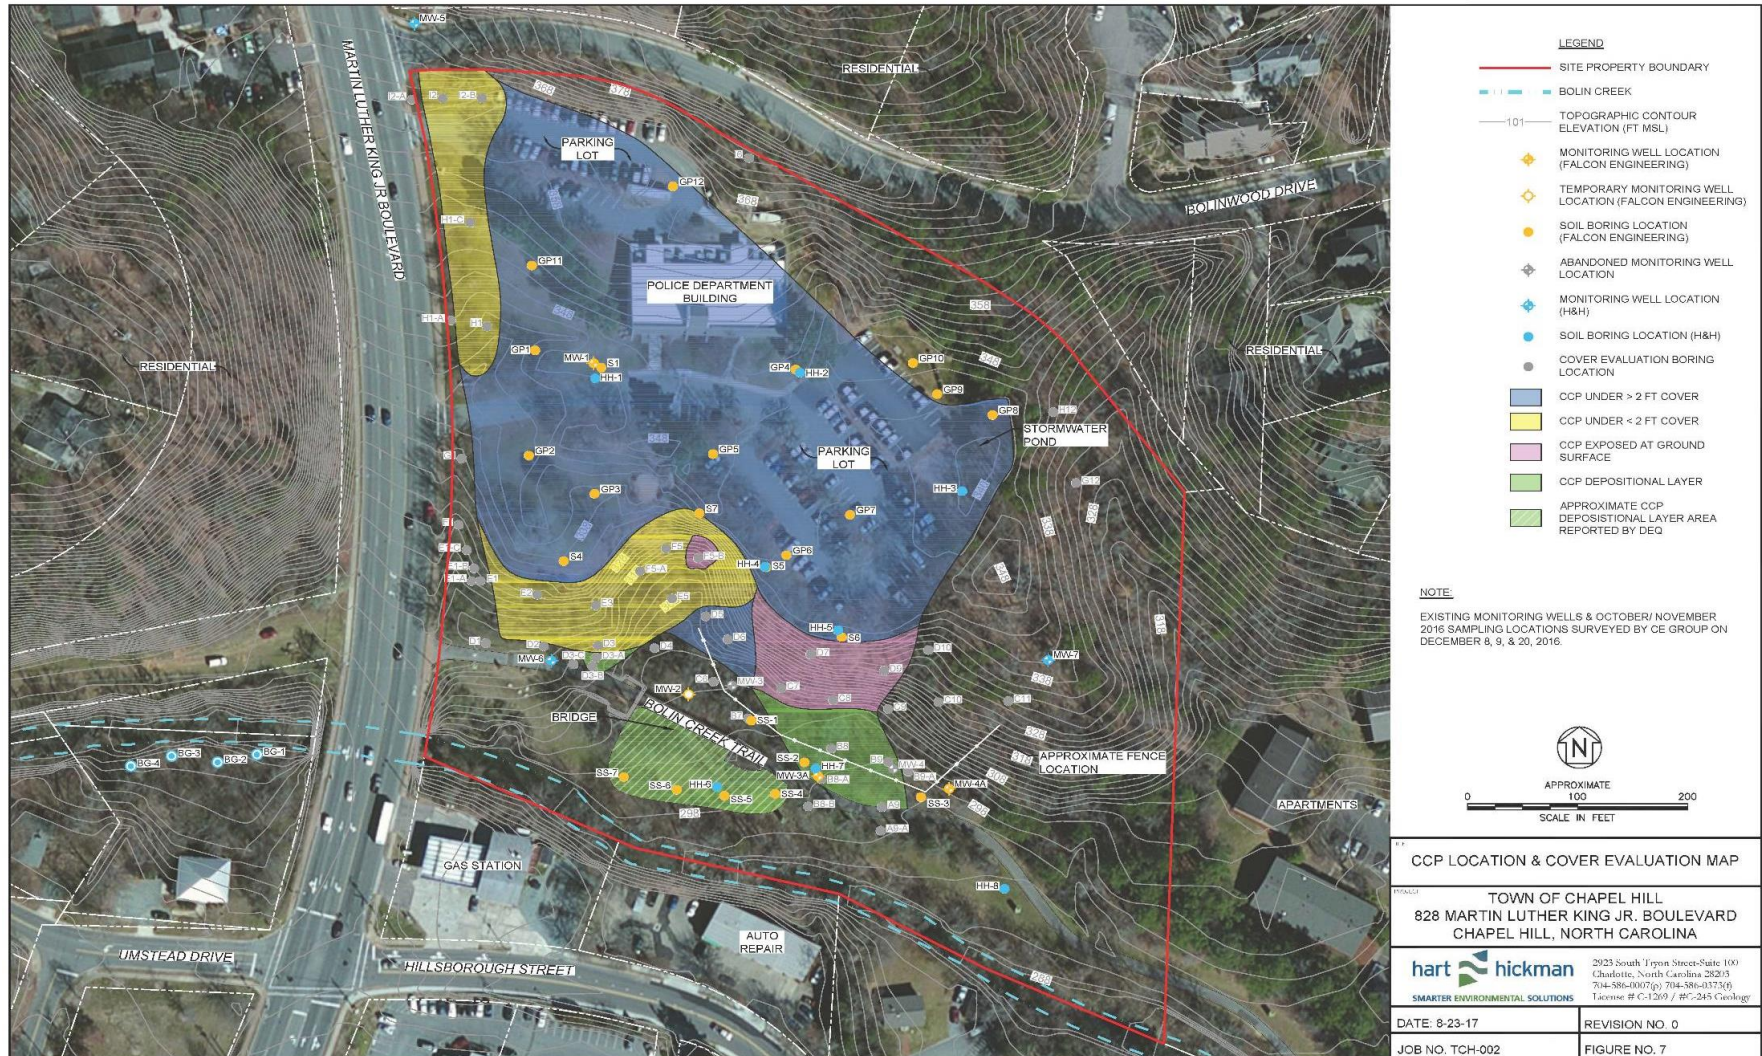
Remove deposits of contaminated soil in the areas next to the trail and the creek (see green areas on map below). This work includes the removal of approximately 6-12" of contaminated soil to a facility that is permitted to receive these materials. Clean soil would then be brought in to replace the amount that was removed.

Add matting, clean soil and grow new vegetation on the areas of the embankment where CCPs are currently exposed (see the pink areas on the map below). The goal of this measure is to reduce the likelihood of CCP erosion and further contamination of the soils next to the trail and the creek.
