11-18-2020 Town Council Meeting

ITEM #13: Open the Public Hearing: Application for Conditional Rezoning - Phi Gamma Delta at 108 W. Cameron Avenue

Subject Property: Columbia Street Annex, 1150 South Columbia Street
Unnamed Tributary to Morgan Creek

On-Site Determination for Applicability to the Jordan Lake Watershed Riparian Area Protection Rules (15A NCAC 02B .0267)

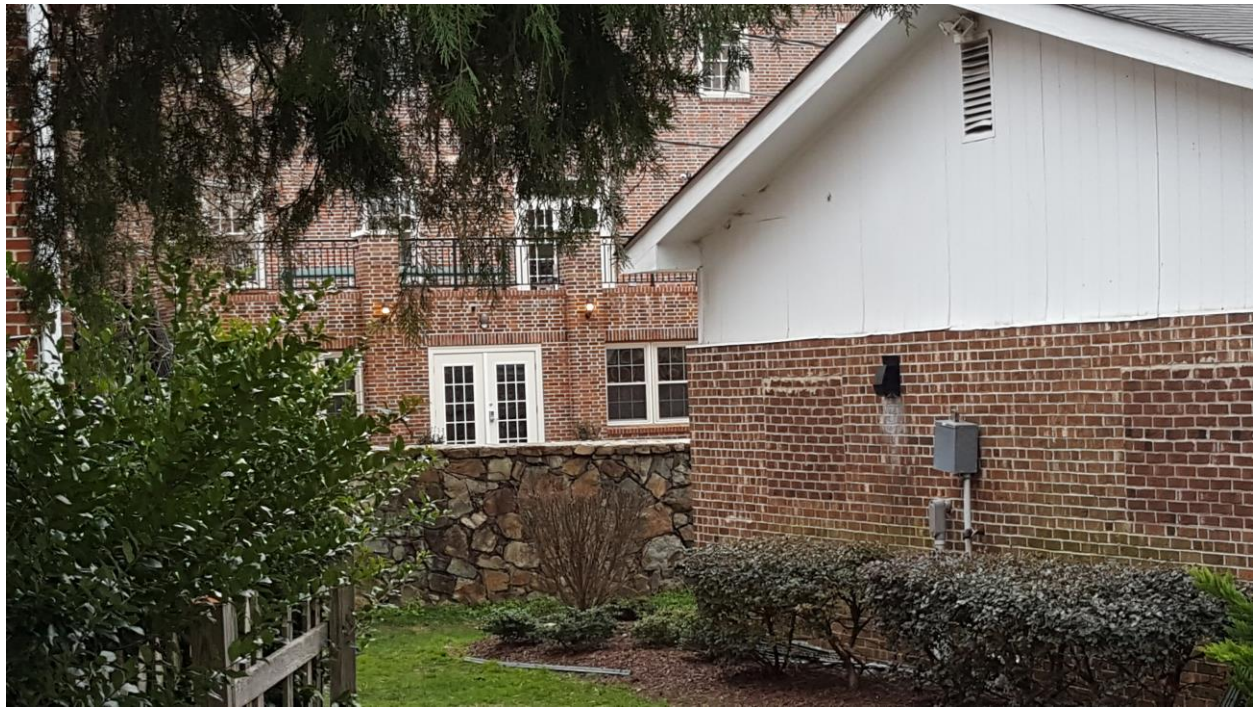
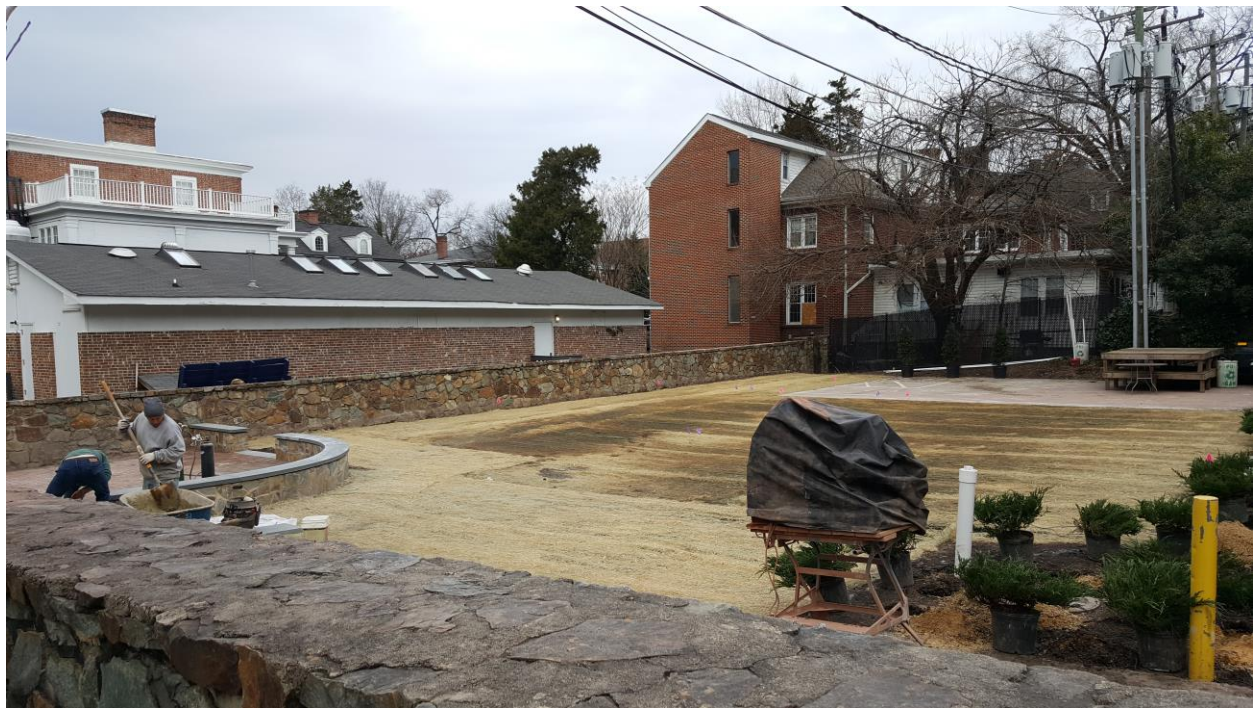
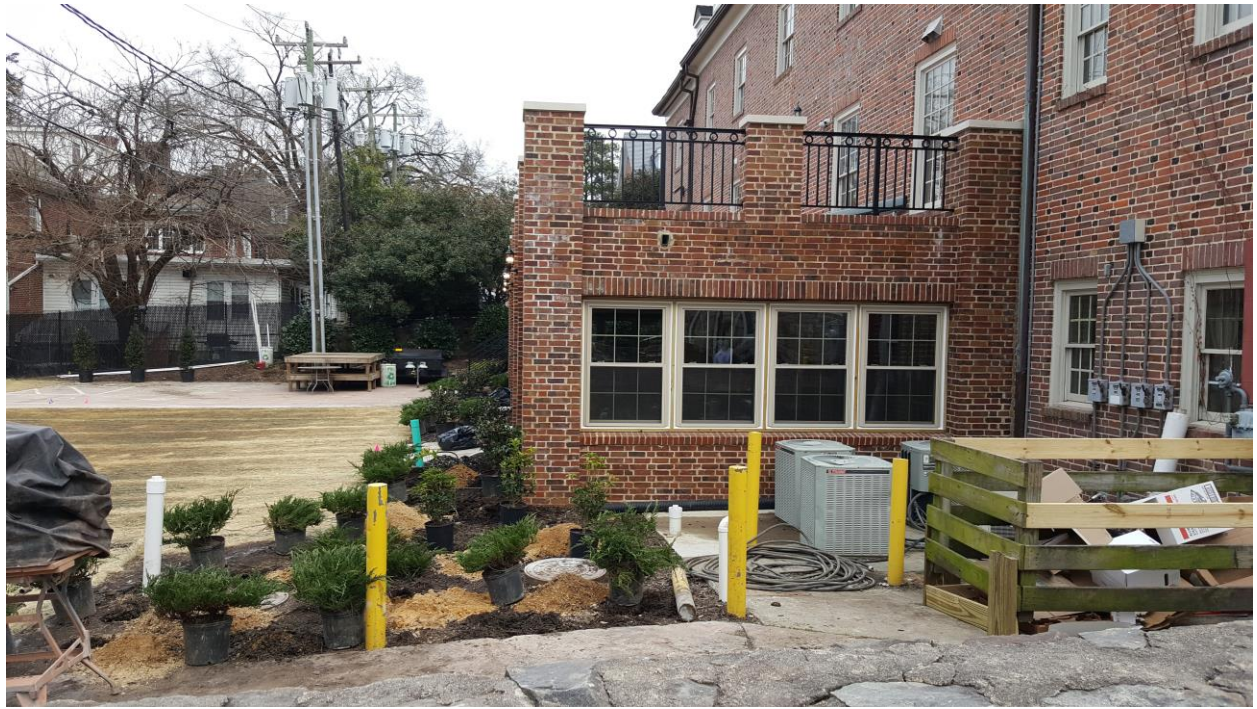
Are there any photos available of the current conditions, with respect to the enclosed rear porch and the current on-site parking?

Please see attached.

Planning staff brought both of these concerns to the Fire Department. The applicant has worked with the Fire Department to ensure that parking in the shared driveway on the west side of the house would not impede fire access. There were also some concerns that the bollards the property owner placed at the end of the driveway to prevent the fraternity brothers from parking on the lawn in the backyard would also prevent emergency vehicle access. We have checked with the Fire Department, and they did not find that the improvements impeded their access to the site. We have spoken to the Inspections Department and confirmed that the porch is sprinklered and does have a fire alarm.
