<p>Chapel Hill Historic District Certificate of Appropriateness Application</p>	<p>Project:</p>	<p>21-033 510 Hooper Lane</p>
<p>Project Description: The scope of the works proposed in this application are summarized below:</p> <p>A – Change of grading of the front yard.</p> <p>B – Provision of a retaining structure to allow a change of slope in the front yard, including new steps.</p> <p>C – Provision of a new entrance walkway, with access to existing driveway and north-west side of building.</p> <p>D – Reintroduction of landscaping features of the front yard to fit with the overall character of the Franklin-Rosemary Historic District and specific site characteristics.</p>	<p>Permit:</p>	<p>STAFF REVIEW</p>
		<p><input checked="" type="checkbox"/> Application complete and accepted</p>
		<p><input type="checkbox"/> Application not complete and returned with a notation of deficiencies</p>
		<p>BY: Anya Grahn, 4/29/2021</p>

3.1 Franklin-Rosemary Historic Districts	6
3.2 Historic Research	7
3.3 510 Hooper Lane Basic History	11
4. Existing Conditions	12
4.1 Site Context	12
4.2 Existing Conditions Report	15
5 Proposed Changes and Justification of Appropriateness.....	27

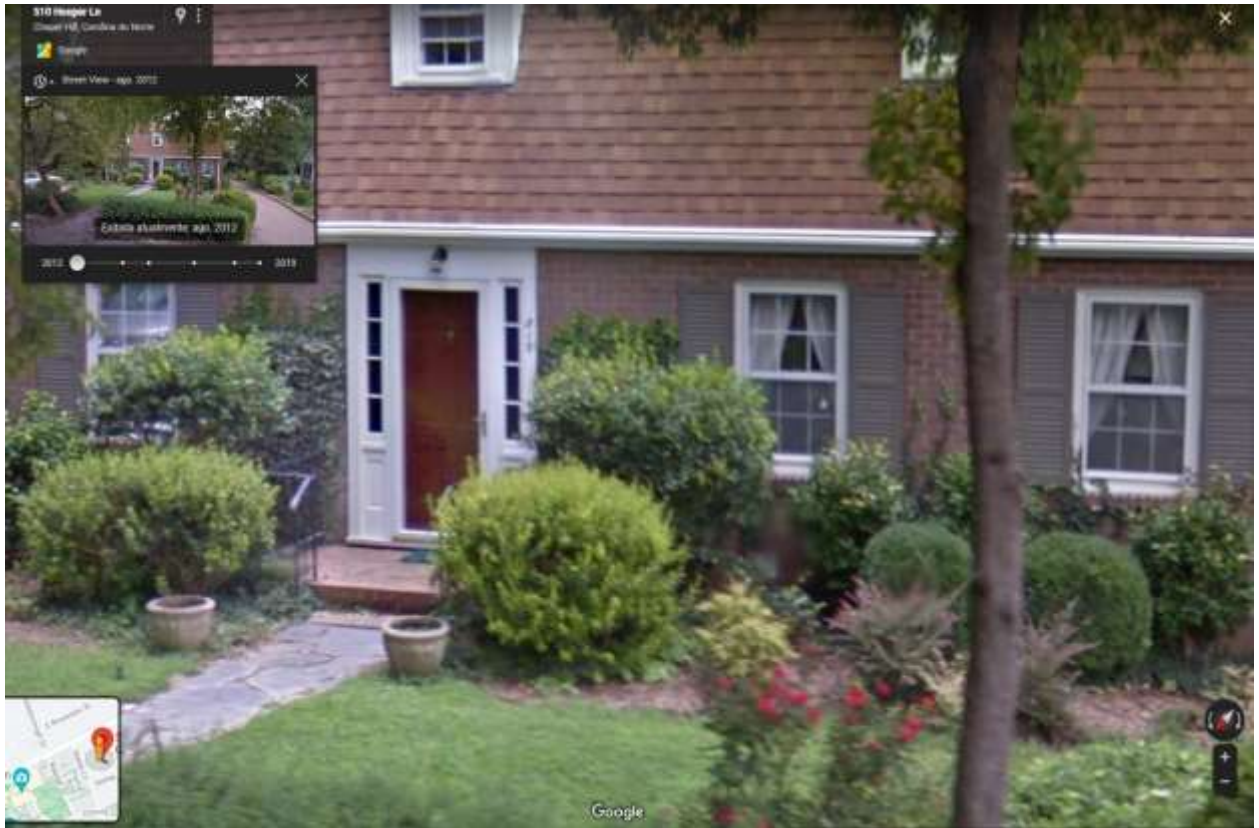
Figure 33 - Vegetation on masonry

- Ensure water does not collect on masonry surfaces and that water drains away from foundations, walls, and piers.
- Ensure masonry is free of vegetation.

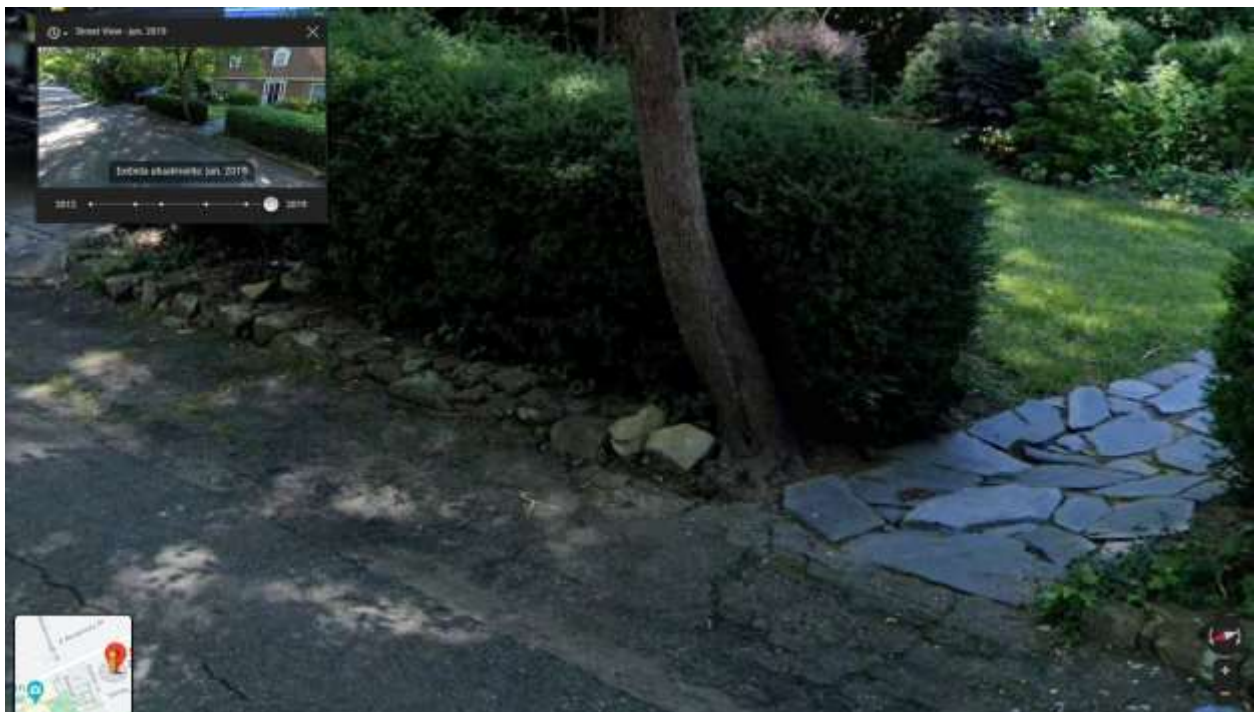
Figure 34 – Street view image from 2019 – Evidence of conditions for fieldstone wall and stone walkway

The stone walkway would need to be removed from the site to change the slope of the front yard. The stone walkway was presenting deterioration and was not providing safety or a pleasant walk for its users. Since the walkway seemed to have been installed somewhere between 2008 and 2010 from previous owner (See Figure 17, Figure 18, Figure 19), it can be argued that the walkway was not an original historic element of the property and trying to replicate it would mimic a historic feature and would go against the Design Principles and Standards. With this consideration, it was proposed that the previously installed walkway would be replaced for a more functional material that will provide a pleasant walk to and from the building.

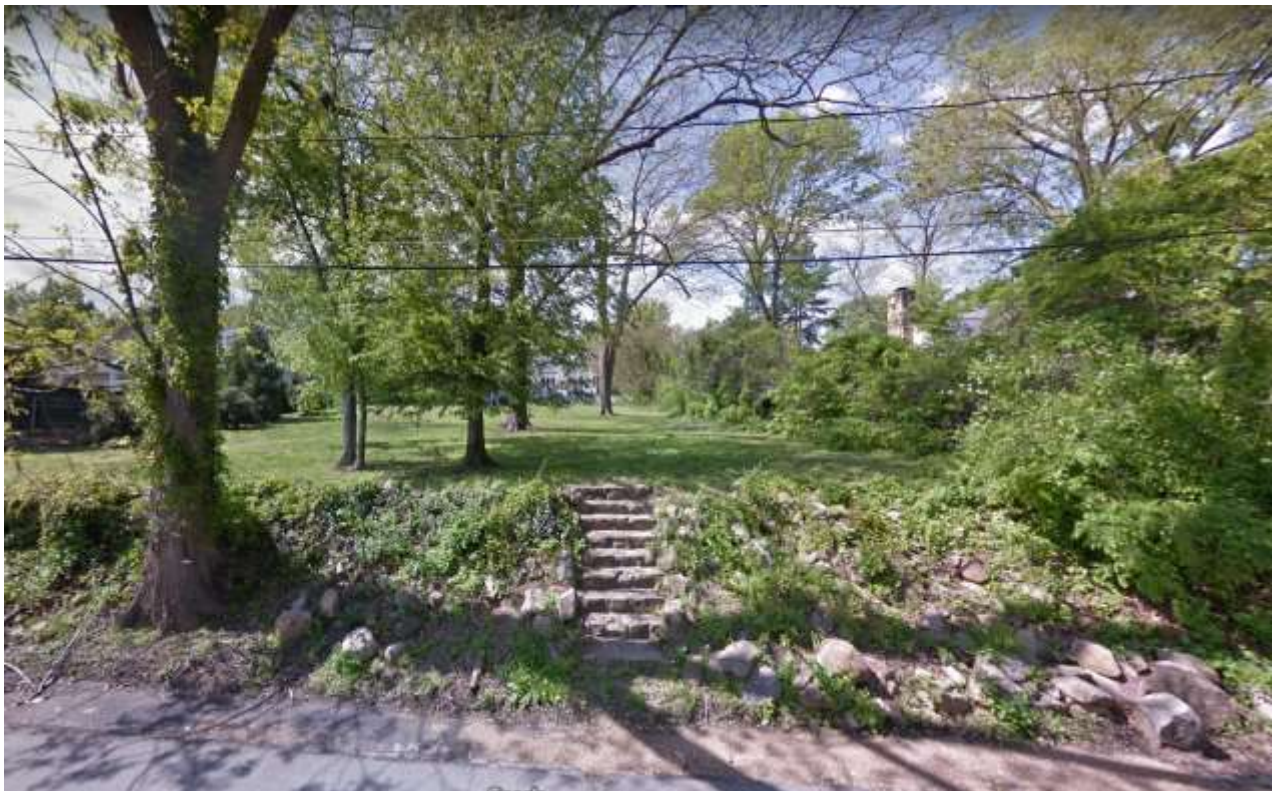
Figure 39 – Empty lot directly opposite to 510 Hooper Lane.

In addition, these naturally occurring events, directly opposed to the site there is an empty lot with very accentuated slope towards 510 Hooper Lane (Figure 39). During heavy rains, this area becomes fully soaked, cannot retain any more water and its only path is to wash down the natural slope straight to the opposite structure (510 Hooper Lane).

Figure 51 – Aerial Photo of directly opposite empty lot mentioned on Figure 38 that shows why drainage requirements are intensified at 510 Hooper Lane.

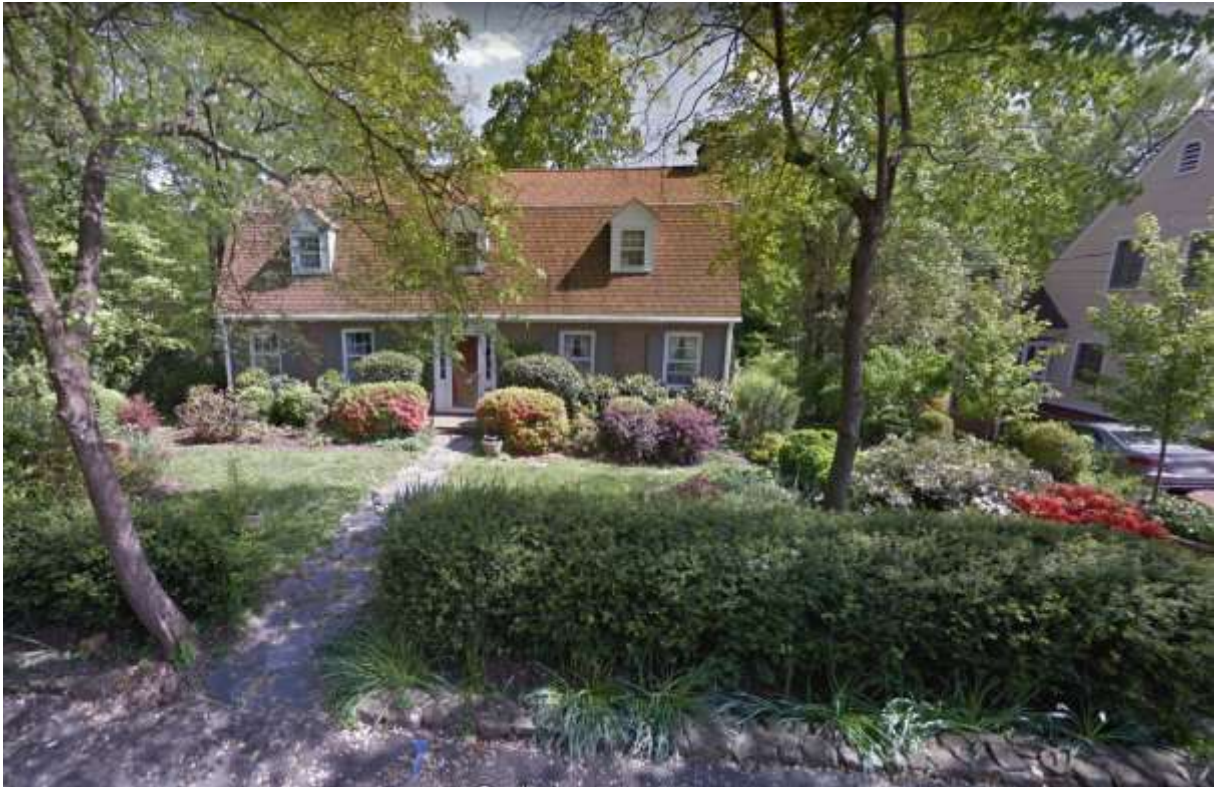
Figure 40 Existing vegetation blocking basement vents.

To aggravate this problem, the front yard had a dense vegetation, causing it to be challenging to keep the front wall dry with natural ventilation and sunlight. The vents installed for the purpose of ventilating the basement were very close to the ground level (Figure 41 and Figure 42), and during heavy rains soil would wash down the vents filling up the basement with water and sand (Figure 43).

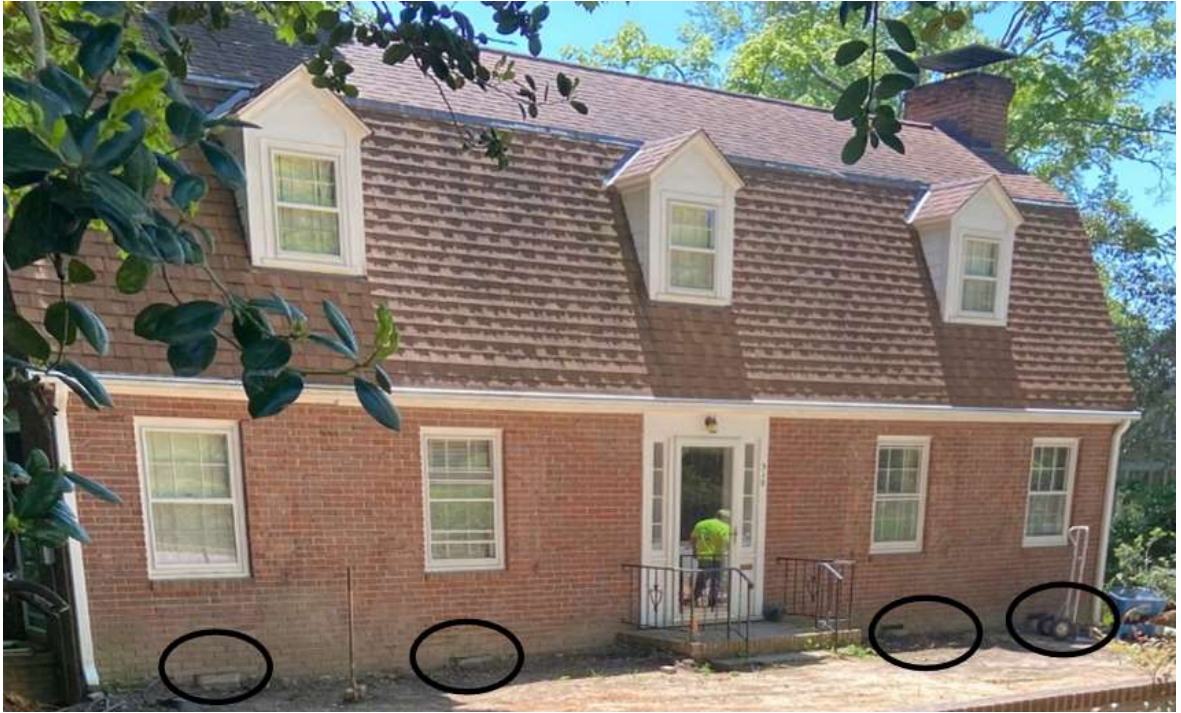
Figure 41 – Basement Vents (Black Circle)

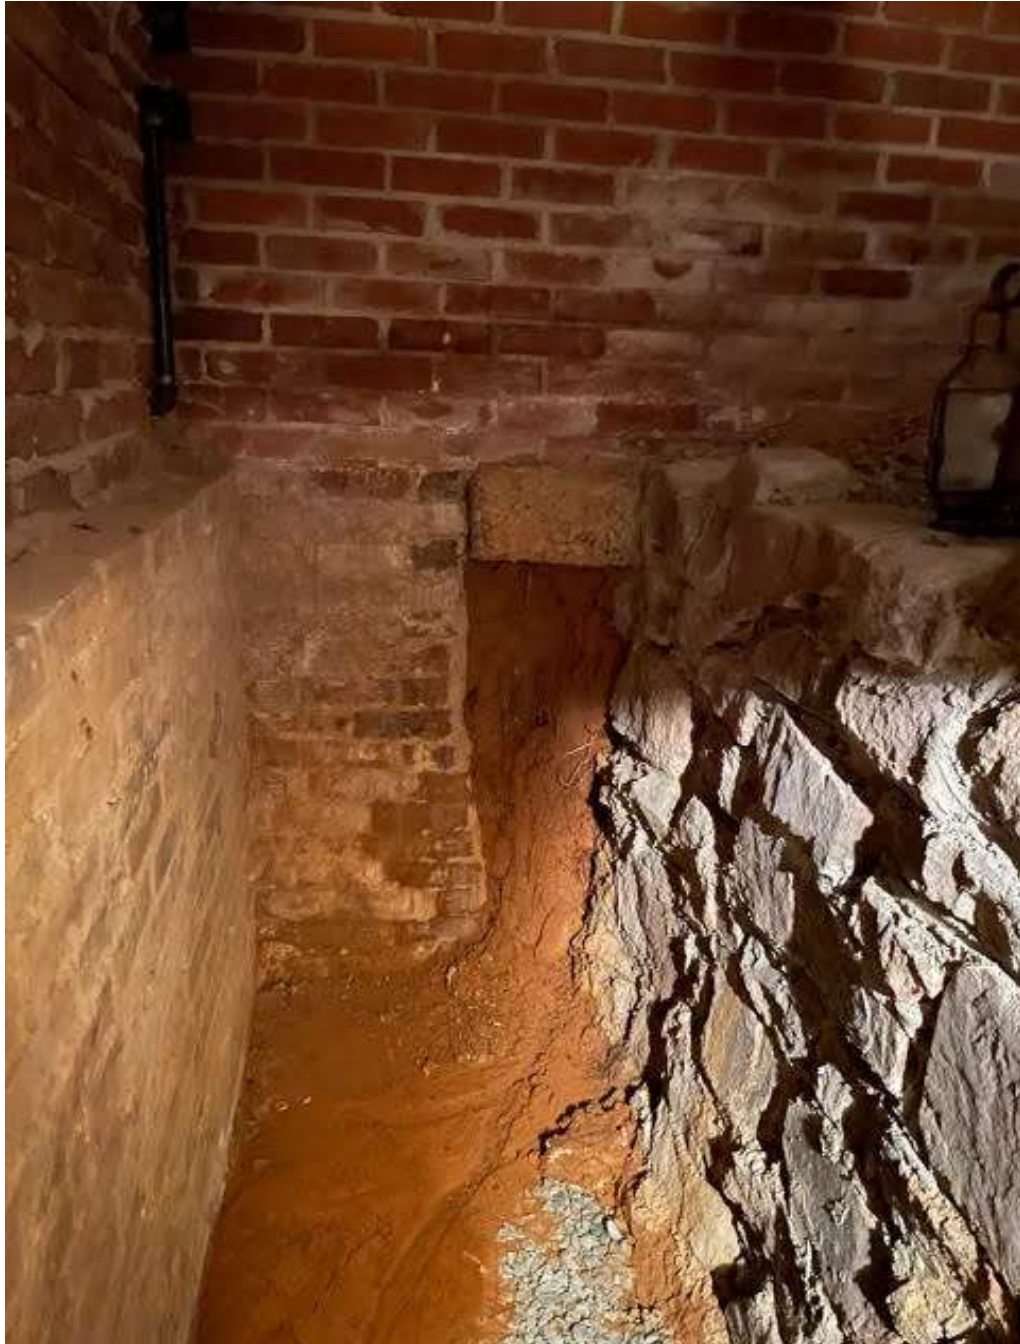
Figure 44 – Northwest side view of the basement (soil sliding).

As previously mentioned, when analysing the conditions of the basement, it becomes clear that on the northwest side a stone wall was installed to contain the soil at an early stage after experiencing problems with the stability of the soil, surrounding walls and foundations (Figure 44). After some time, on the northeast side of the building, there was another wall constructed using a more recent material (Concrete Block) to retain the soil (Figure 45). It is also noticeable that there is a section of the newly constructed wall that is poured concrete which shows this has been a recurring problem and there were several attempts to remediate it. However, these measures can be considered only palliative measures to temporarily stabilize the issue without resolving its actual source: Drainage.

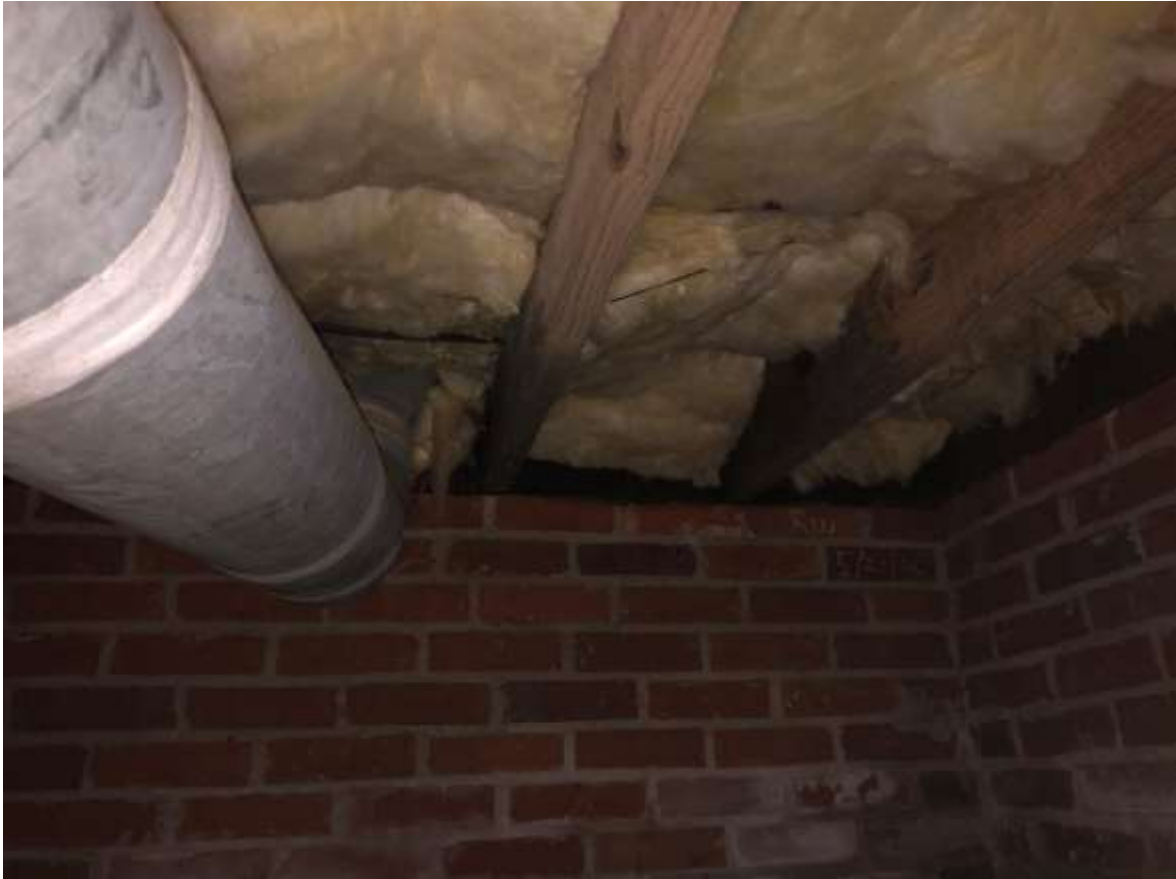
Figure 47 - Evidence of wood floor joist in contact of brick wall suffering deterioration (black and humid appearance)

Furthermore, since the house's external envelope is made of brick, which is a soft, porous material, the walls were suffering from a capillary effect where the constant accumulation of water under the house and inside the basement, would draw up water and keep the walls of the building constantly wet. These conditions were prime for mold to develop because although brick is an inert material, when constantly wet, mold can thrive. These conditions can be observed on Figure 47 where the wood structure that is in contact with the external brick wall has a black color and is constantly wet. This can also be seen on Figure 48 where water pours through the foundation wall during heavy rains and soaks the soil, brick walls, and consequently the entire structure.

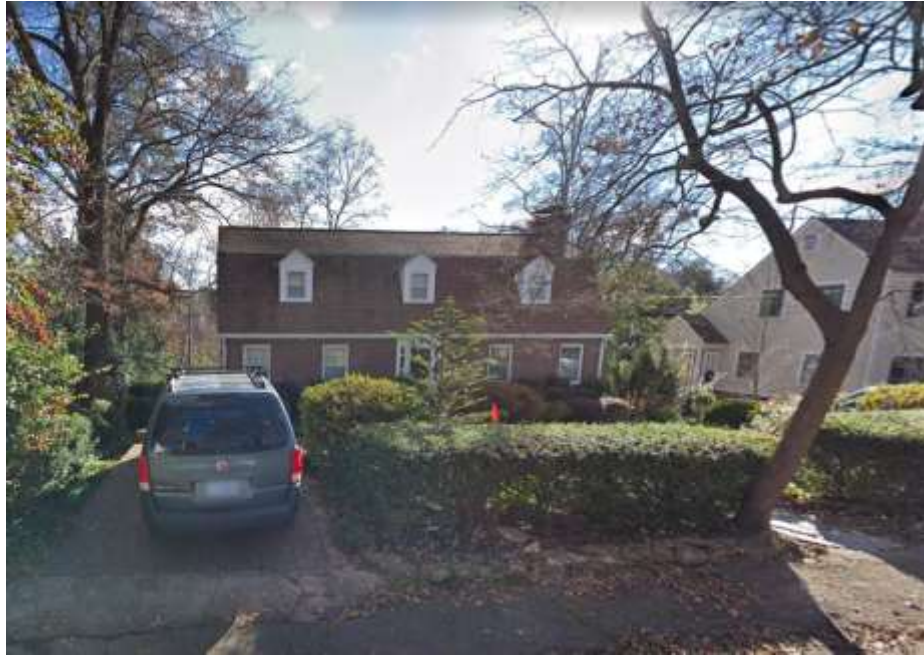
Figure 49 - Parking Pad & Parked Car

Due to the required grade change, the existing parking pad was removed to put in place new slope of the front yard. The parking pad was located on the northwest side of the site and had access directly from Hooper Lane. This site feature is not common on Hooper Lane, and all surrounding properties have secluded driveways and parking spaces. 510 Hooper Lane was the only property with such feature. It is possible to see the parking space on satellite images dated back to 2008, but there were no available images at this stage to show when this feature was introduced and its historic relevance. In addition, the parking pad did not contribute to the historic look of the building, blocking its main features and front façade when a car was parked on that space (Figure 49).

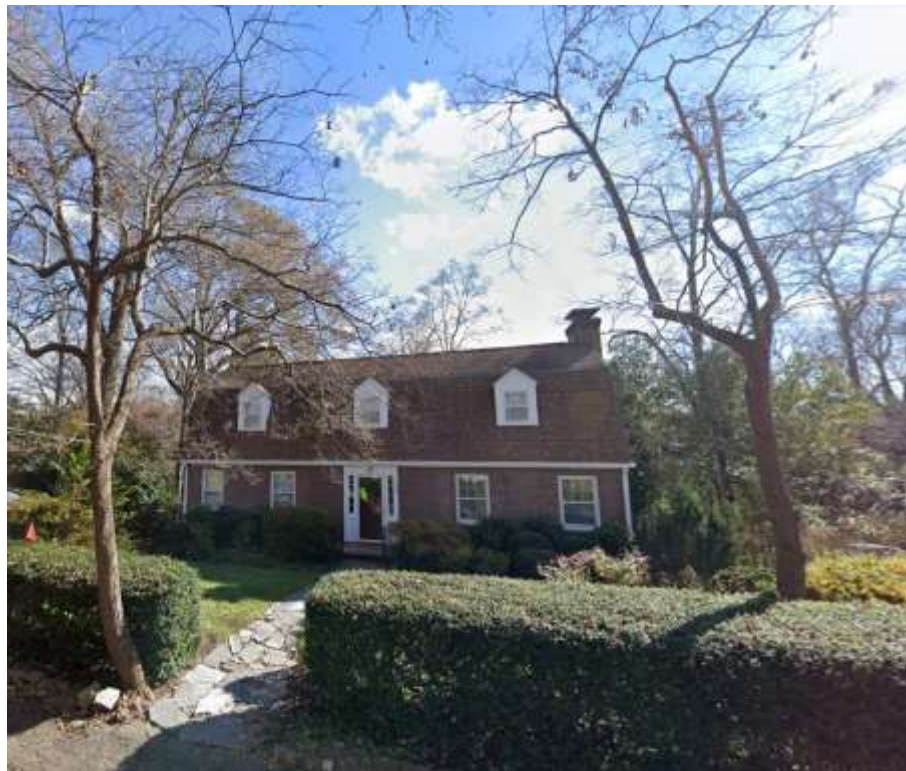
Figure 50 - Evidence location and characteristics of existing trees that needed replacing.

There were two mature calliper dogwood trees on the front yard that had to be removed to make place for new walkway and retaining wall. All efforts were made to avoid their removal, but their location was in strategic points. These trees will be replaced in similar locations with the long-term plan of achieving the same look for the site once they mature. This is explained in more detail later in this application.

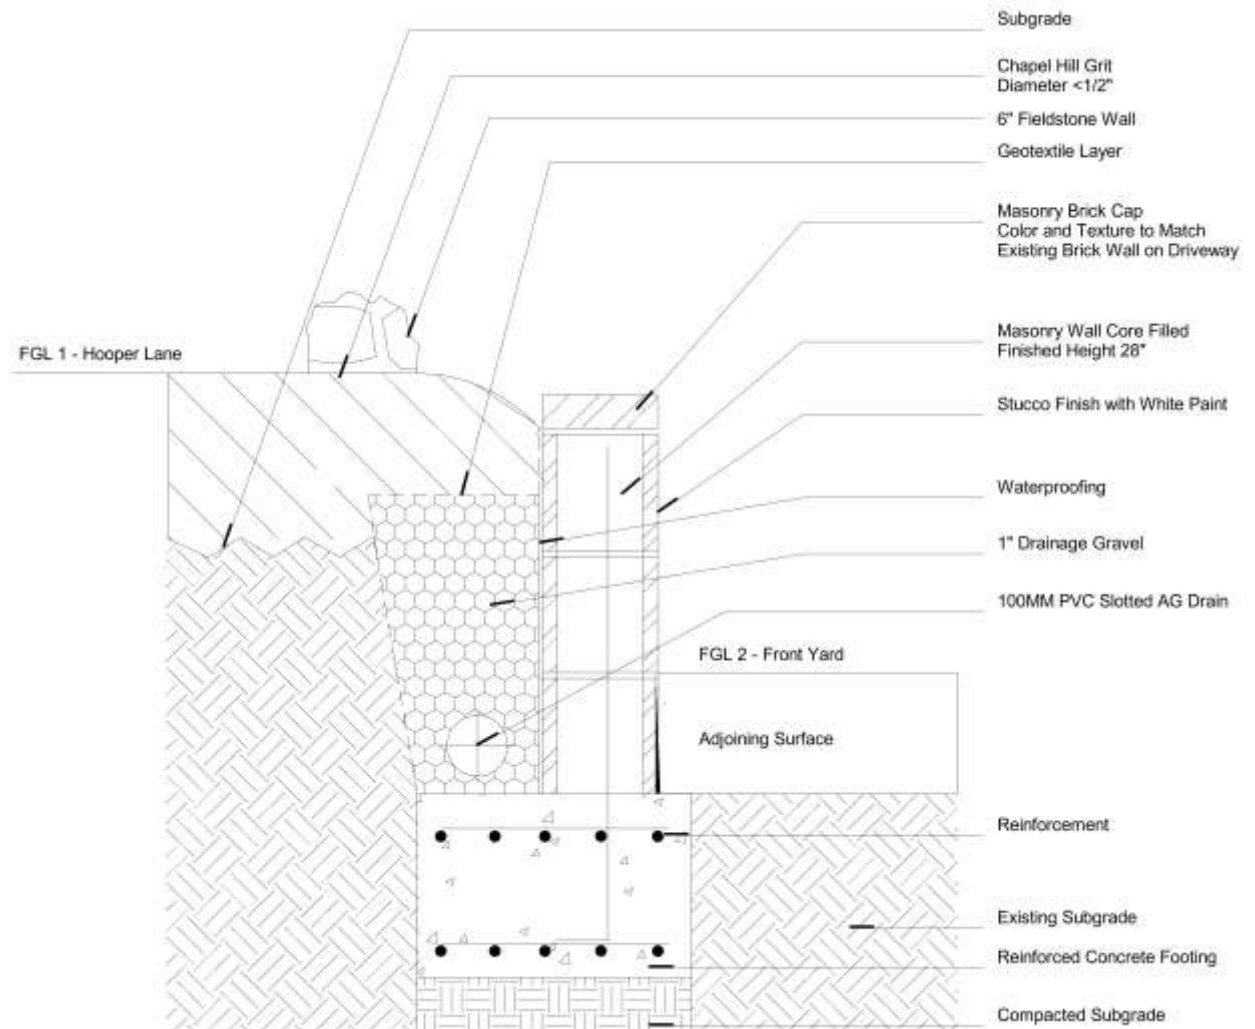
Figure 56 - Proposed Retaining Wall - Cross Section

In this case, a light, ductile structure seemed to be the best option to perform under its structural requirements. Since the wall has proximity to the road, it was required to be a reinforced structure to support naturally occurring loads under extreme conditions of heavy rain and live loads.

The cross section drawing of the proposed retaining wall, its details and materials are shown on Figure 56.

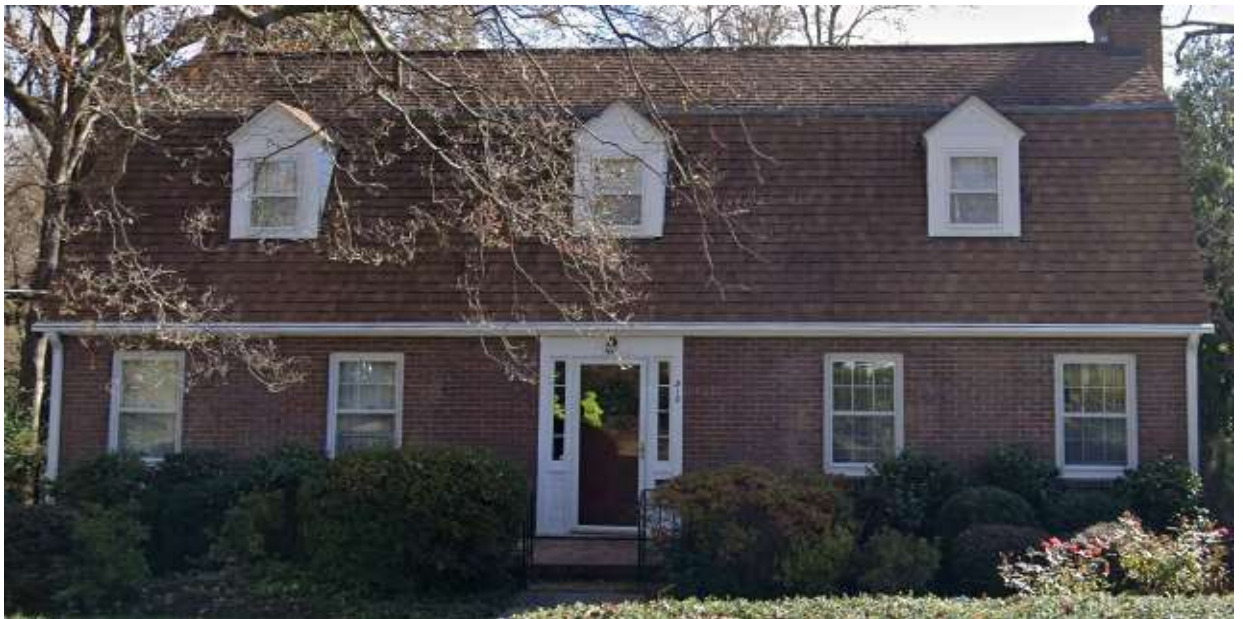
Figure 58 - Front Facade - White finishes

Regarding its finishes, the wall received a stucco treatment and white paint. It was also proposed that a brick cap be installed to match the existing brick wall on the driveway (Figure 60). The white paint is relevant to the site as it matches with overall colors of the property and it is not visible from any angle outside the property. The windows, roof dormers, walls and door all have white trim and white paint, and the back side of the house has white wood siding, windows, and doors (See Figure 58 and Figure 59).

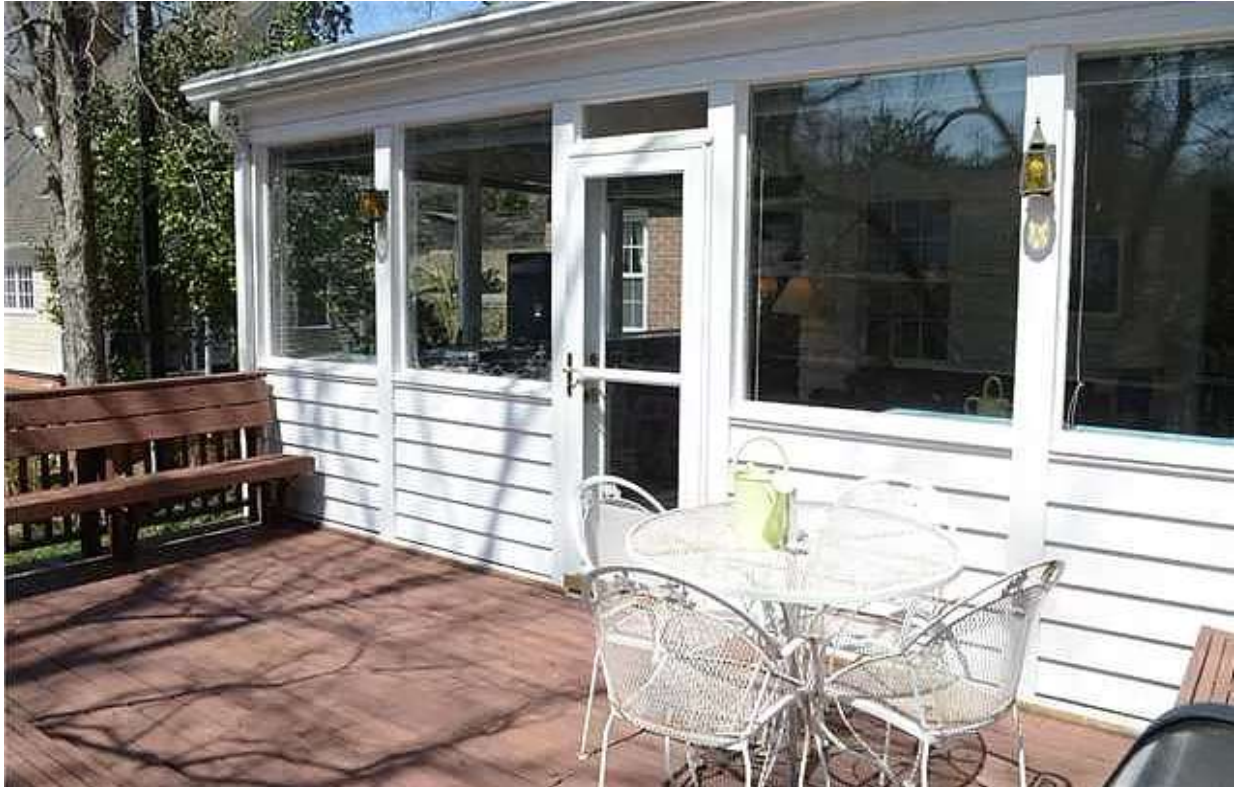
Figure 59 - Rear Deck - White Finishes

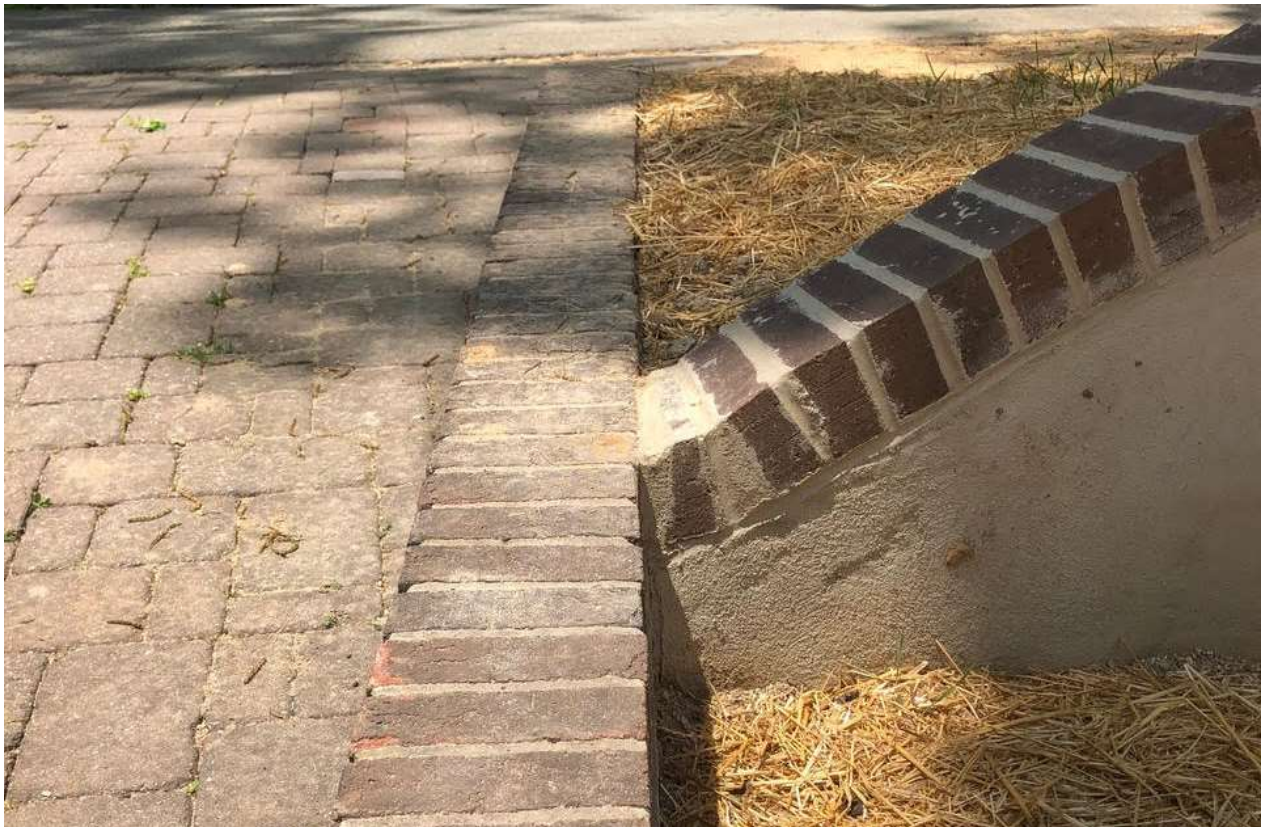
Figure 60 - New Brick Cap of Retaining Wall Meeting Existing Brick Wall on the Edge of the Driveway

The brick cap on the new wall was designed to match with the brick wall of the driveway to make it seem part of the property and not just a new element that does not fit.

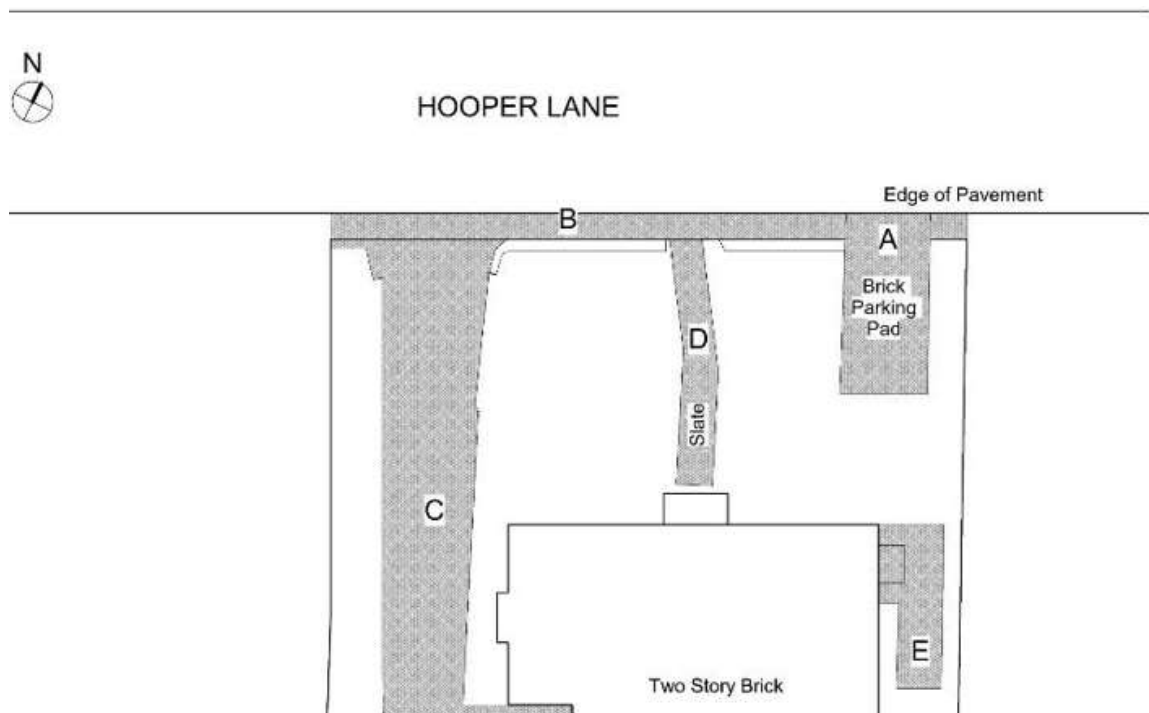
Figure 61 - Front Yard - Existing Conditions Plan

In the previous existing configuration, the site had no access steps or footpath to the driveway or the side of the building where the side porch is located. This meant having to walk across the landscape damaging grass and surround plants or around the entire property (Figure 61).

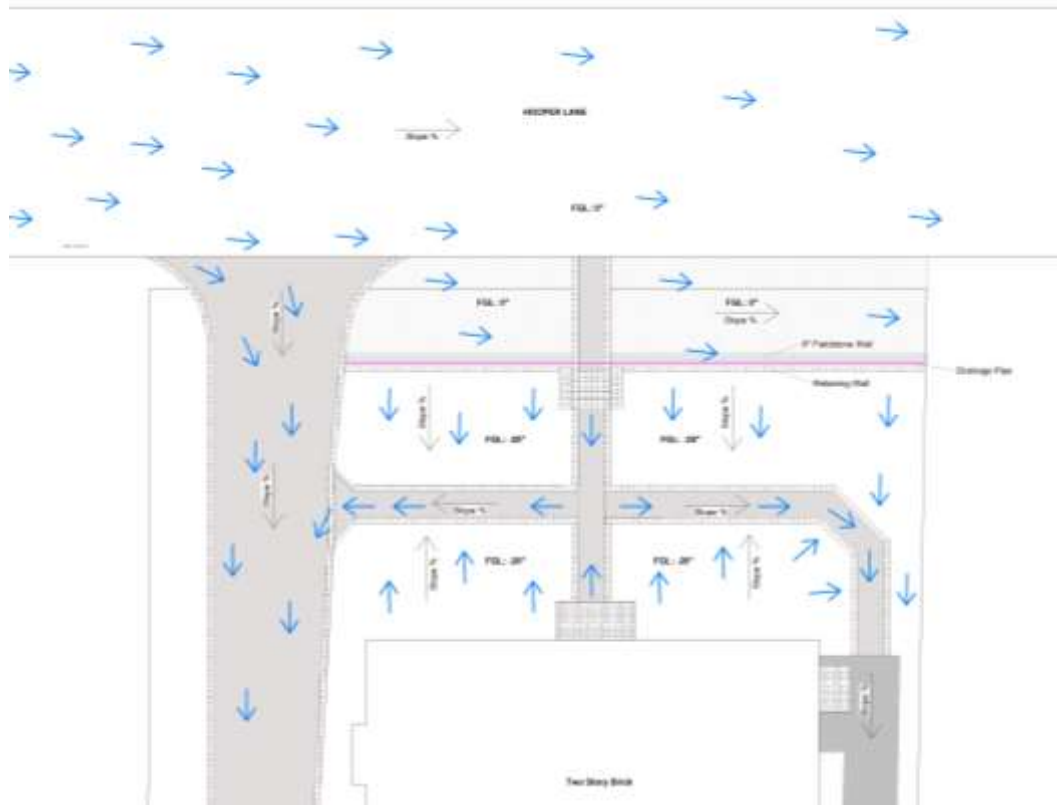
Figure 62 - New Landscape - Stormwater Drainage Diagram

It is also important to note that the walkways are acting as a means of access to important portions of the site as well as acting as an open drainage path for stormwater to flow away from the building structure and foundations. This arrangement is shown on Figure 62, where the front yard slopes to the central walkways and water is directed to the northwest and northeast side of the building, and finally to the back yard towards existing creek.

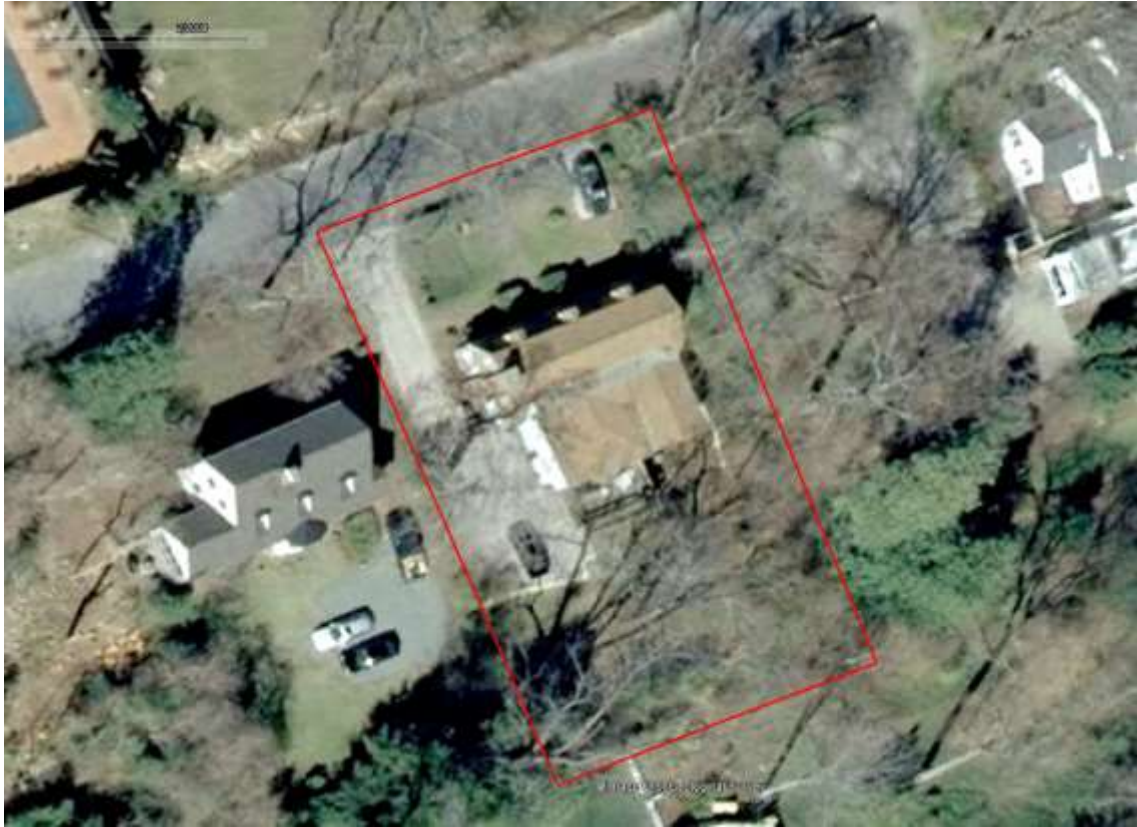
Figure 63 - Satellite Image from 2008 Showing Possible Different Color and Material for driveway and parking pad.

The new walkways were proposed to be constructed of brick pavers that match existing driveway and are consistent with surrounding properties within the historic district in its current state. As stated on Section 3 and 4 of this application, great effort was put into finding evidence of previous conditions of 510 Hooper Lane. After reviewing available information, it was noticed that in 2008 the property seemed to have a different material for the driveway and parking pad (Figure 63) compared to a street view picture from 2012 (Figure 64) which shows a brownish brick driveway with a boundary brick wall that joins the original fieldstone wall (Figure 65). From the satellite information available, this change seems to have happened somewhere between 2008 and 2010.

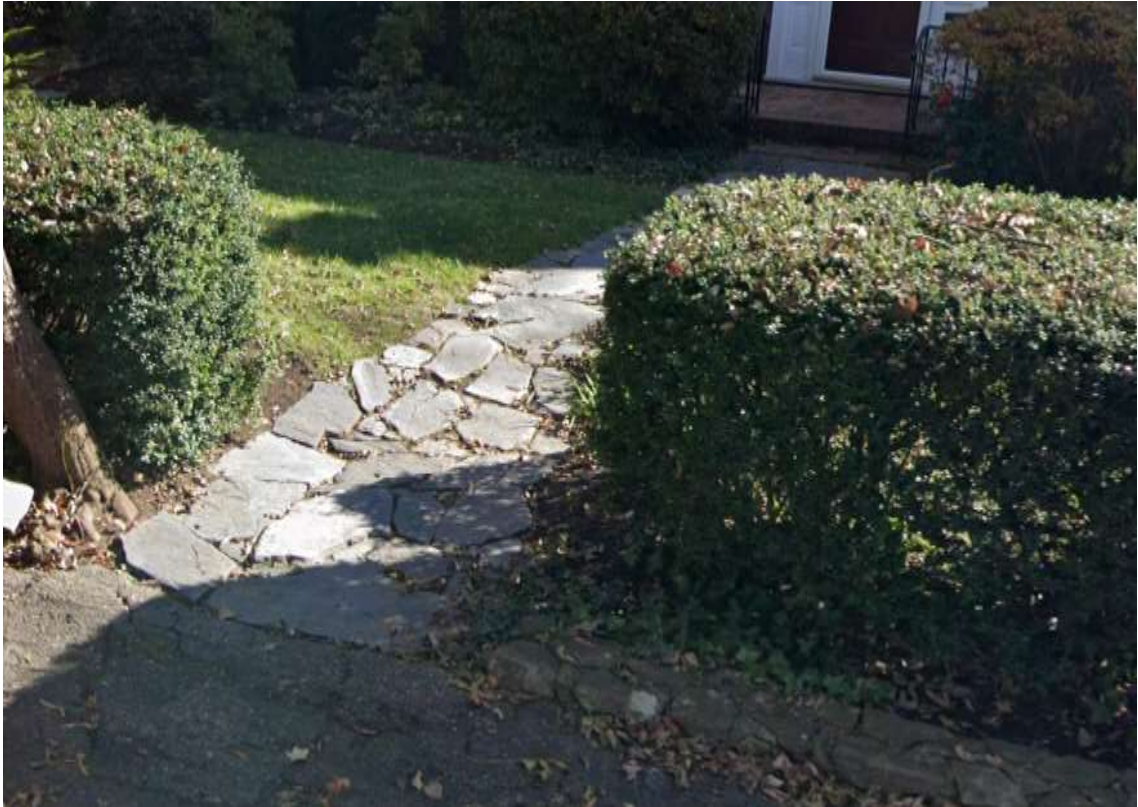
Figure 70 - Previously Installed Stone Walkway

The previously installed stone walkway (Figure 70), as previously suggested, was installed sometime between 2008/2010, and it was not matching with any property on Hooper Lane. Furthermore, the stone walkway was deteriorated and presented a safety risk because of its configuration, setting and roughness. The walkway did not match with any finish or color of other walkways in the site and did not provide a safe or pleasant walk, which is required as functionality for the main and only path with access to the front door.

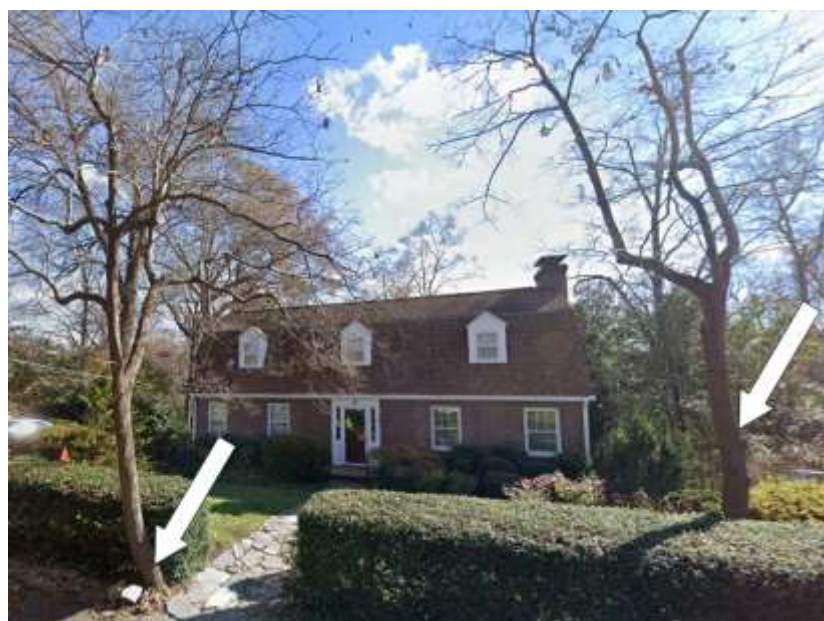
Figure 72 – Removed Trees to be Replaced.

In the process of changing the landscaping of the front yard, two trees had to be removed. These trees will be replaced with the same species and be placed in very similar locations to their original positions (Figure 72). In its maturity the trees will have very similar look and size to the original trees.

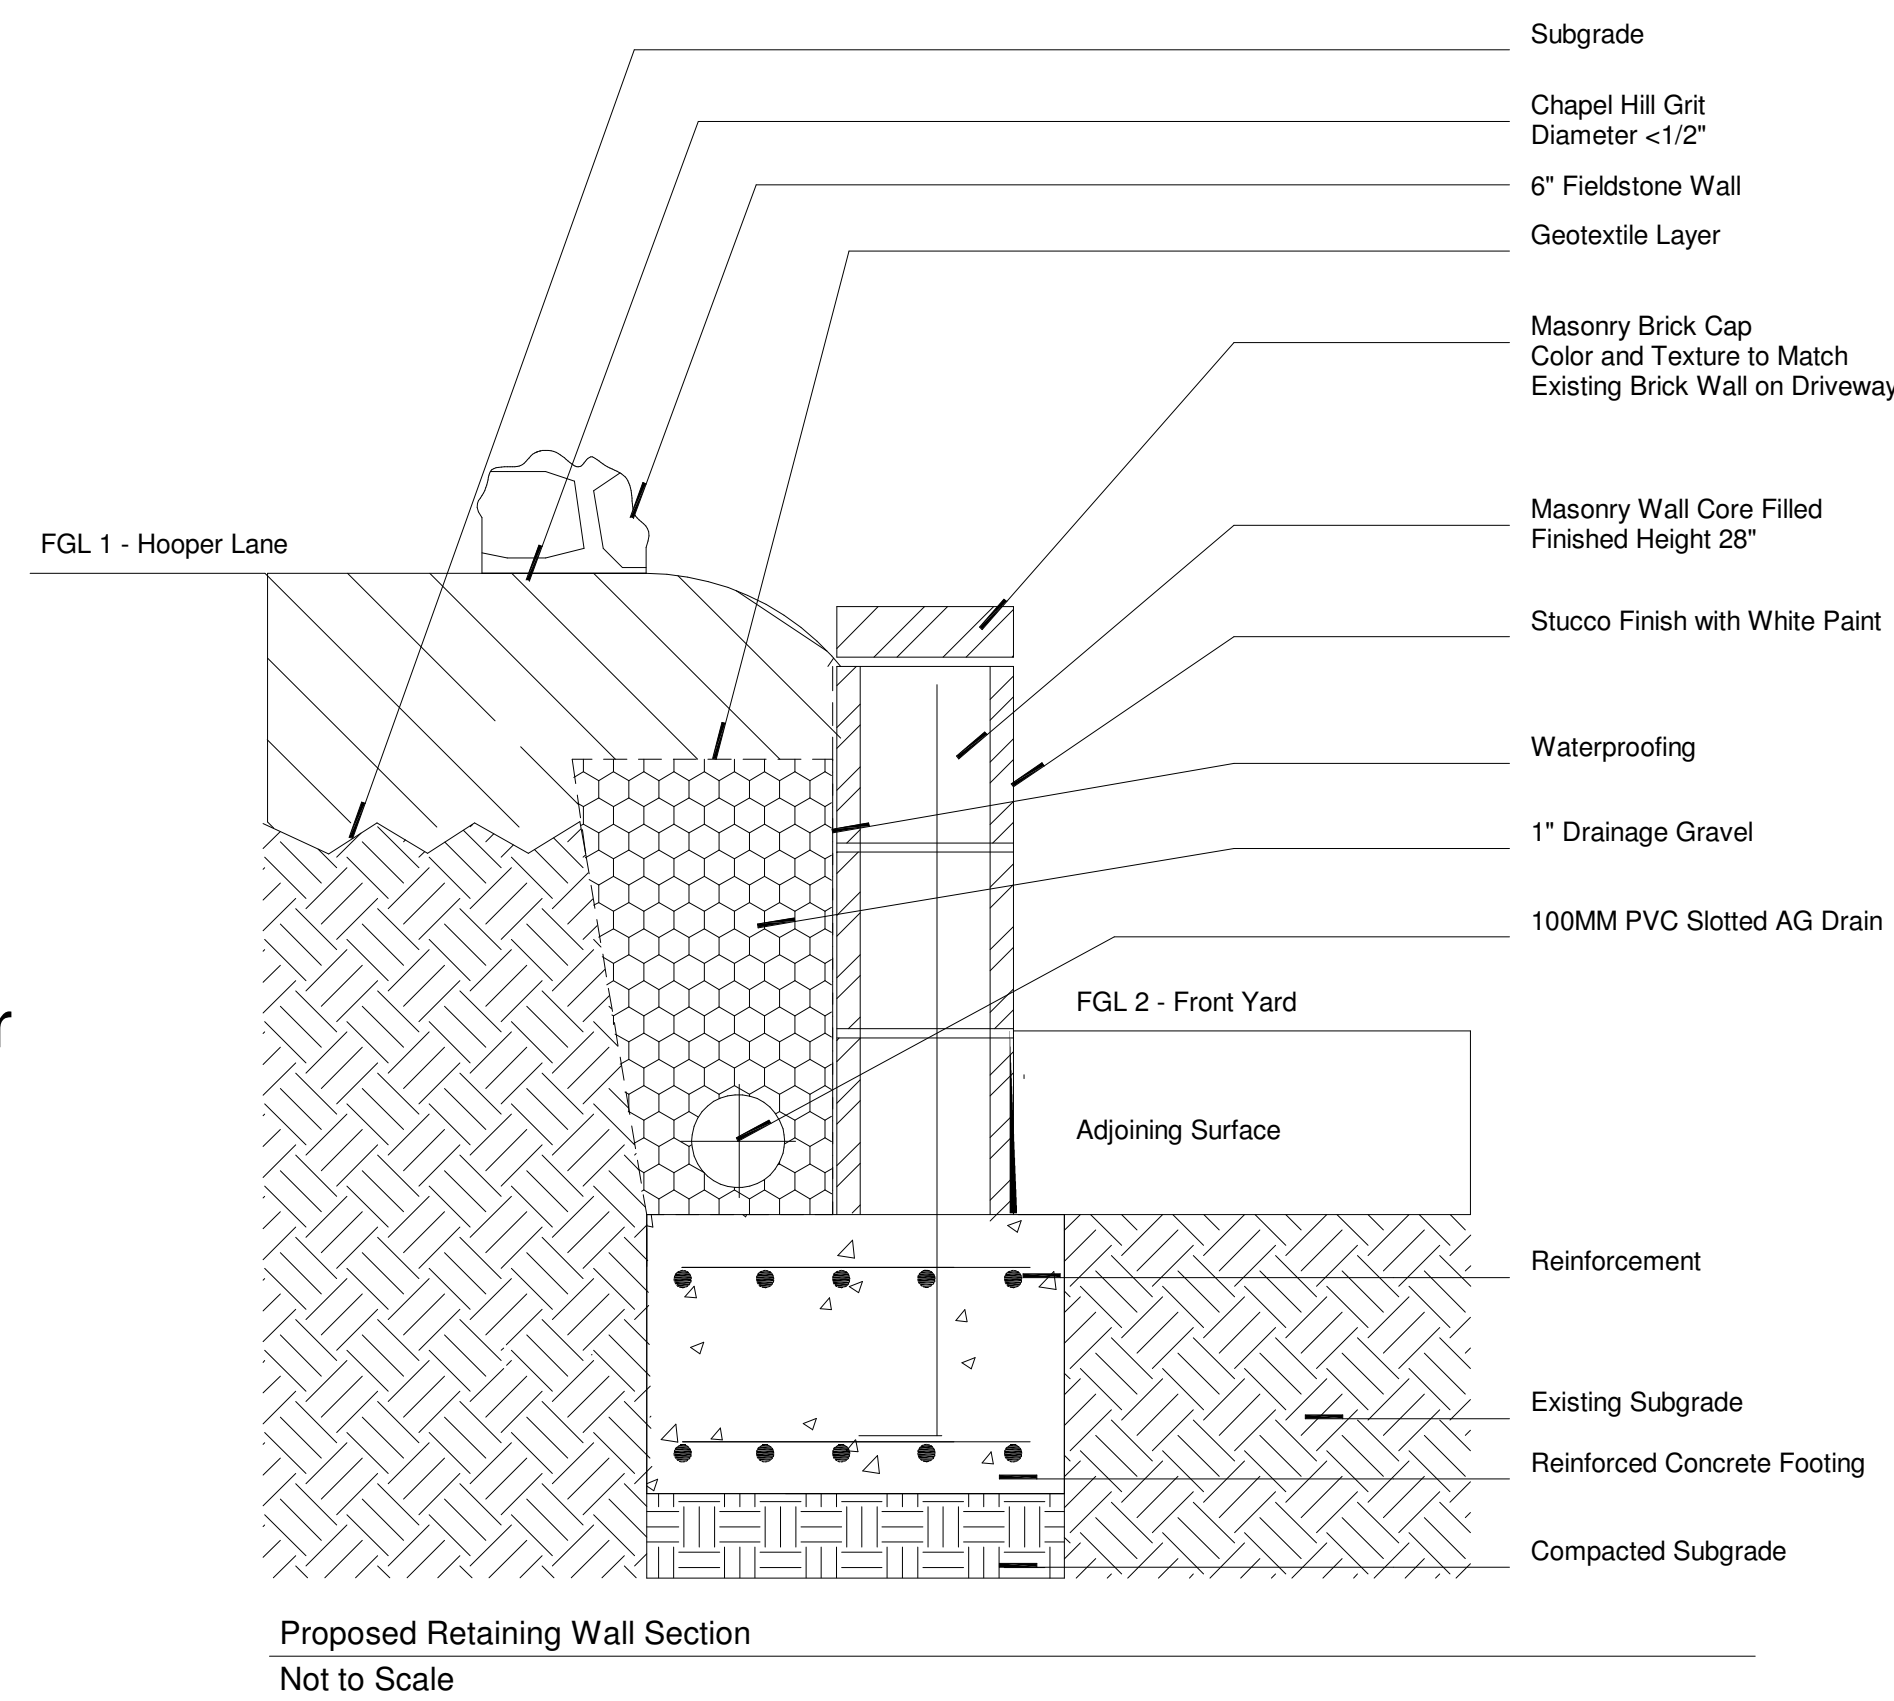
Proposed Retaining Wall Section
Not to Scale

1. New Retaining Wall to no be visible from the street.
2. Brick cap to only be visible from inside the property.
3. Stucco finish with white paint to match white tones of the property elements and to no be visible from street.
4. New Fieldstone wall to match previously existing wall.
5. Calliper Dogwood Trees to be located in similar position as previously existing trees.
