Town of Chapel Hill Legion Pond Dam

Preliminary Engineering Report

May 2023

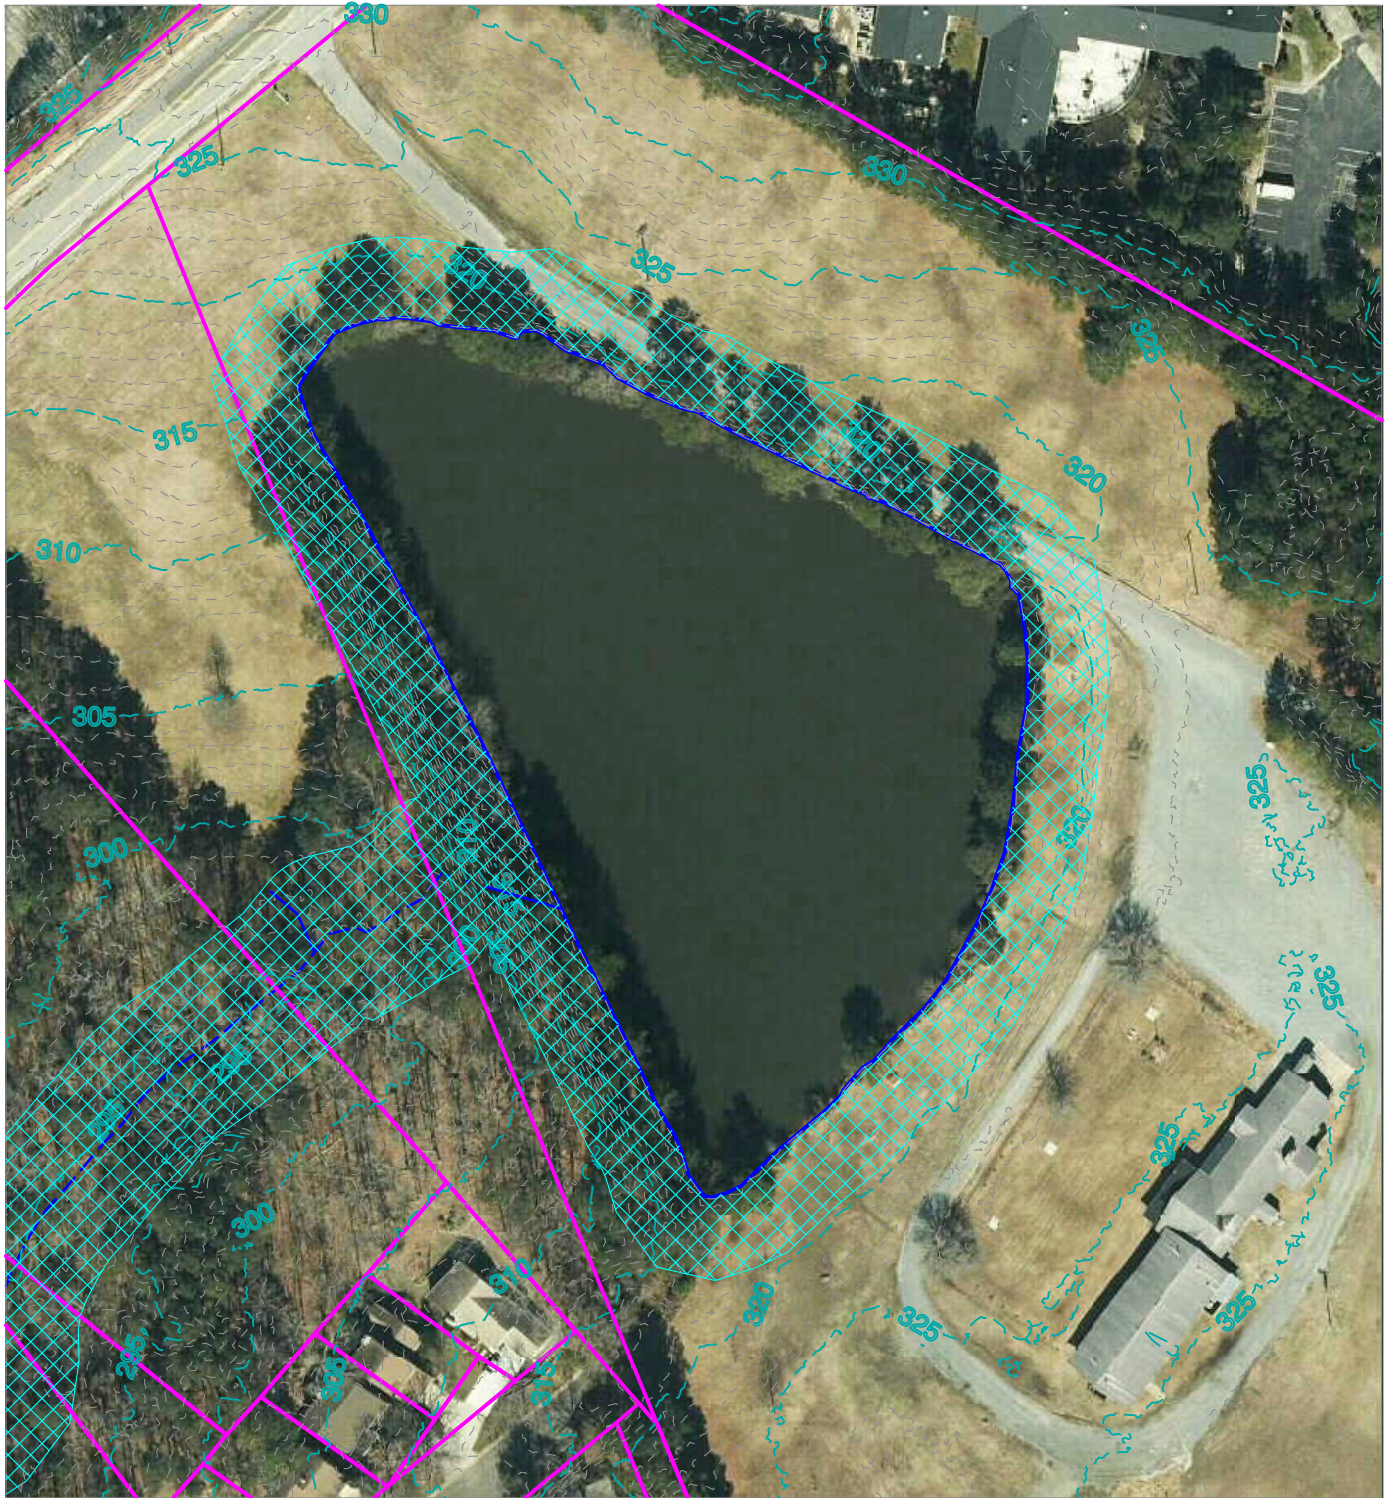
EXISTING CONDITIONS

The project site occurs on two separate parcels owned by the Town of Chapel Hill totaling 36.23 acres (PIN #9799555951, 33.64-ac; PIN #9799467392, 2.59-ac). The pond is approximately 2.7 acres. Figure 2 presents the existing project site conditions. Attachment 1 includes tax maps of the site highlighting both parcels.

- **Outlet Structures:** Observed outlet structures include the original ductile iron pipe outlet, an 8-inch PVC pipe overflow device, and an approximate 10'-wide emergency spillway on the eastern abutment of the dam. The inlet of the original outlet structure was submerged and could not be observed. The downstream end of the original outlet structure includes a ductile iron butterfly valve that was closed at the time of observation. None of the observed outlet structures included energy dissipating structures. All outlets discharge to a well-defined drainage channel.

- **Toe:** The toe of the dam contains trees of varying size, up to 21-inches in diameter. No significant signs of erosion or seepage were observed.
- **Groins:** Trees cover the groins of the dam. There are no signs of erosion or seepage.

The most specific concern is the extensive pine tree vegetation on the downstream face of the dam. If any of the large pine trees were to blow over and expose the root ball, a dam failure could become possible.

Dam Repair: Dam repair will include dewatering the pond, riser barrel structure replacement, and a filter diaphragm, an outlet energy dissipater, and a drainage blanket will be added.
