Chapel Hill Historic District Certificate of Appropriateness Application	Project:	18-126
Project Description: Replacement and Repair of Fire Escapes at 233 & 235 McCauley Street	Permit:	
	STAFF REVIEW	
	<input checked="" type="checkbox"/> Application complete and accepted	
	<input type="checkbox"/> Application not complete and returned with a notation of deficiencies	
Instructions: Submit one paper copy and a digital copy of all application materials collated in one file (pdf preferred) Deadlines: Applications are due by the close of business 30 calendar days prior to the scheduled meeting date. Note: Only complete applications may be accepted for Certificate of Appropriateness review. Applications that are not complete will be returned with a notation of deficiencies.

COA Application Section A. Property Information

PROJECT NAME:	233 & 235 McCauley Street Fire Escape Assessment	PROJECT NO.:	17-409
PROJECT ADDRESS:	233 & 235 McCauley Street Chapel Hill, NC 27516	FIELD REPORT NO.:	SUMMIT - 1
		DATE:	09/11/2017
Owner:	Ted Parenti, Rampart Management	REPORT DISTRIBUTION:	OWNER <input checked="" type="checkbox"/> ARCHITECT <input type="checkbox"/> CONSULTANT <input type="checkbox"/> F

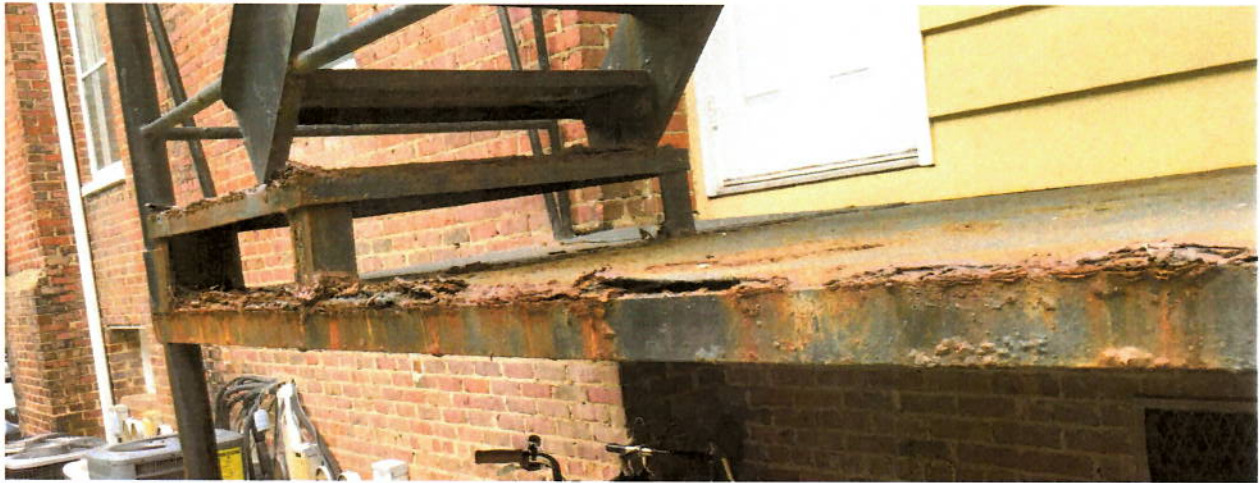
IMAGE 4 – Stair #1 Landing Deck

An overall image of the stairway can be seen in **IMAGE 3**. The checkered plate deck which comprises the landing surface of the stairway is heavily corroded. The corrosion is most significant at the perimeter of the landing and joints between individual plates (See **IMAGE 4-7**). Most of the weld between the deck and the perimeter framing has corroded away, which is evidenced by the deck curling or bubbling upward from the support framing below (See **IMAGE**

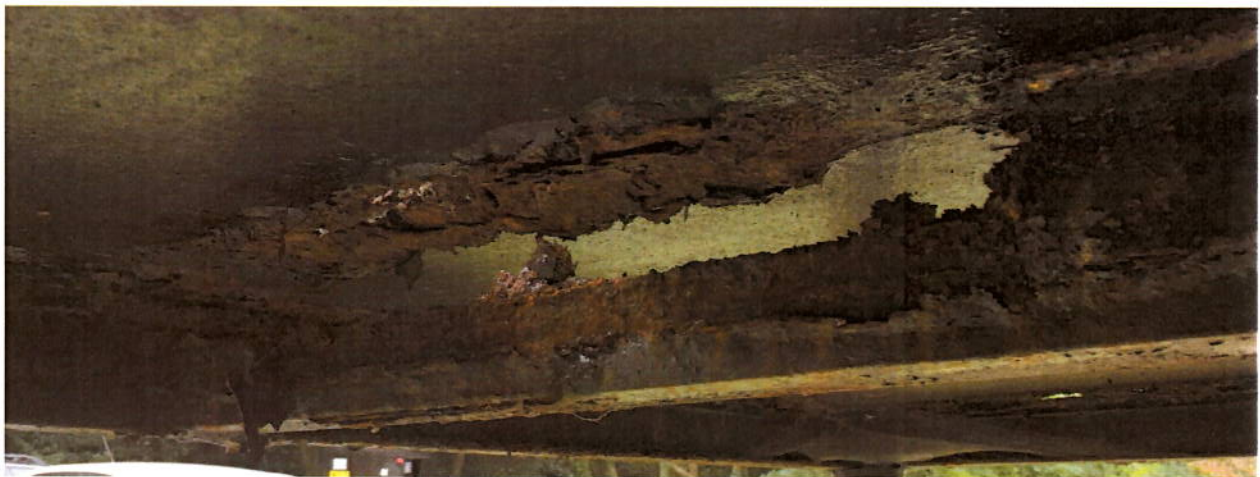
IMAGE 9 – Stair #1 Landing Framing

8). Framing members which are in contact with the plate deck have experienced varying degrees of corrosion; some members having lost nearly all the cross-sectional area and connection welds (See **IMAGE 9**). The checkered plate stair treads have varying degrees of surface to deep penetration rusting, located predominately on the underside of the plate and at the end connection to the stringers (See **IMAGE 10**). Some treads appear to have been repaired in the past by the addition of an angle support at the connection to the stringer; the repair angles are mostly in a similar state of corrosion (See **IMAGE 11**). The connection to the building structure on the inside of the stairways appears to be angles slotted into grout joints of the structural brick exterior wall (See **IMAGE 12**).

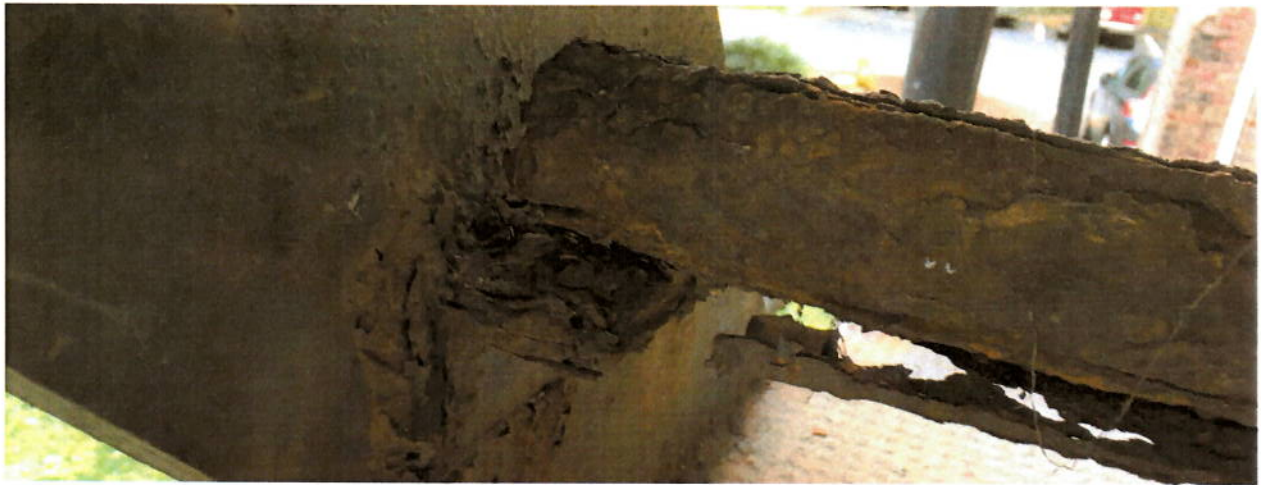
IMAGE 10 – Stair #1 Tread

Additionally, there are some connection and framing layout details which are not in line with proper design practice. The pipe columns do not run continuous up the height of the stairs, and terminate at each landing (see **IMAGE 10**). The fully vertical loads from the pipe columns must pass through the 3-inch landing support channels. Second, the triangular shaped tread which turns the egress from the landing to the typical stair treads is supported at the corners by angle stub columns (see **IMAGE 4**). These stub columns are not placed directly above the landing

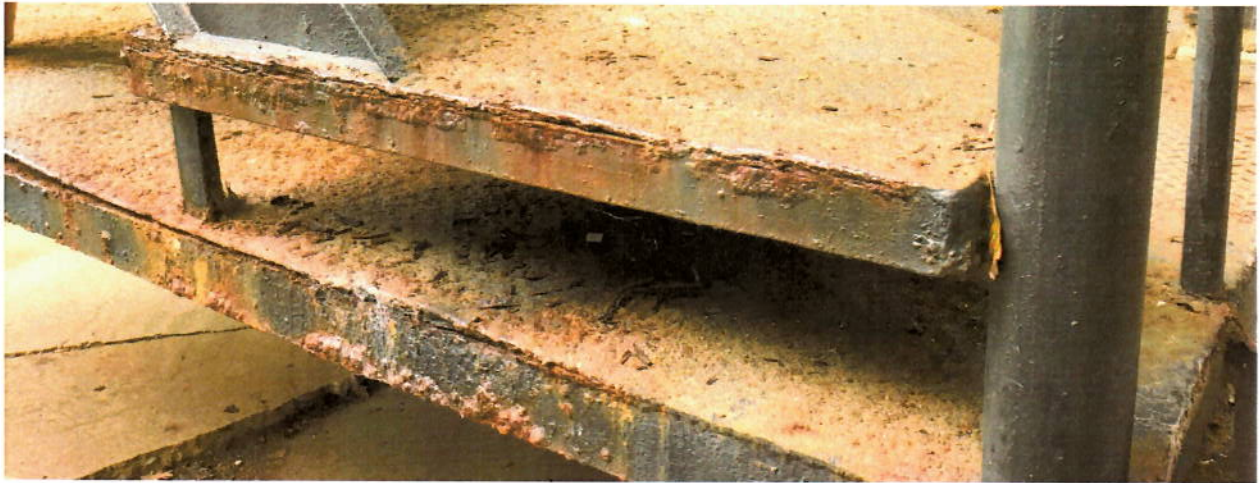
IMAGE 14 – Stair #2 Landing Deck

An overall image of the stairway can be seen in **IMAGE 13**. A similar level of corrosion damage is present on stair #2 as stair #1. The checkered plate decking has experienced significant loss of area in several locations (See **IMAGE 14-17**). The deck has bubbled and curled upward from the support framing predominately at the landing perimeter and joints between decking pieces. Welds between the deck and support framing are compromised or non-existent in several locations. Framing members have some loss of area due to corrosion, mostly in locations where in contact with the plate decking. The stair treads are in varying degrees of corrosion, with some treads experiencing near full loss of area and welds at the connection to the

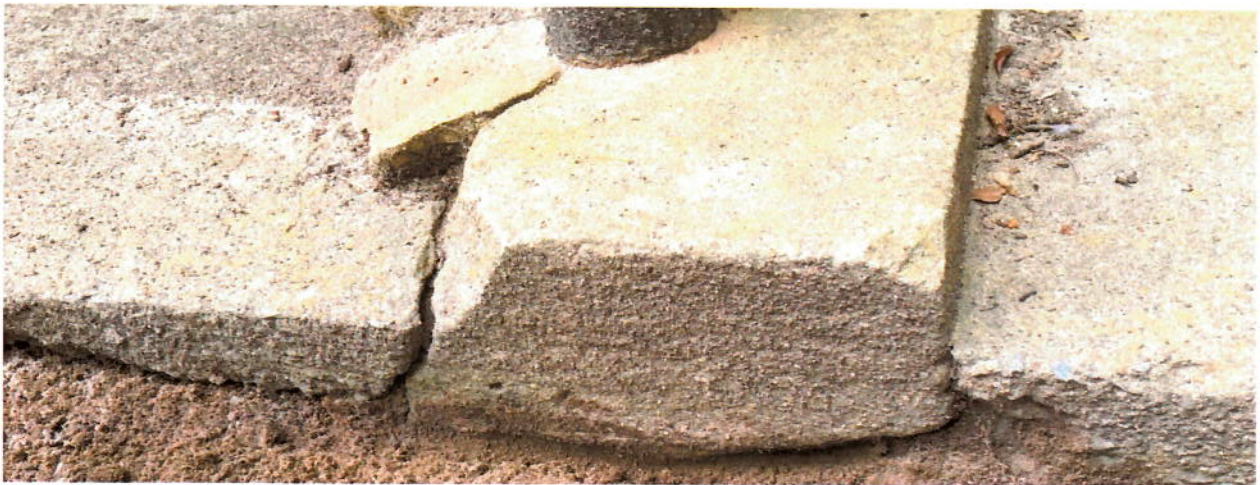
IMAGE 21 – Stair #2 Foundation

stringers (See **IMAGE 18-19**). It appears select locations were repaired in the past with the addition of a support angle at the tread to stringer connection (See **IMAGE 20**). The pipe columns are connected to a concrete grade slab. It is typical for these foundations to extend below the frost depth to eliminate yearly frost heave during the transition of seasons from winter to spring. It was observed that the foundation sits inches below the grade elevation with no additional footing extending below the frost depth (See **IMAGE 21**). Significant splitting of the foundation slab was observed; the slab does not contain any steel reinforcement in the form of a welded wire frame or deformed rebar (See **IMAGE 22**).

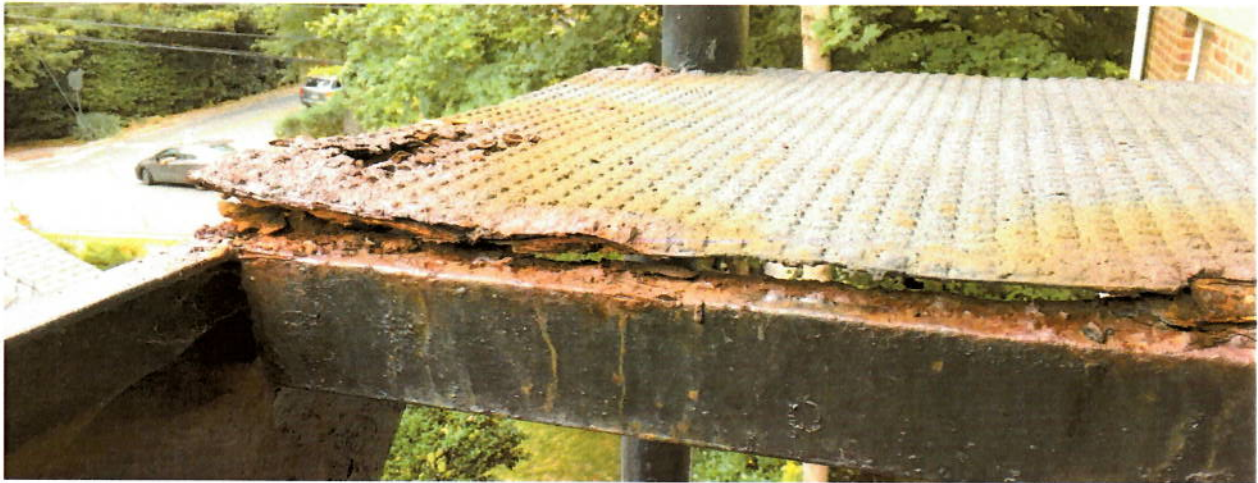
IMAGE 24 – Stair #3 Landing Deck

An overall image of the stairway can be seen in **IMAGE 23**. The stairway is in better condition than noted for stairs #1 and #2. The corrosion of the stair structure is mostly limited to the perimeter and joints of the checkered plate decking, as well as connected framing surfaces (See **IMAGE 24-26**). Similar bubbling of the decking was observed, with most perimeter welds no longer connecting the deck to the support framing. Some of the support framing has concerning loss of area at locations with heavily corroded deck, with most of the framing having minor surface rust at the top flange. Some of the stair treads and connection welds are in poor conditions, with significant loss of area due to long term corrosion (See **IMAGE 27-28**). A portion of these members appear to have been repaired in the past by the addition of a support angle. The connection of the stairway to the building is unique to those observed for stairs #1 and #2 (See **IMAGE 29**). A vertical angle is connected to the perimeter framing, and bolted into the brick wall.

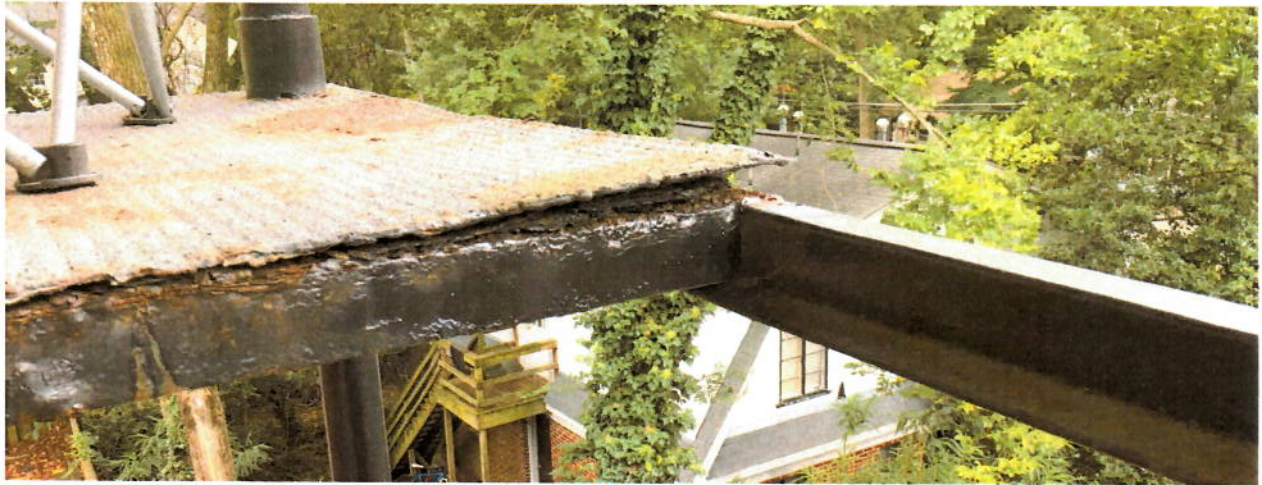
IMAGE 31 – Stair #4 Landing Deck

An overall image of the stairway can be seen in **IMAGE 30**. The stairway is in similar condition as noted in stair #3. At the perimeter of the checkered plate decking, corrosion has degraded the steel significantly. At these locations connecting welds with the support framing have rusted away. Support framing members adjacent to the heavily corroded deck see similar levels of degradation at the contact surfaces (See **IMAGE 31-34**). Select stair treads have significant rust penetration, predominately on the underside and at the welded connection to the stringers (See **IMAGE 35**). Angle reinforcement of treads was observed at some locations like those previously noted. Connection of the stairway with the building is the same as stair #3 (See **IMAGE 36**).
