206 McCauley Street Certificate of Appropriateness Application-3/11/22

1) **WRITTEN DESCRIPTION**

This 1932 McCauley house is located between Ransom Street and Pittsboro Street and backs up to UNC's Nash parking lot, very close to the intersection of Pittsboro St and McCauley Street, the Carolina Inn and UNC's FedEx Global Education Center. It is a lovely Two-story L-plan house with side-gabled roof, front-facing cross gable, and painted wide front porch. The 2nd story is shingled siding. 206 McCauley was deemed a Contributing Building in the 1998 survey.

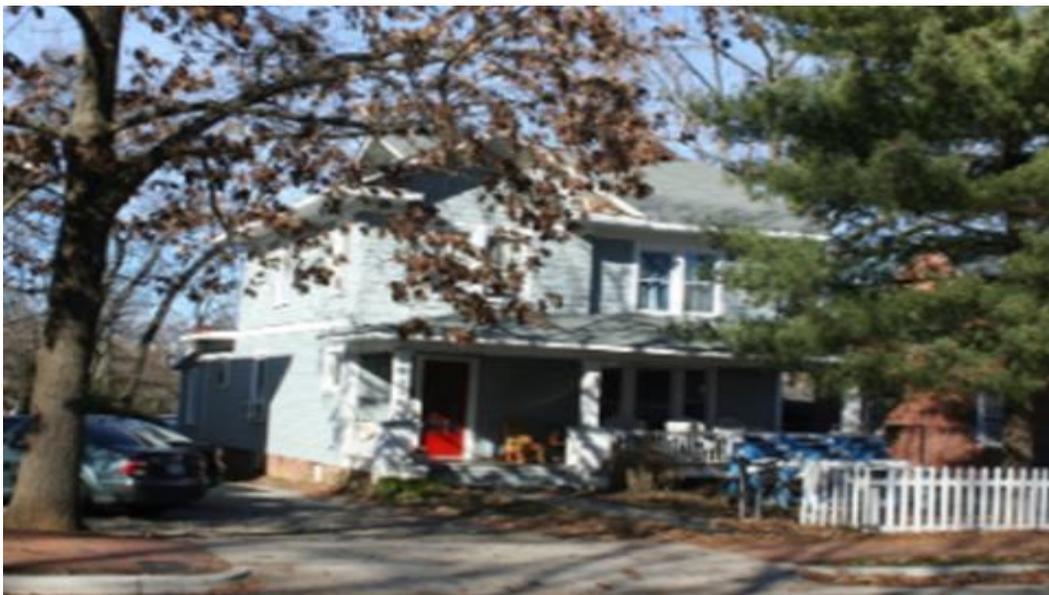
- Subject property is a Two-story L-plan, with shingle siding on second story, double-hung windows, and wide front porch. Examples in Chapel Hill were usually painted light, neutral colors. Our records indicate it was built in 1932.

Older photo of subject property found at www.historicchapelhill.org

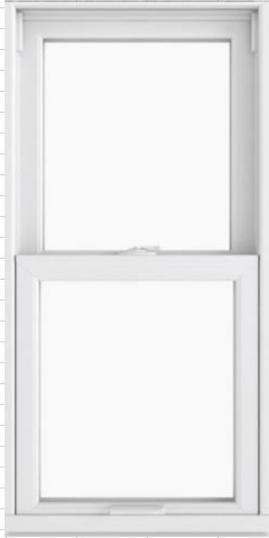
Fiberglass Option-Marvin Essential-Stone White
LowE2 with Argon gas fill U-factor 0.29 SHGC 0.29

Replacement windows would be prefinished in white with no grid as are existing windows in subject property as well as several of the surrounding properties (see photos of neighboring properties above and proposals below for both fiberglass and aluminum wood clad). Windows are replacement windows so they are built in specific sizes to fit the openings on the home. With older homes like this one, stock sizes sometimes won't fit. Window contractor will be measuring each window opening and building the window to fit what is provided.

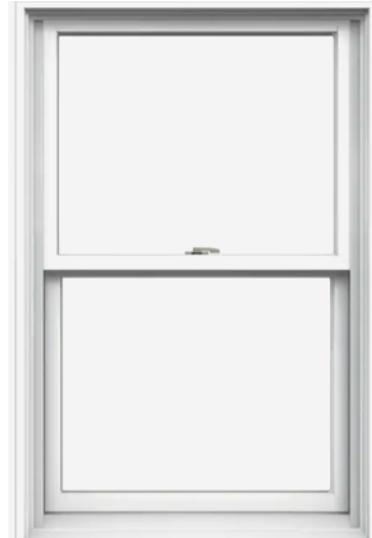
Aluminum Option-Pella Lifestyle-EndurClad-White
LowE with Argon gas fill U-factor 0.30 SHGC 0.30

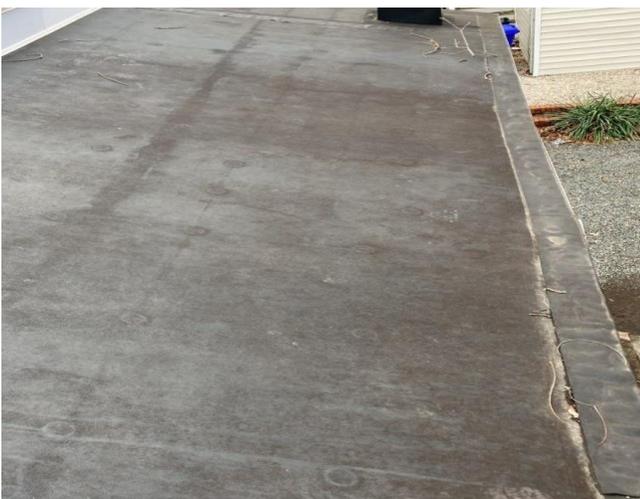
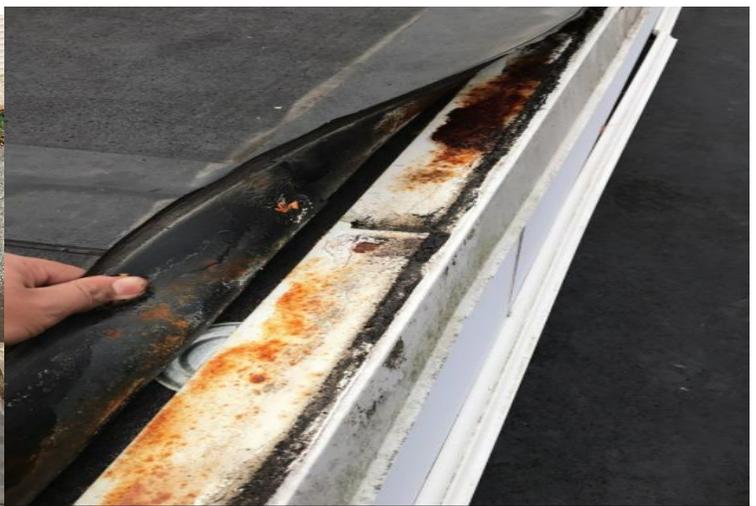
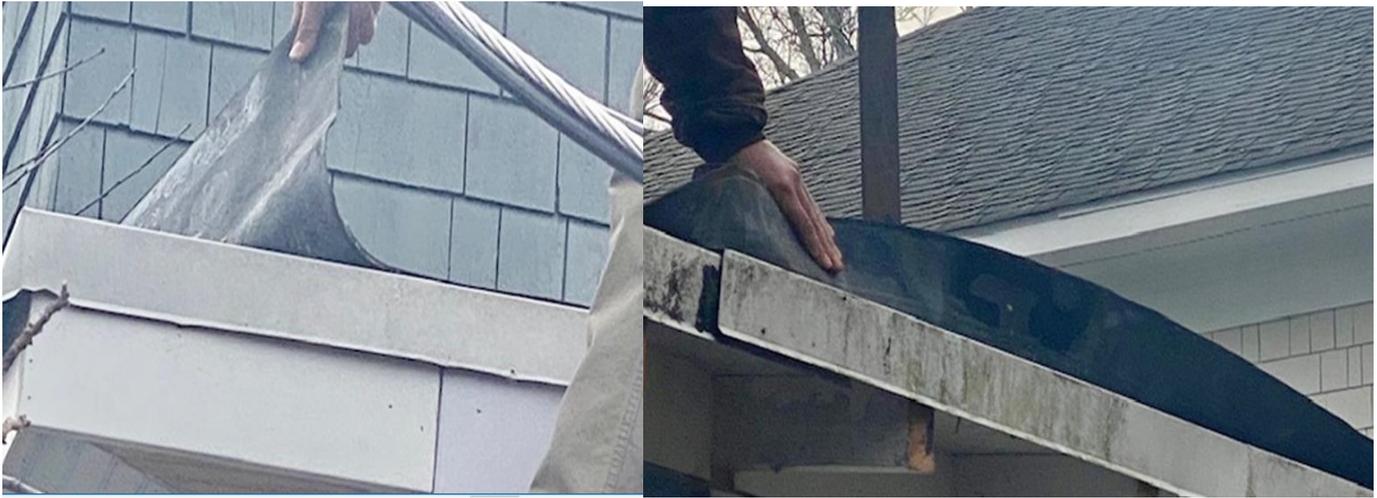
Existing rear flat EPDM roof is not sealed around seams and edges and allows water infiltration.

Views of Existing EPDM roof-current materials are not sealed around the perimeter nor on seams

Applicant proposes In-kind replacement of existing improperly installed and malfunctioning rear EPDM membrane flat roof.

SERVICE	RATE	AMOUNT
<p>Flat Roof</p> <p>Remove all existing EPDM membrane and insulation to bare roof decking from the two flat roof at the rear of the house. Replace one damage sheet of roof decking. (If more damage is found owner will be alerted and this can be added as a change order at an additional cost) Mechanically attach new insulation boards over the roof decking where previously removed. Install new custom white drip edge on the edges of the flat roofs. Cut a straight line along the siding on the walls to properly flash the new EPDM membrane. Cut reglect in the mortar of the two chimney to properly add new metal flashing. Adhere the new EPDM membrane on to the new insulation. Adhere the membrane around the edge of the roof with seam tape. Properly secure the epdm membrane under the siding. Clean and dispose of resulting debris.</p> <p><small>Any damaged roof decking or other damage found while performing work can be repaired on a time and material basis if needed (\$90 an hour plus material). Owner will be alerted of any additional work needed. For repairs: shingles, paint, siding or any other new materials being installed next to older components may not be an exact match.</small></p>	5,751.00	5,751.00

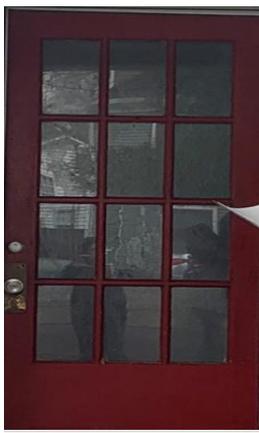
The age of the existing door is unknown, it is believed to be birch, but it does not seem to be of the highest quality.

Exterior front door (red was recently painted navy)

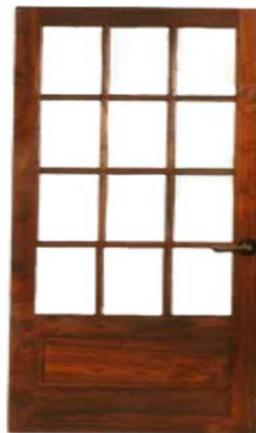
The applicant is requesting replacement with an in kind 12 light fir wood door in the same existing dimensions, in the event that restoration according to the standards is not possible.

Proposed in kind replacement exterior front door

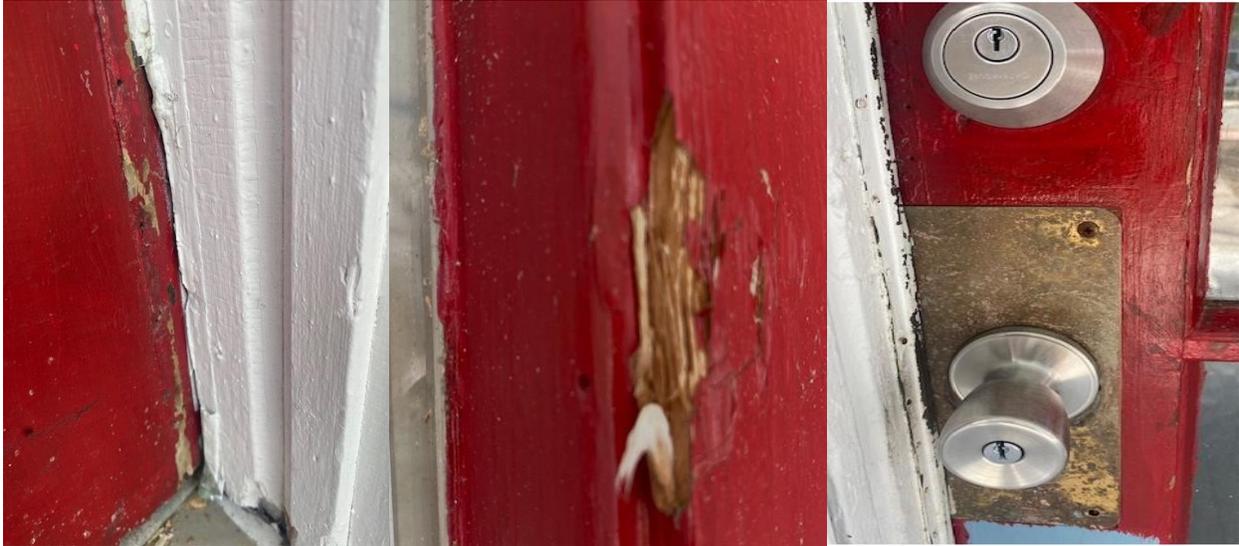
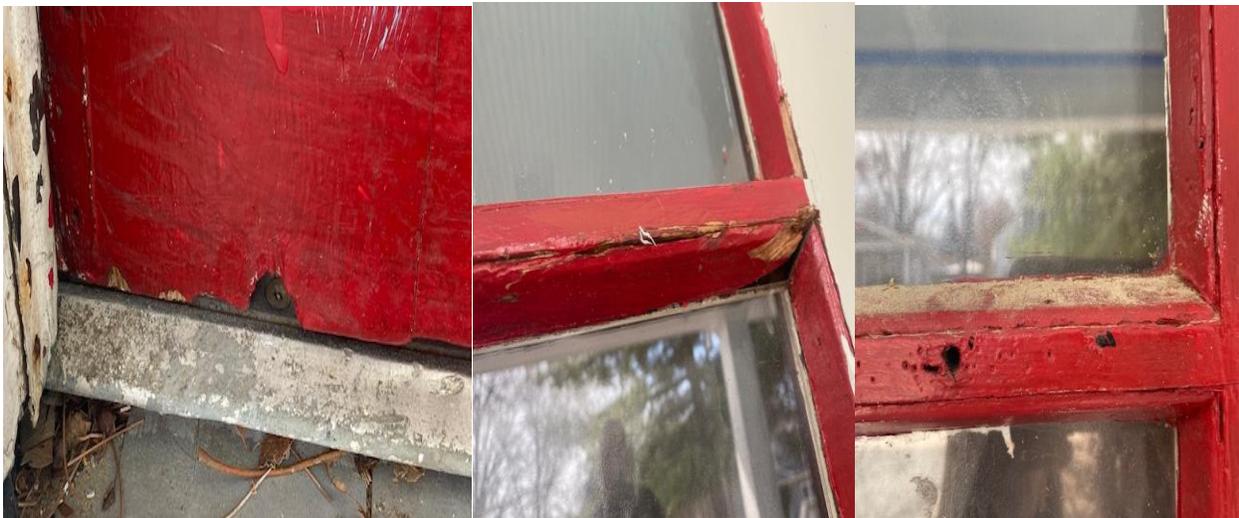
Poor conditions of existing front door

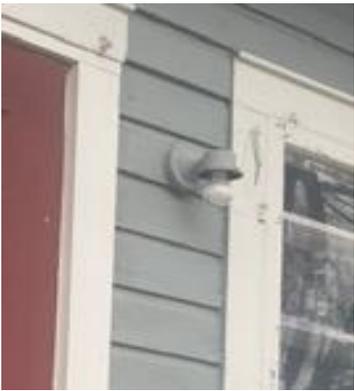
Existing side porch light

Applicant proposes in kind replacement of white front porch flush mount light with exact light in black as well as replacement of side porch and rear lights.

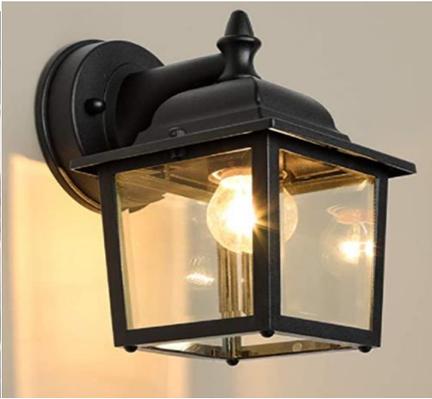
proposed side porch & rear light

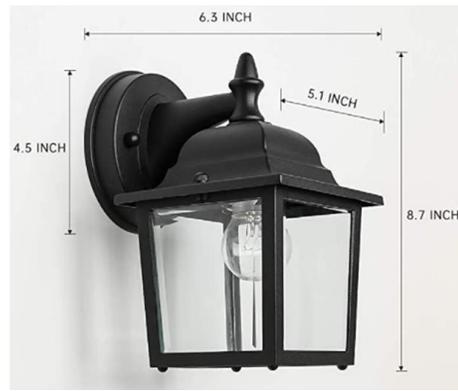
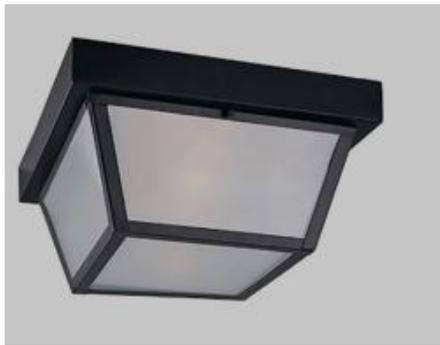
Proposed in kind replacement of front porch ceiling mount light in black instead of white

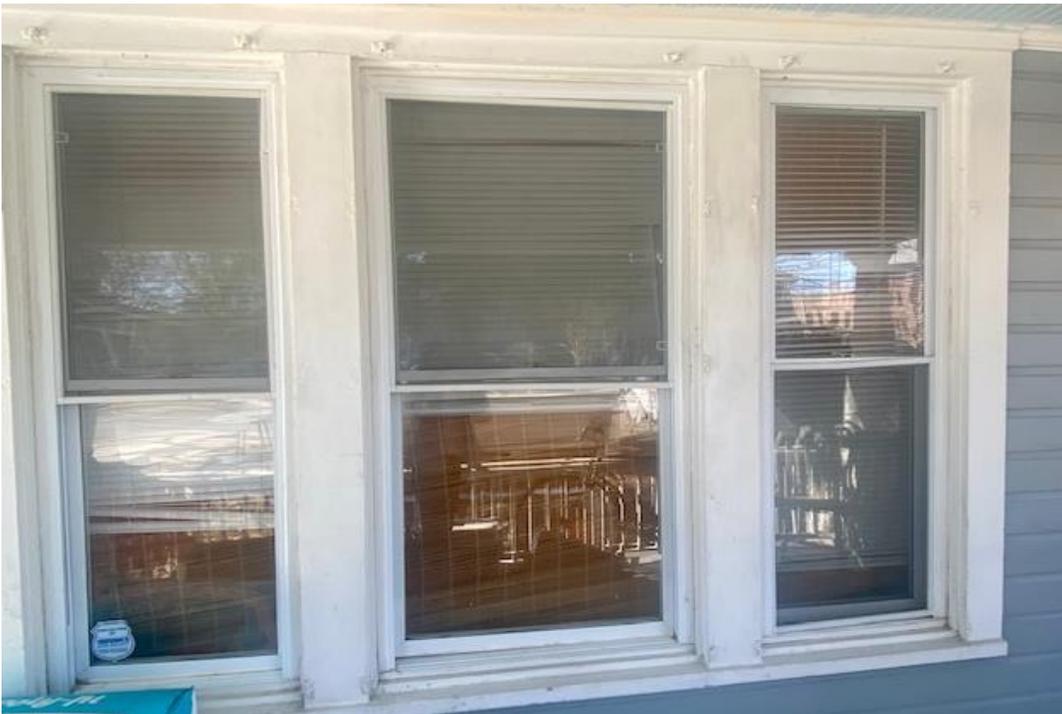
Closer view of existing vinyl windows-front of house

The original windows were replaced with vinyl sometime prior to current ownership. Existing vinyl windows are in poor condition. Owner is proposing fiberglass or aluminum clad since in kind replacement of vinyl windows is not permitted. We understand custom wood is preferred, but this option is much more expensive upfront and requires yearly maintenance and repainting. Our goal is to provide a solution that matches the aesthetic and quality of the original windows while protecting the building envelope, and in keeping with neighboring properties.

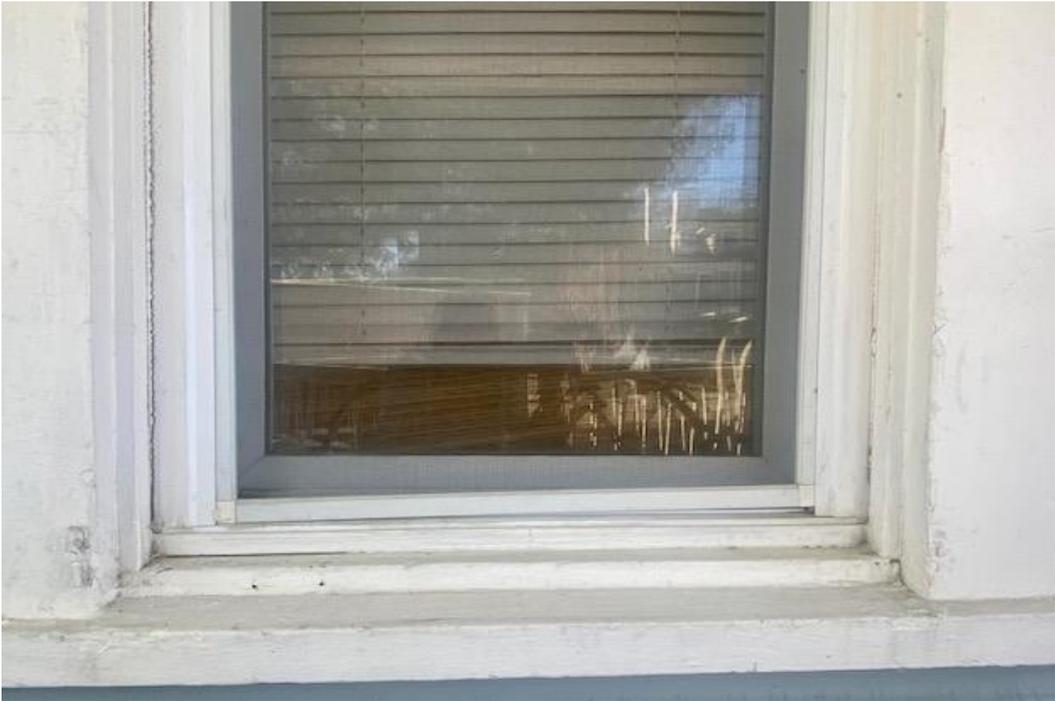
Closer view of existing vinyl window-front of house

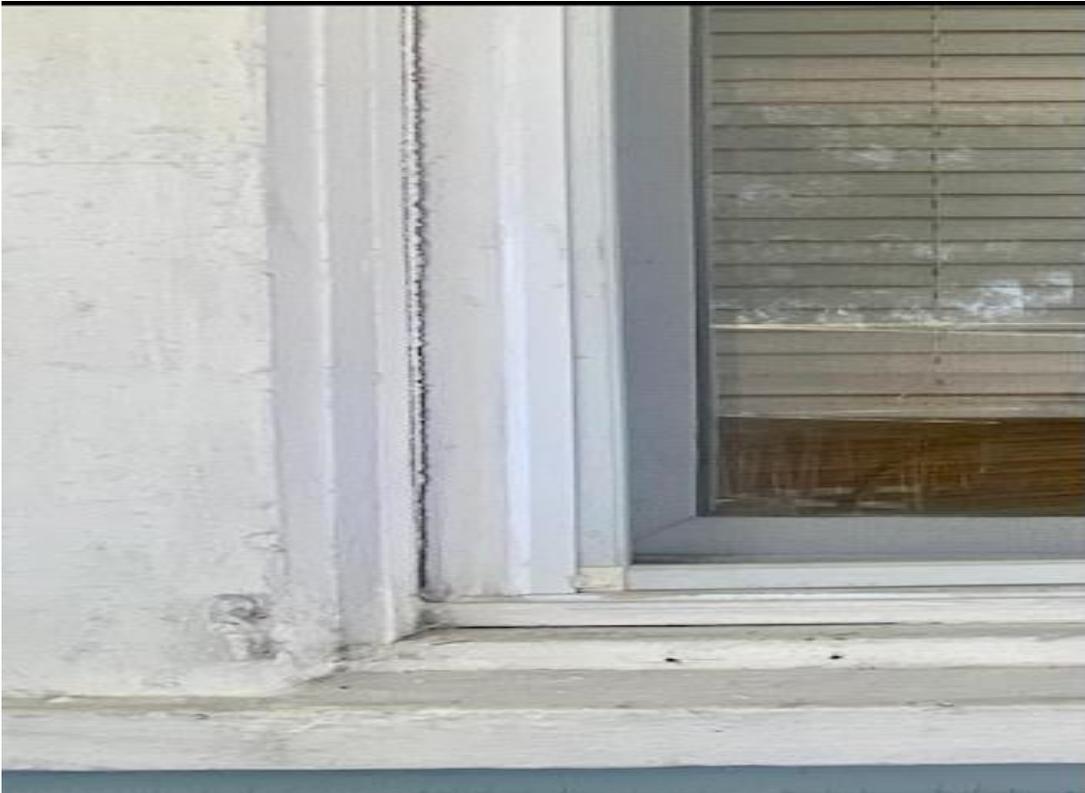
Closer view of existing vinyl windows-front of house

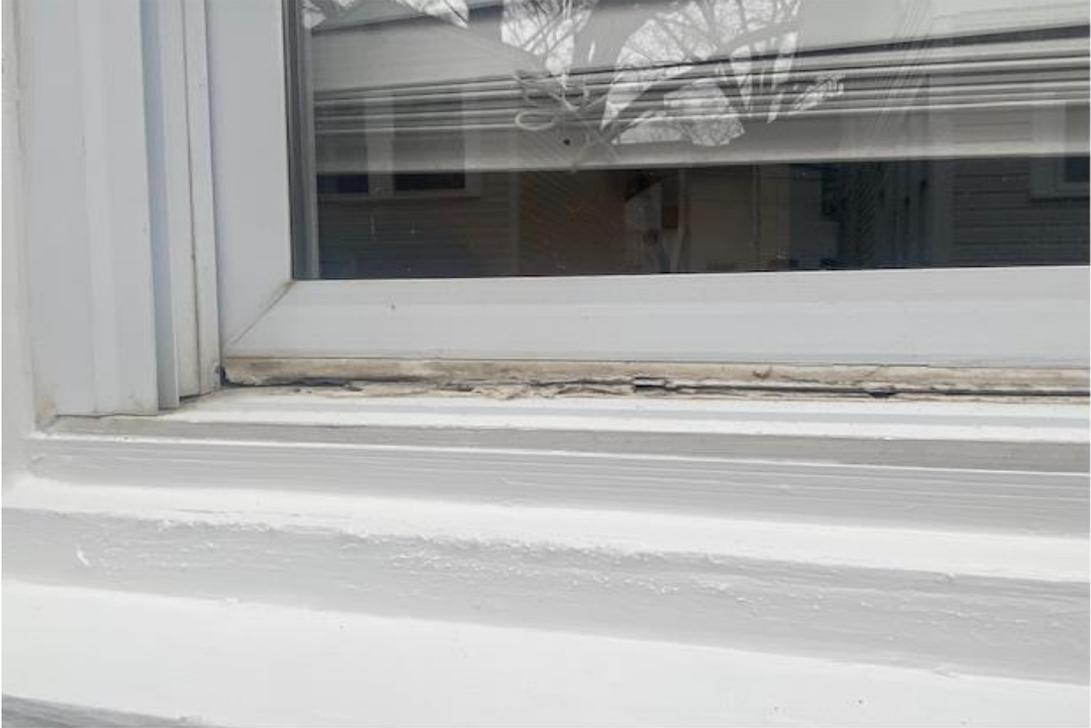
View of existing window-west rear side

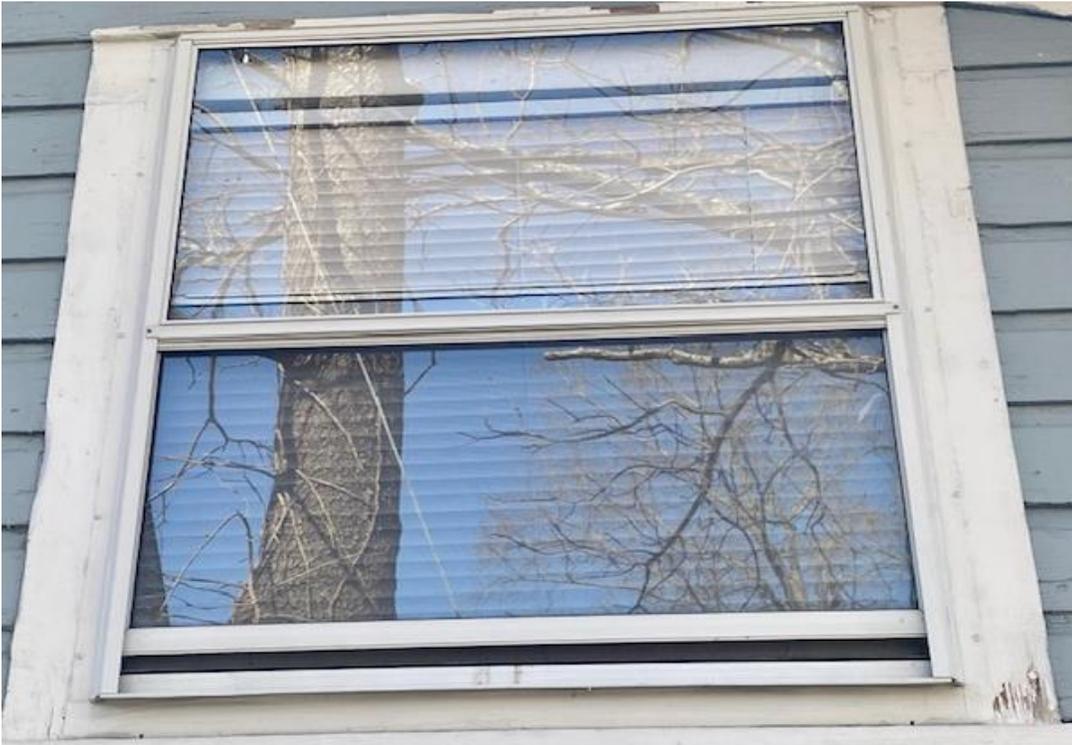
Existing window-east side

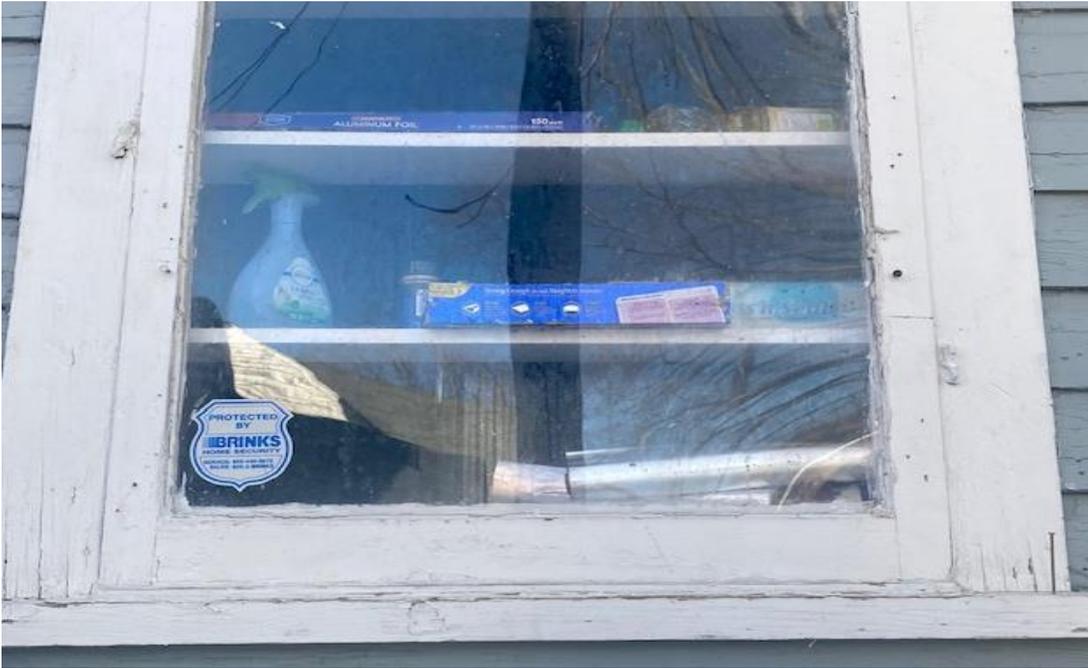
Existing window-east side (near side porch)-this one is not vinyl-perhaps original

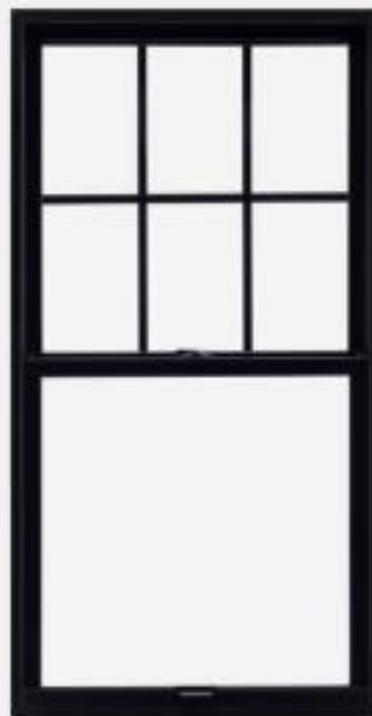
PULTRUDED FIBERGLASS

Thin strands of strong glass cables, saturated with compounded resins, create a durable material.

Ultrex fiberglass is highly impact resistant and more rigid than vinyl and vinyl/wood composites. Issues of instability and less-than-perfect alignment that can complicate installation—and long-term performance—are not a concern with Essential collection windows and doors.

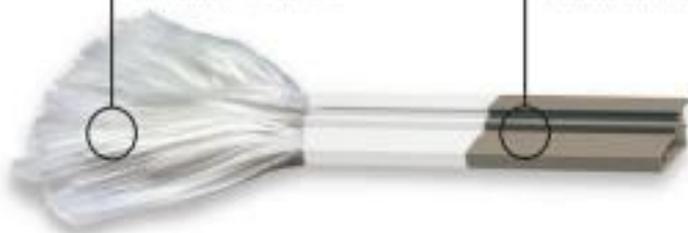
EXPANSION MEASUREMENT

Ultrax® expands and contracts at virtually the same rate as glass so it works with glass rather than against it. This means seals aren't as prone to leaking and windows aren't subjected to sagging issues like other composites.

This is especially true when compared to vinyl, which can distort in extreme heat and crack in fluctuating temperatures. Ultrax resists distortion even at temperatures up to 285°F. Rapid temperature change doesn't faze Ultrax. From -30°F to 70°F, a 6 foot stile changes less than 1/2 inch in length.

Ultrax expands and contracts at virtually the same rate as glass.

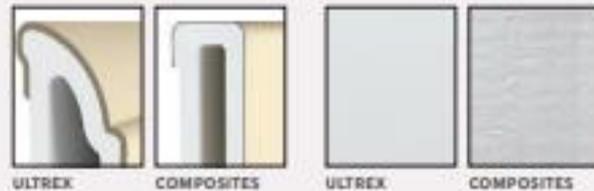
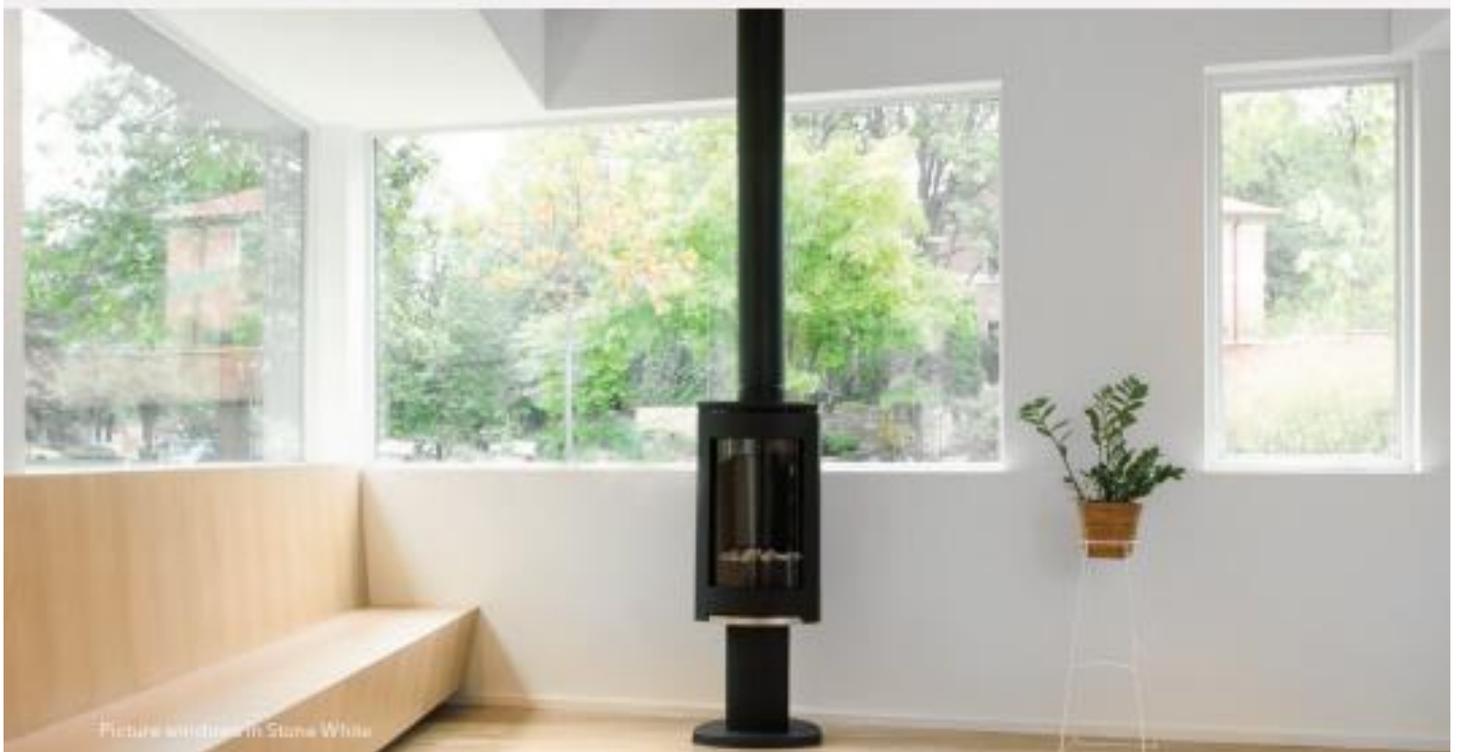
PATENTED ACRYLIC CAP

Windows and doors made with Ultrax resist scratches, dings, and marring more than vinyl. Our patented, mechanically bonded acrylic finish is up to three times thicker than painted competitive finishes, and it resists UV degradation up to five times longer than vinyl—even on dark colors.

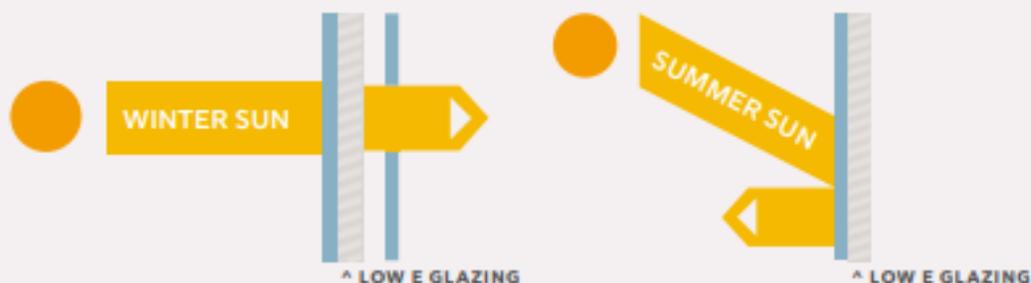
LOW E GLASS COATING

The Low E coating is specially designed to take advantage of the angle of the winter and summer sun. Winter sun is absorbed and conducted indoors. Summer sun is filtered and reflected back outdoors.

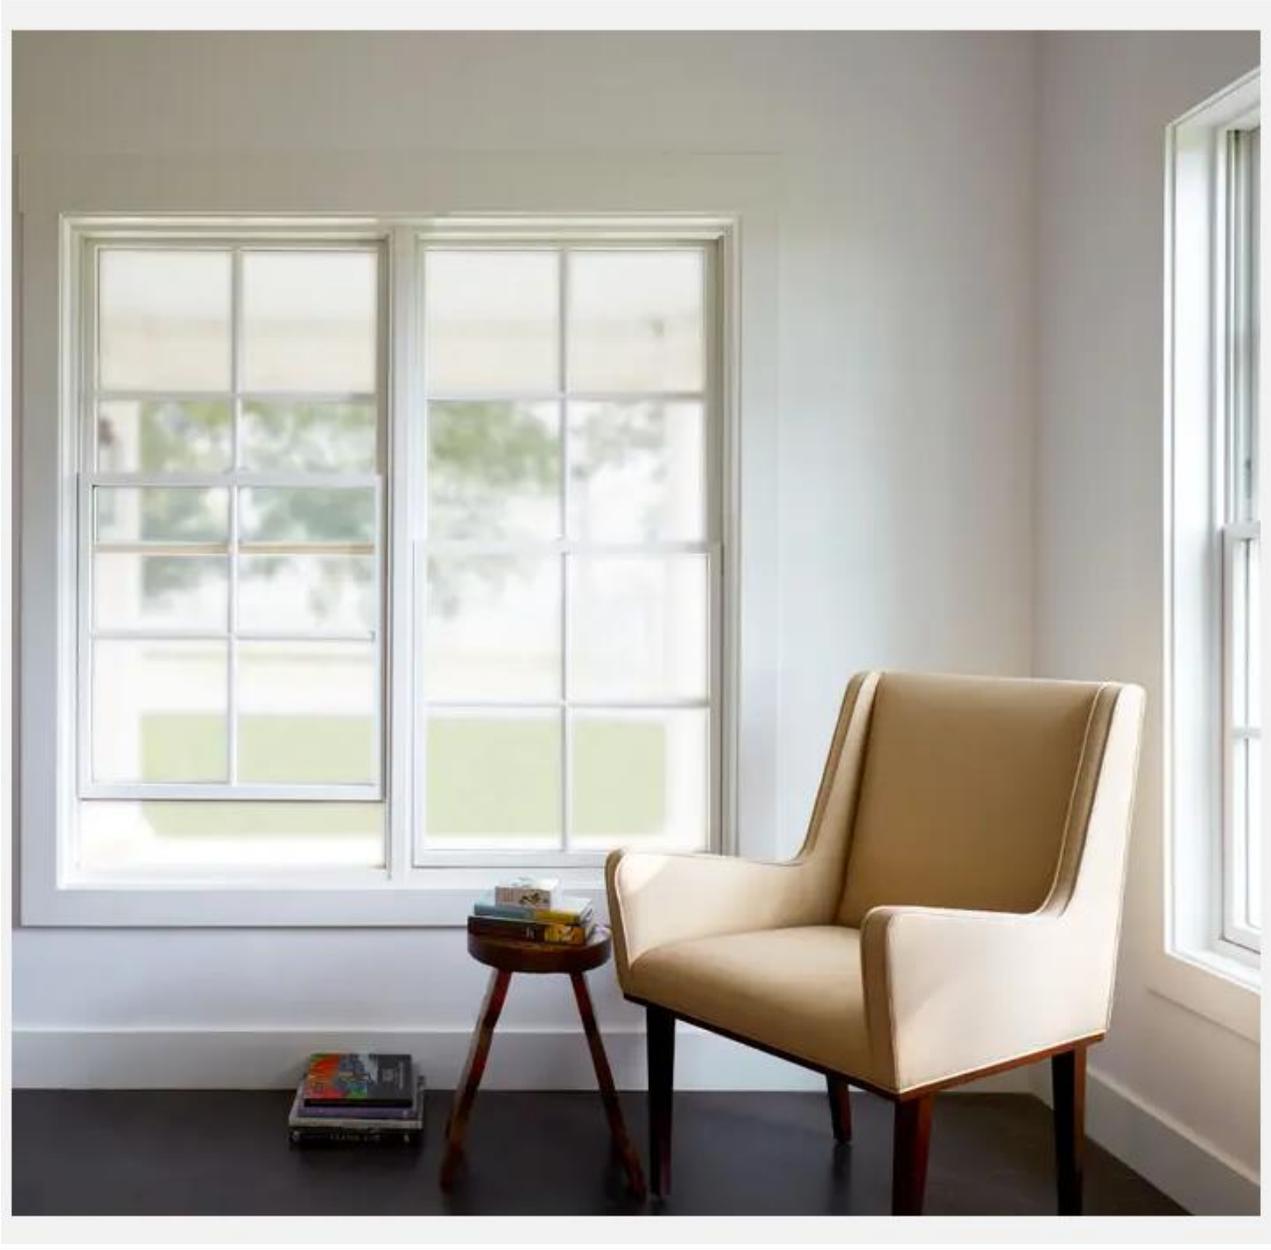
Aluminum Clad Window Specifications

Pella® Lifestyle Series Double-Hung

Aluminum EnduraClad® Exterior
