Phi Delta Theta Fraternity 304 South Columbia Street

Historic District Commission Review, March 12, 2024

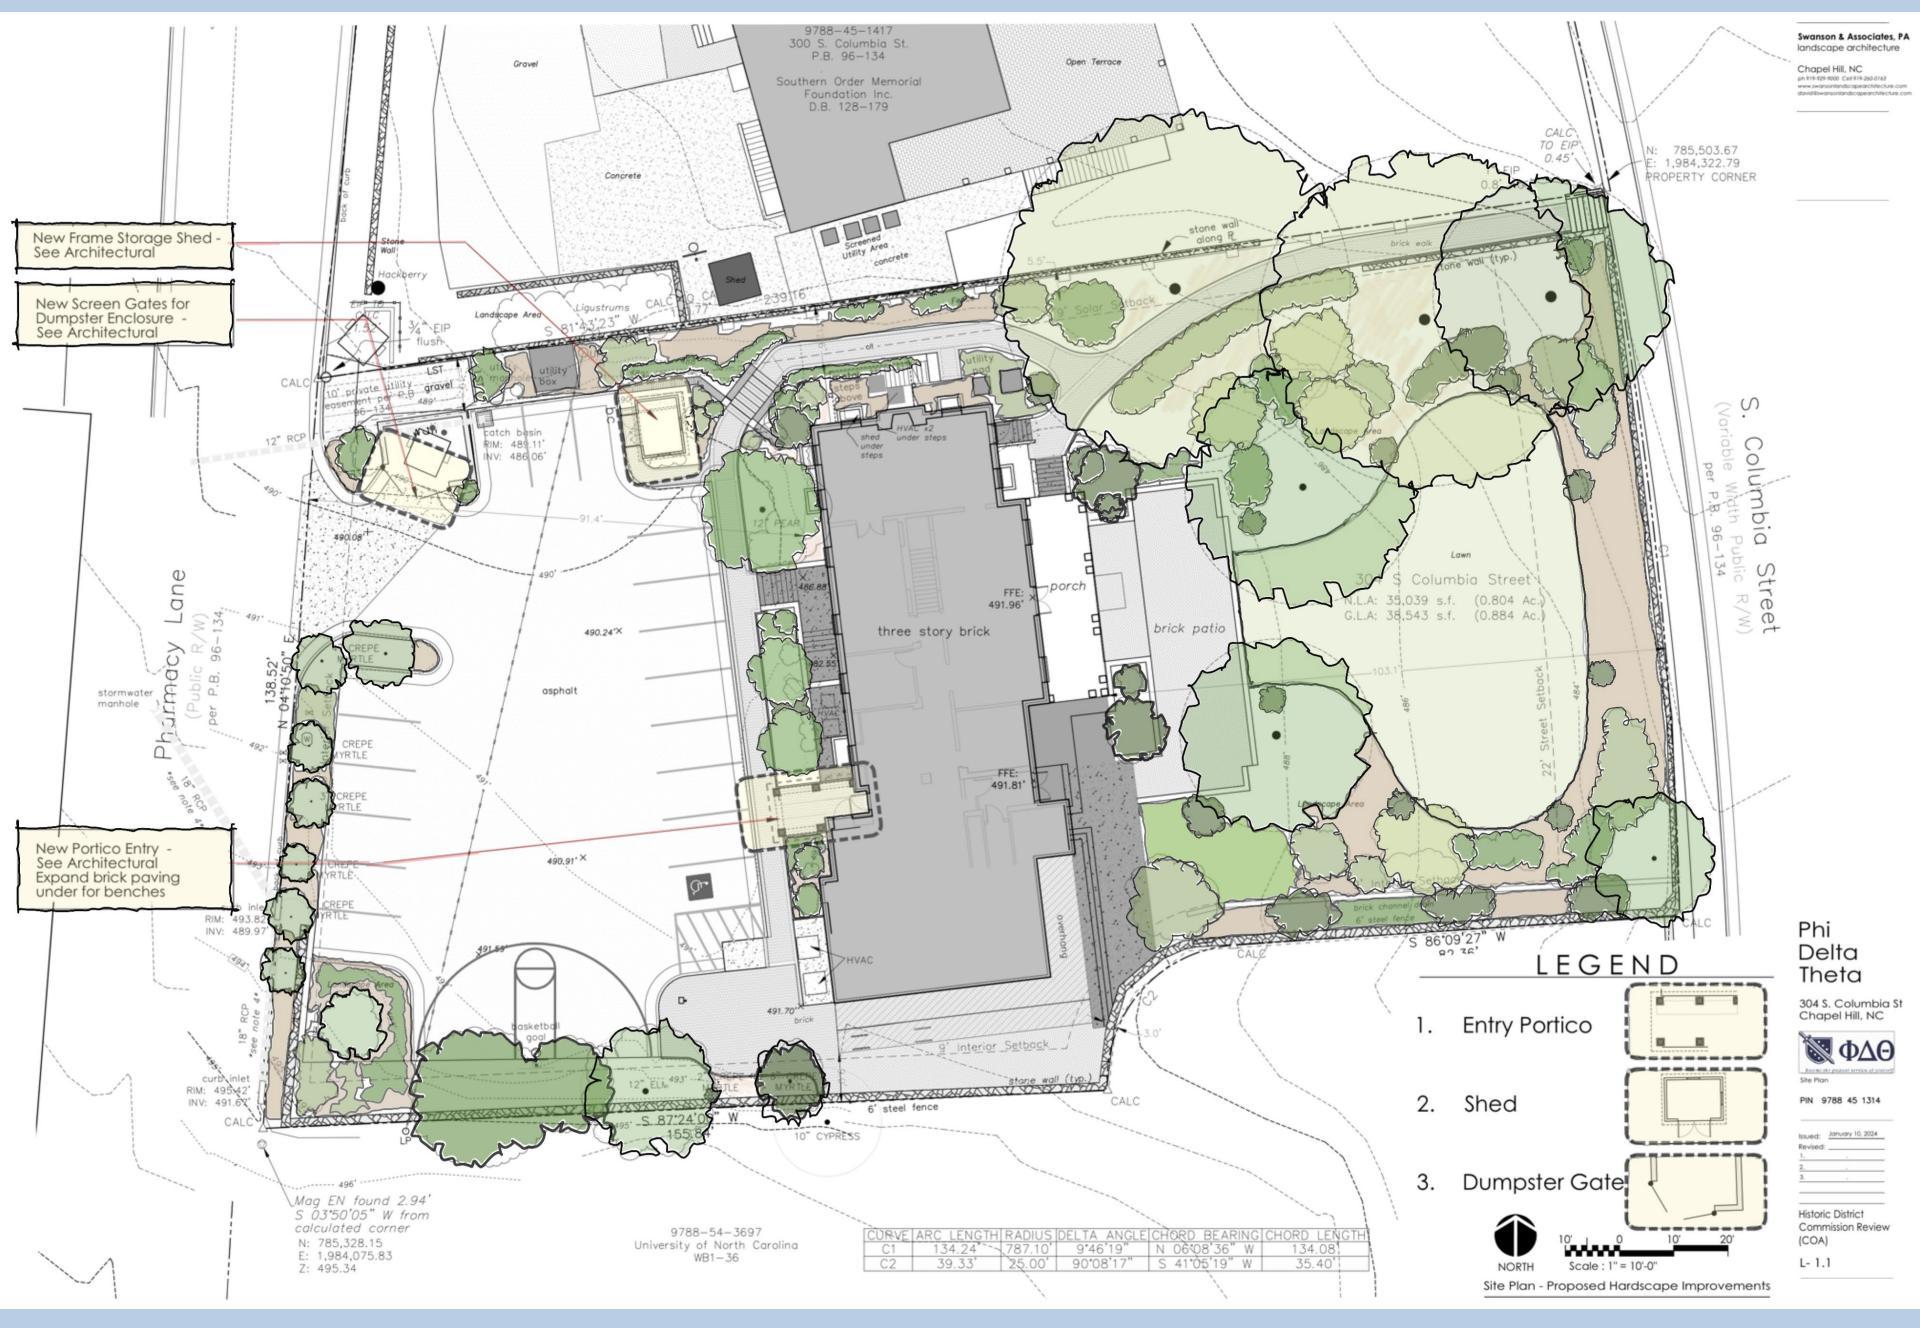
Site Plan showing locations of areas for improvement

This application concerns improvements, all at the rear of the property, to the rear entrance and dumpster gate panels, and replacement of the storage shed.

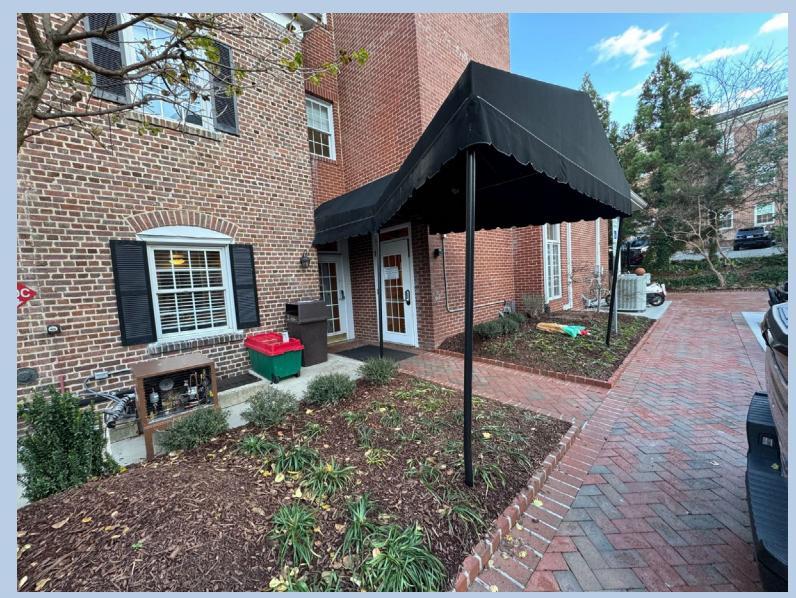
Existing Rear Entrance Canopy

• The portico will replace a canvas structure at the rear entrance of the building. The portico's form, configuration, and materials will be compatible with the existing building and front porch.

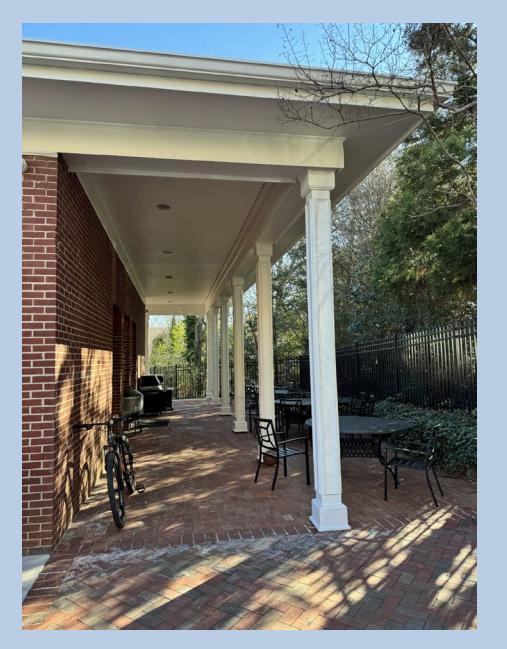
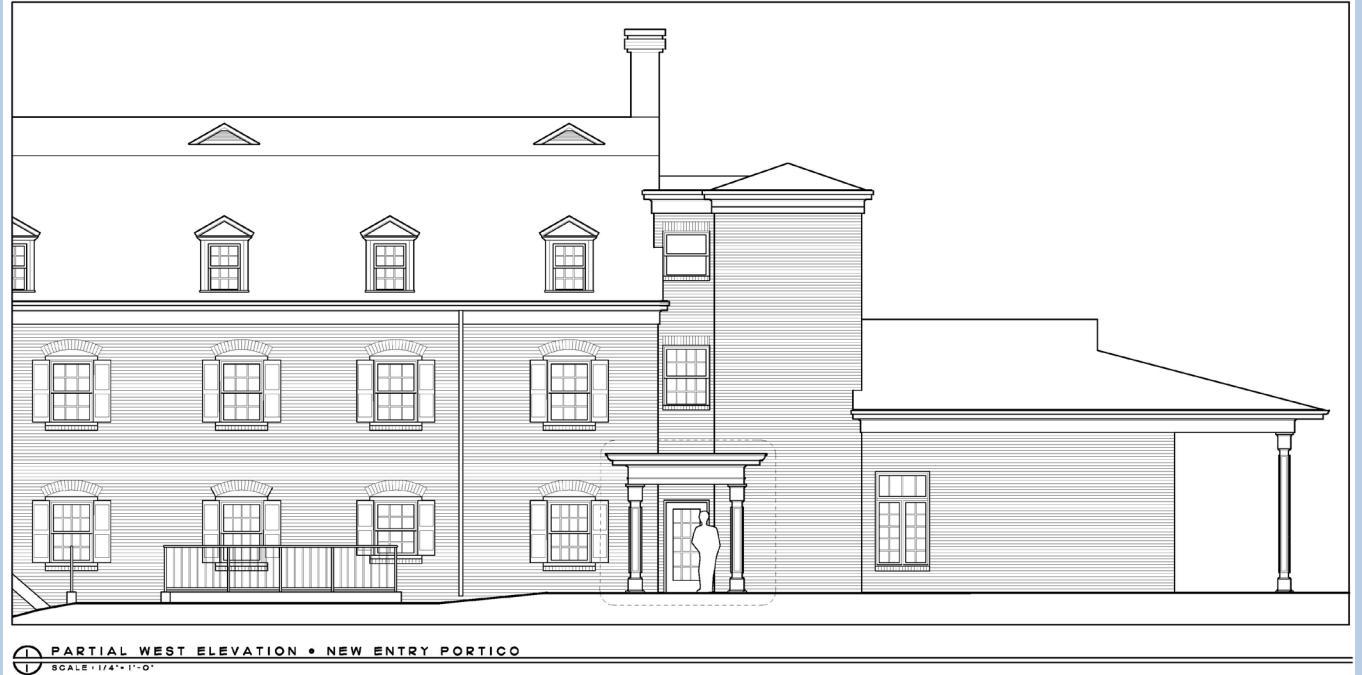
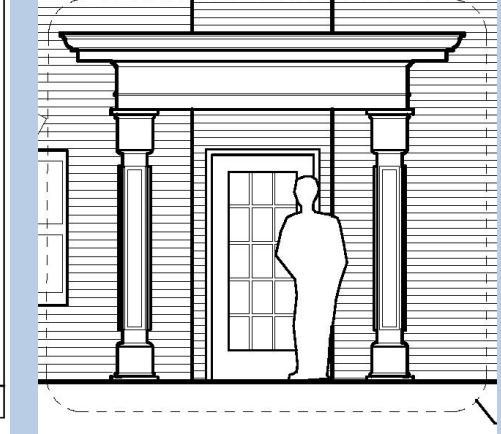
Appearance and elements will be similar to existing side patio

Proposed Rear Entrance Portico

• The rear entrance portico will use traditional materials in keeping with the existing building and the district setting.

• The portico will use traditional materials compatible wth the existing building and will be in scale with the existing building. The existing brick floor will remain and will be extended on either side by 2 feet.

• The portico will provide covered space and will be constructed of compatible materials.

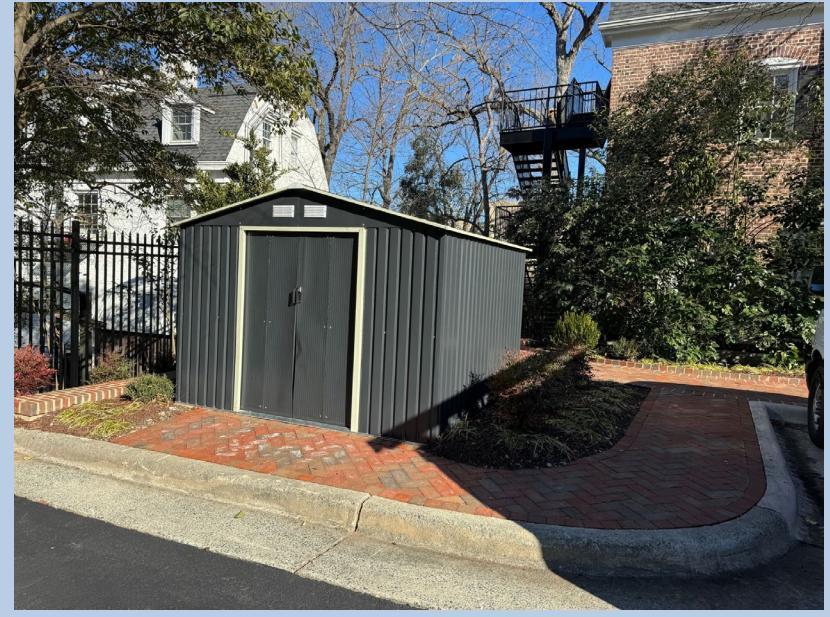
Existing Metal Shed

• The wooden shed will replace an existing metal shed in the same location the rear yard, not visible from the street.

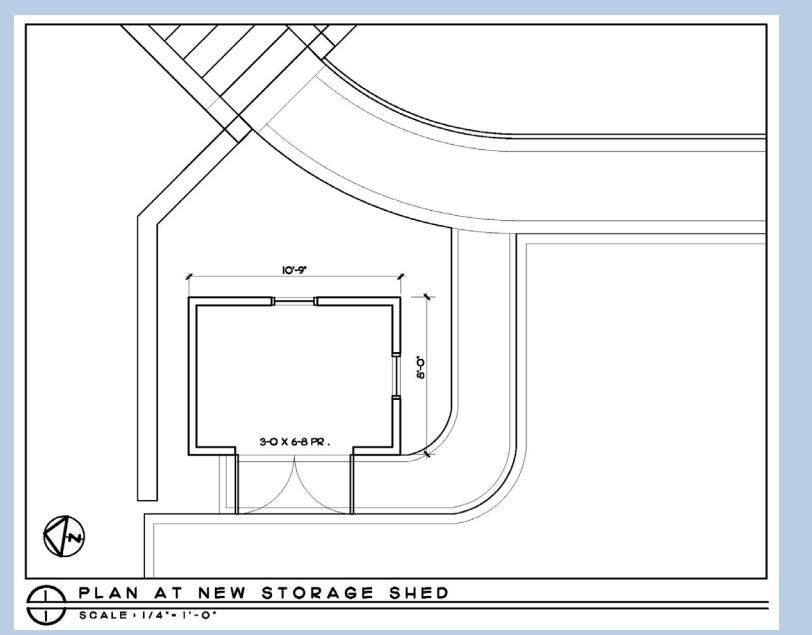
Plan of Proposed Shed

• The wooden shed will replace a recently approved and installed metal shed in the same location. It will be approximately the same height and length and will be 2 feet wider.

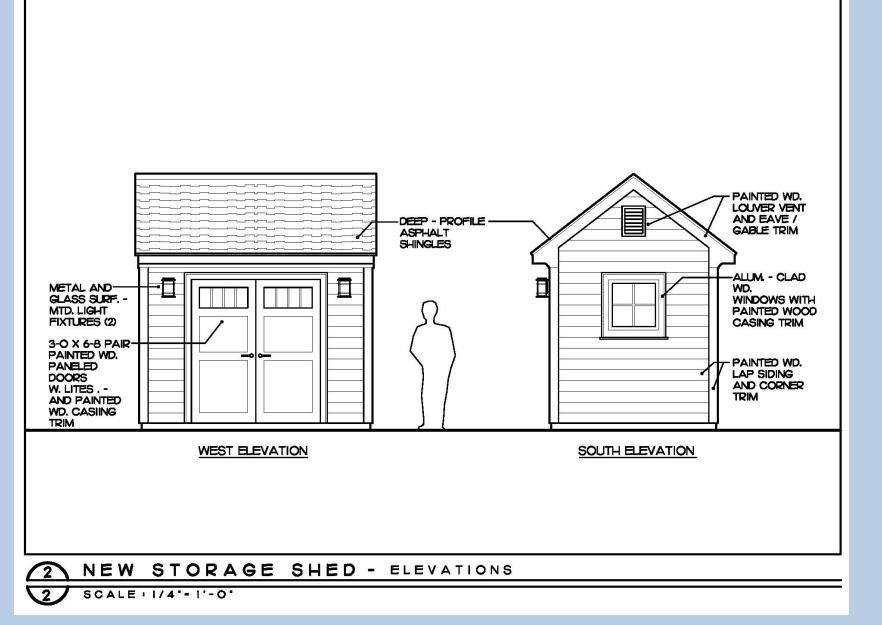
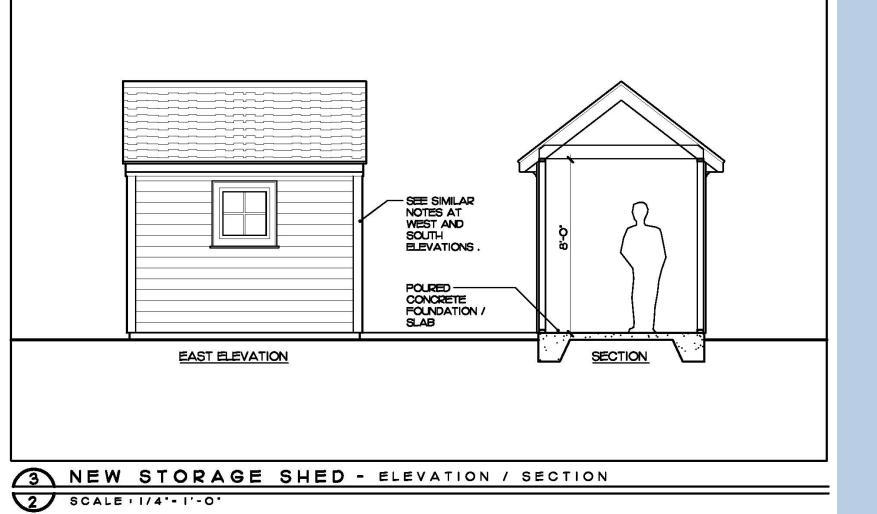
Proposed Wooden Shed

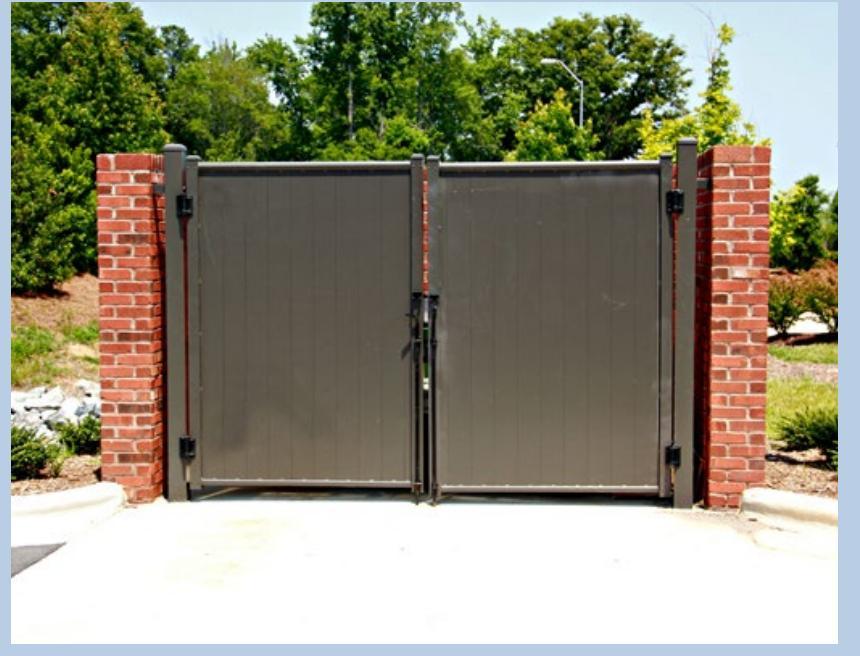
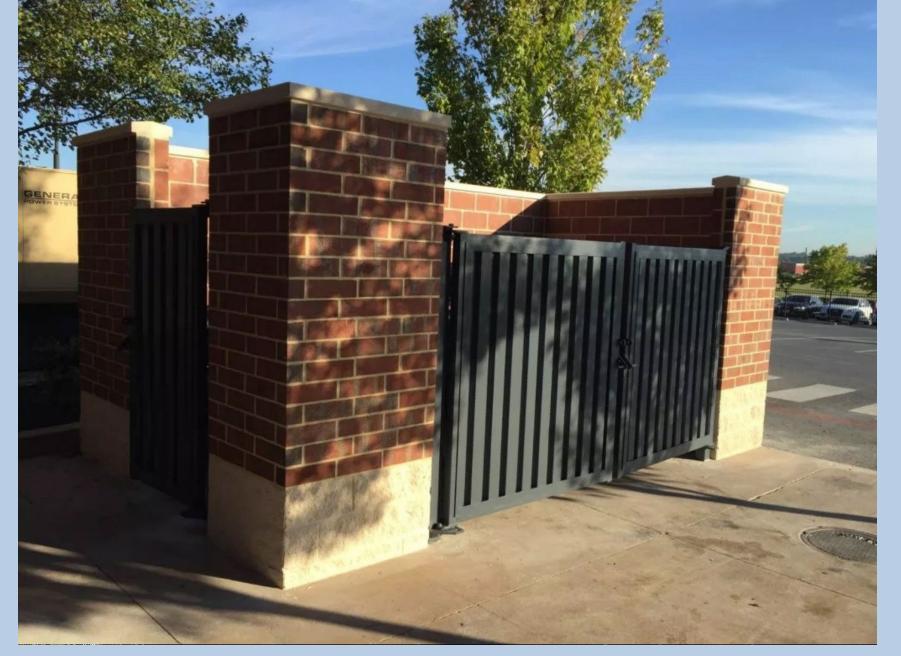
Proposed Dumpster Gate Panels- one of these two styles

• The panels in the dumpster enclosure gates will be dark metal to replace deteriorated white vinyl panels.

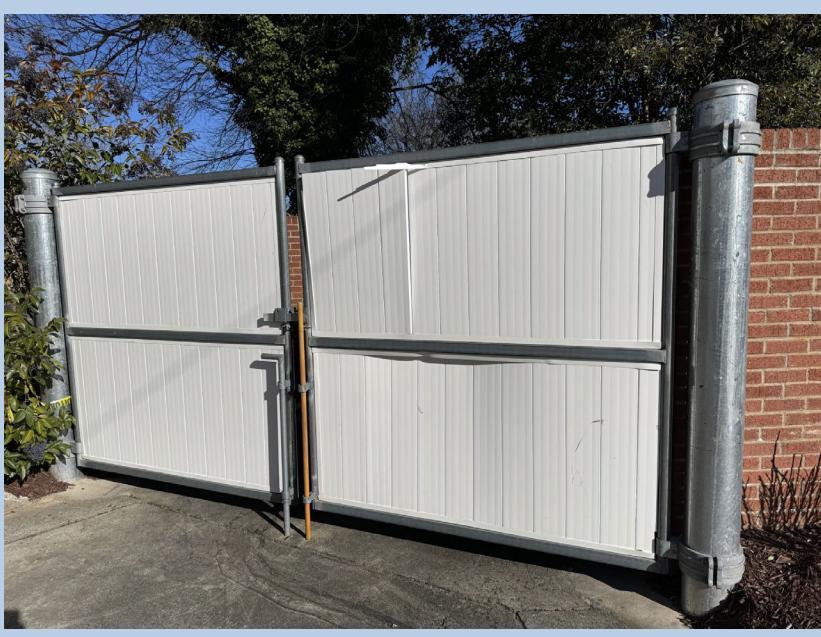
Existing Dumpster Panels

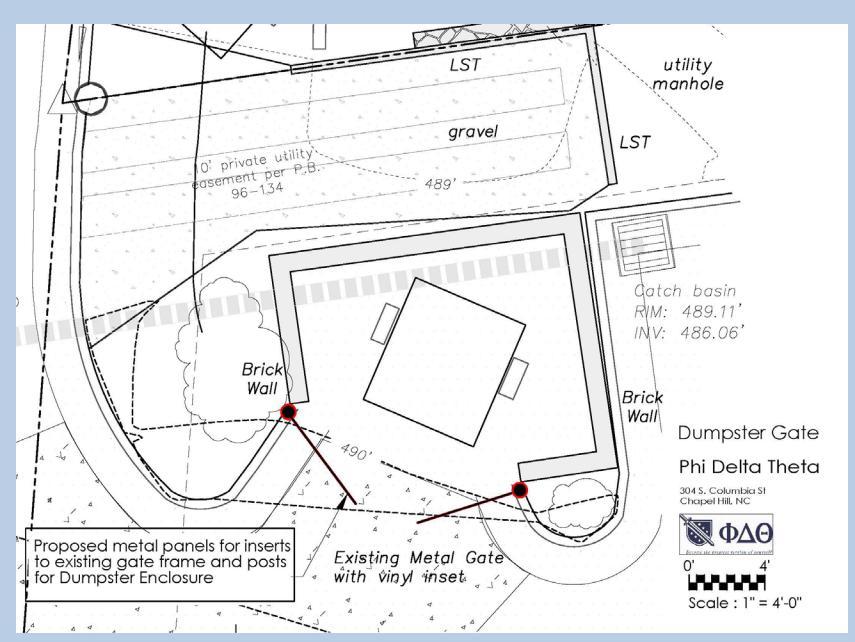
Plan View of Existing Dumpster Gates
