Phi Delta Theta Fraternity  
304 South Columbia Street

*Historic District Commission Review, March 12, 2024*

***This application concerns improvements, all at the rear of the property, to the rear entrance and dumpster gate panels, and replacement of the storage shed.***

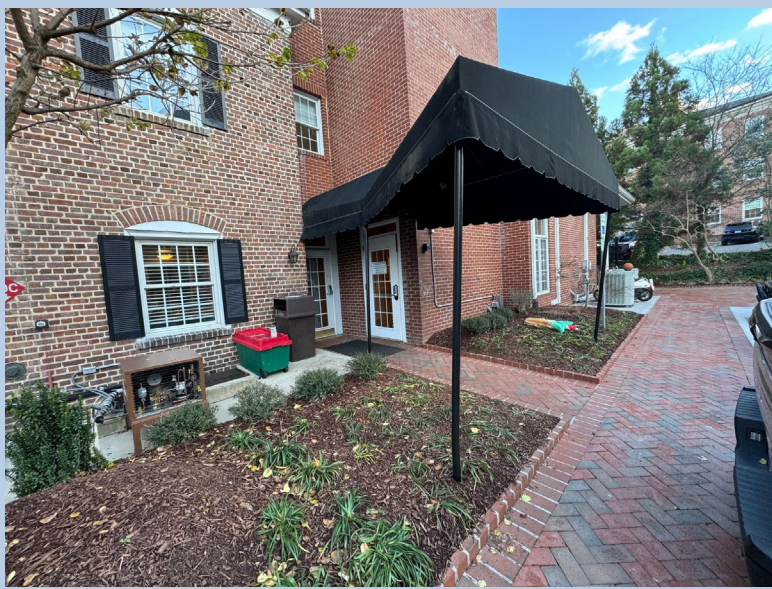
*Existing Rear Entrance Canopy*

- The portico will replace a canvas structure at the rear entrance of the building. The portico's form, configuration, and materials will be compatible with the existing building and front porch.

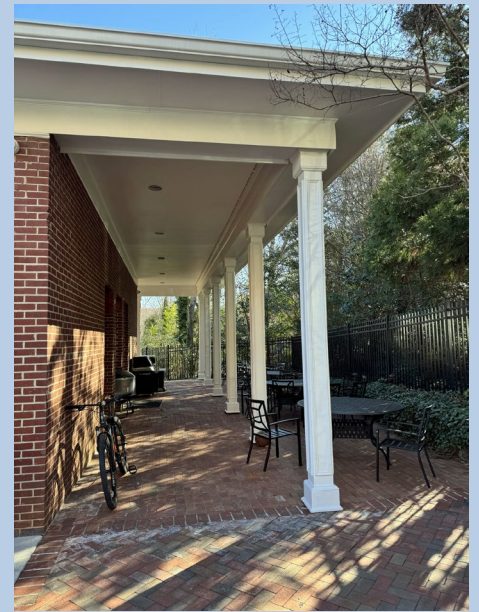
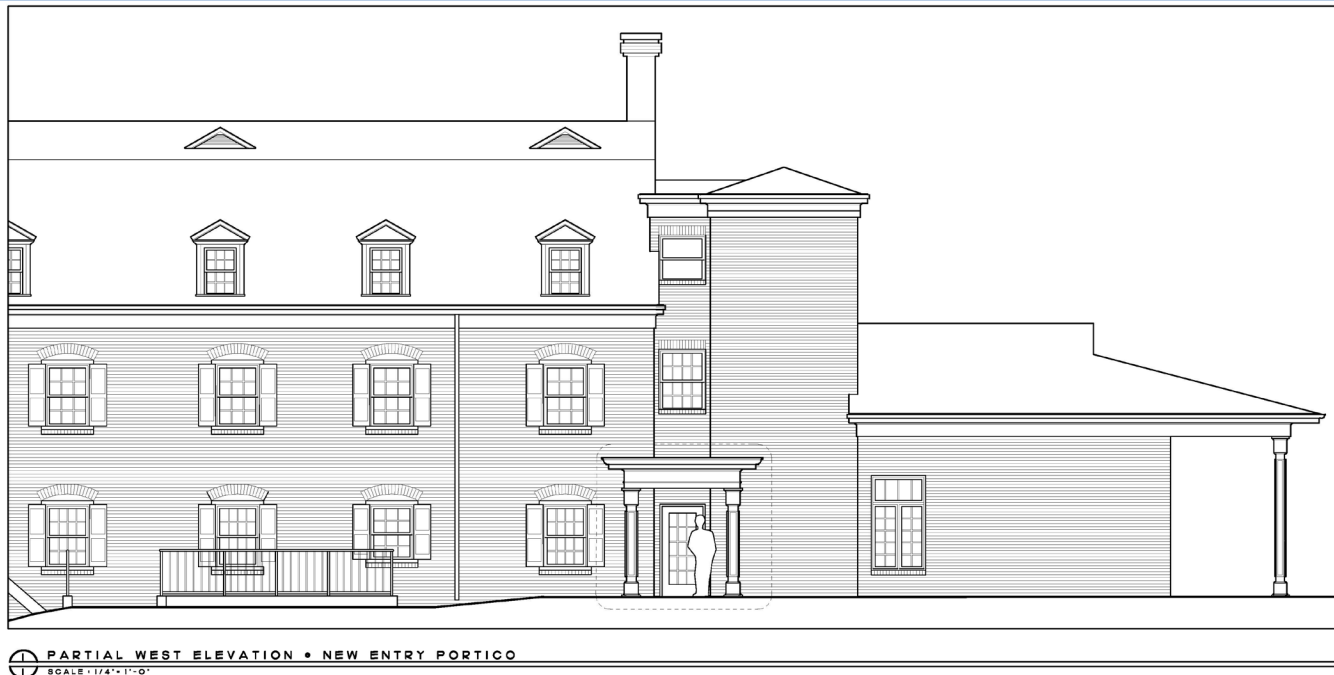
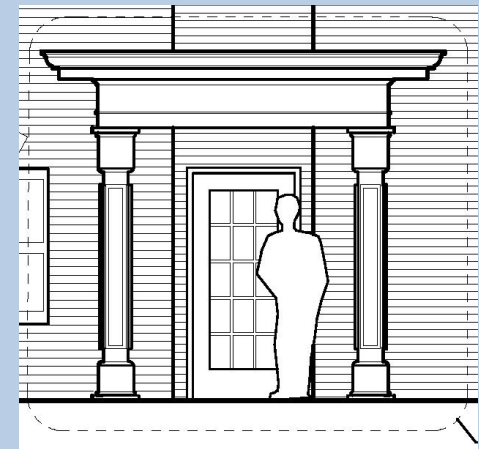
*Appearance and elements will be similar to existing side patio*

*Proposed Rear Entrance Portico*

- The rear entrance portico will use traditional materials in keeping with the existing building and the district setting.

- The portico will use traditional materials compatible with the existing building and will be in scale with the existing building. The existing brick floor will remain and will be extended on either side by 2 feet.

- The portico will provide covered space and will be constructed of compatible materials.

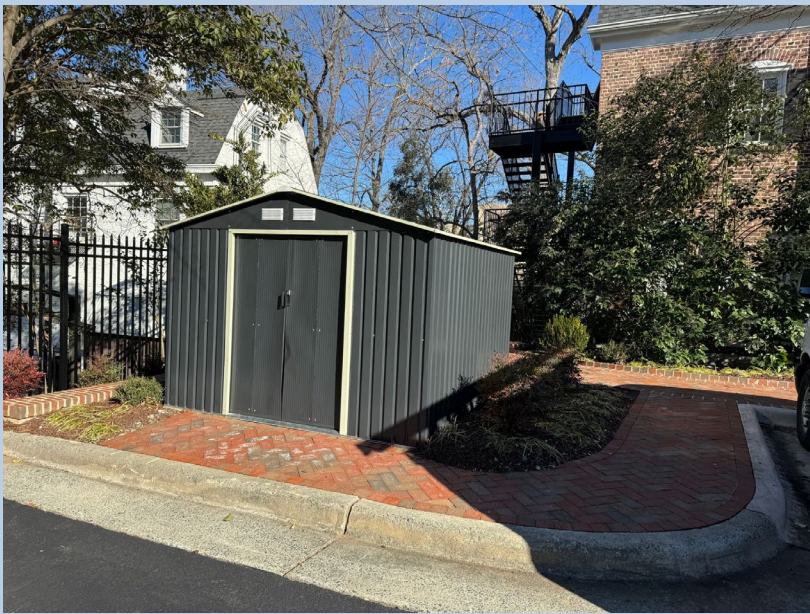
Existing Metal Shed

- The wooden shed will replace an existing metal shed in the same location the rear yard, not visible from the street.

- The wooden shed will replace a recently approved and installed metal shed in the same location. It will be approximately the same height and length and will be 2 feet wider.

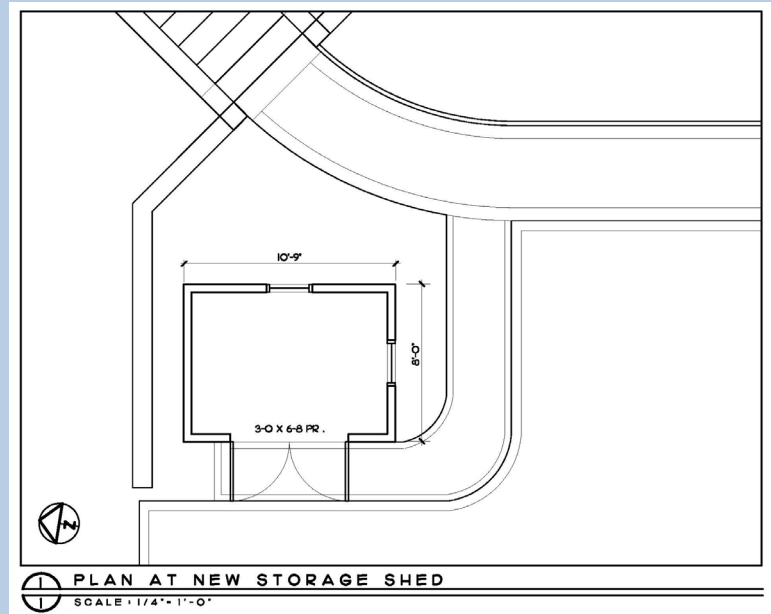
Plan of Proposed Shed

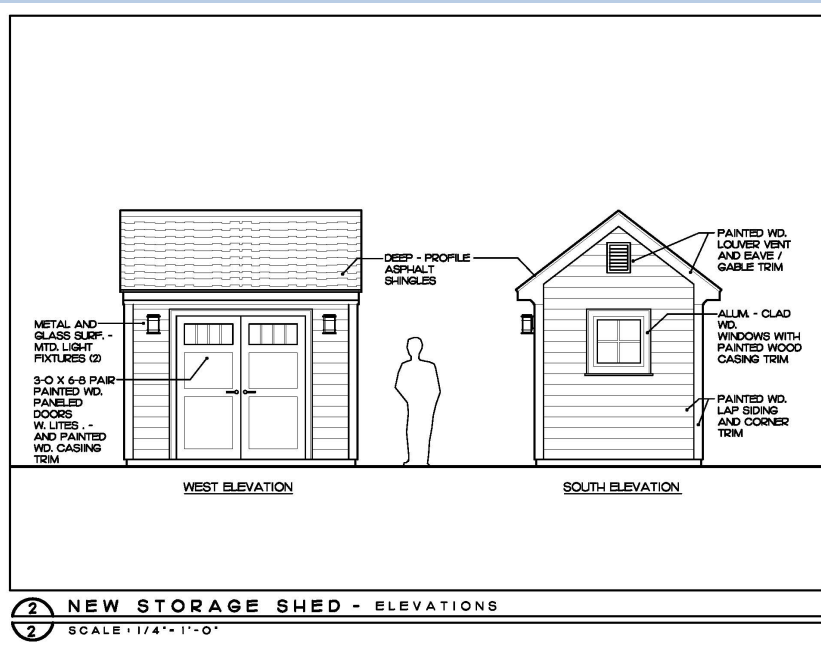
Proposed Wooden Shed

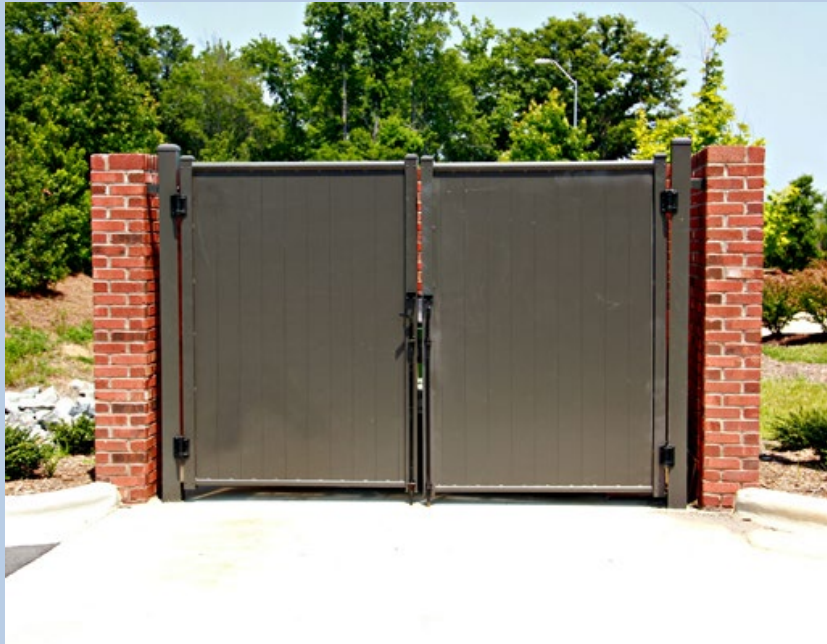
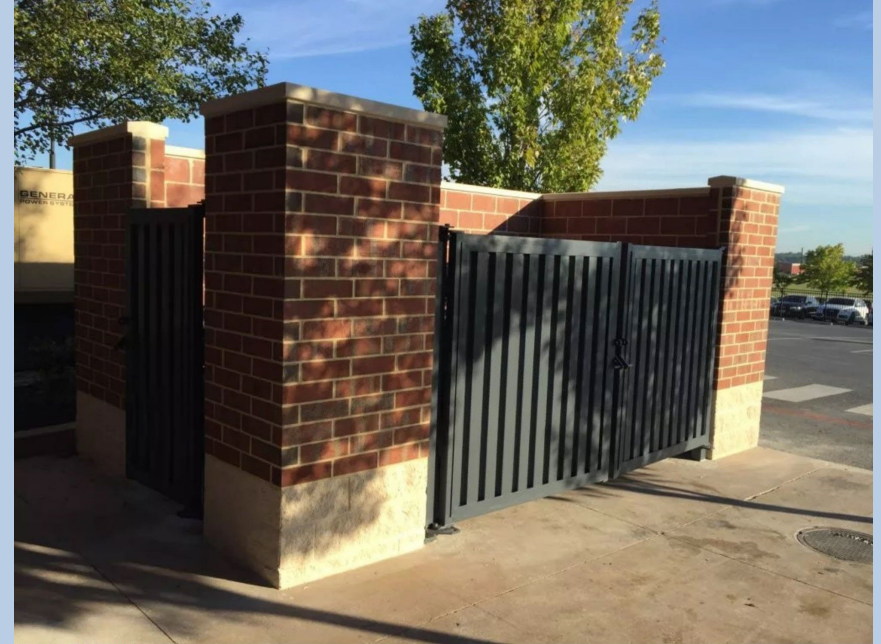
*Proposed Dumpster Gate Panels– one of these two styles*

- The panels in the dumpster enclosure gates will be dark metal to replace deteriorated white vinyl panels.

***Note:** This Standard may not be applicable in that the panels are not replacing a historic feature; rather, they would be sturdier and less obtrusive than the present panels. See “New Construction” Standard on next slide.*

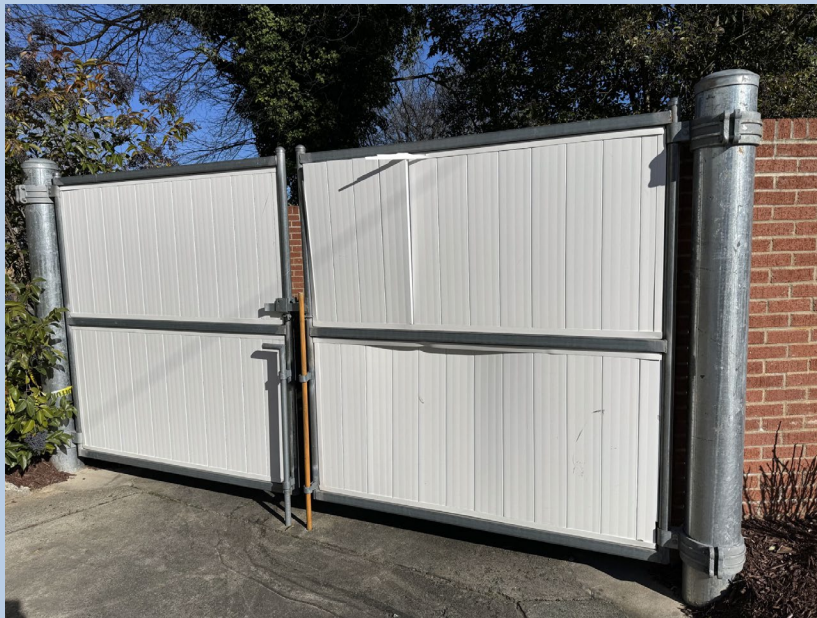
*Existing Dumpster Panels*

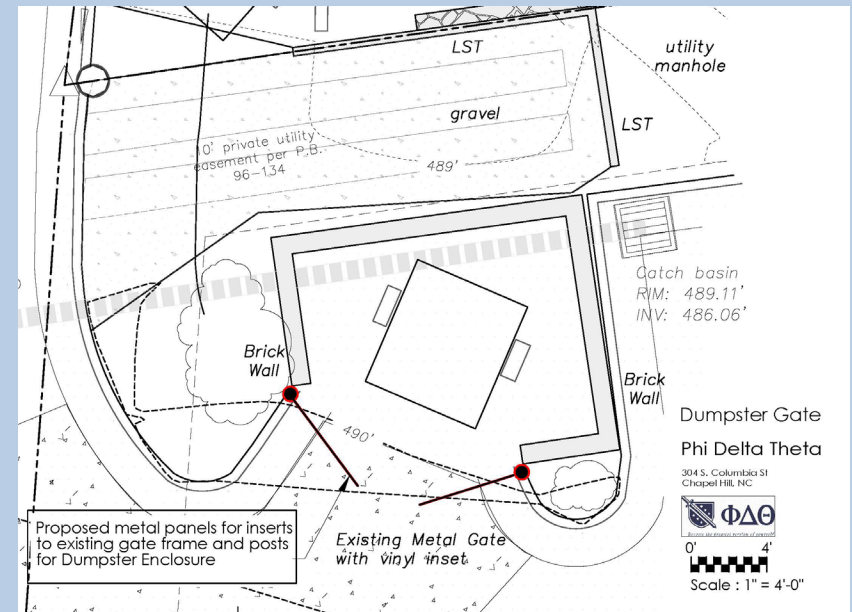
*Plan View of Existing Dumpster Gates*
