Link Rosemary Apartments Transportation Impact Analysis

COMMITTED & RECOMMENDED IMPROVEMENTS

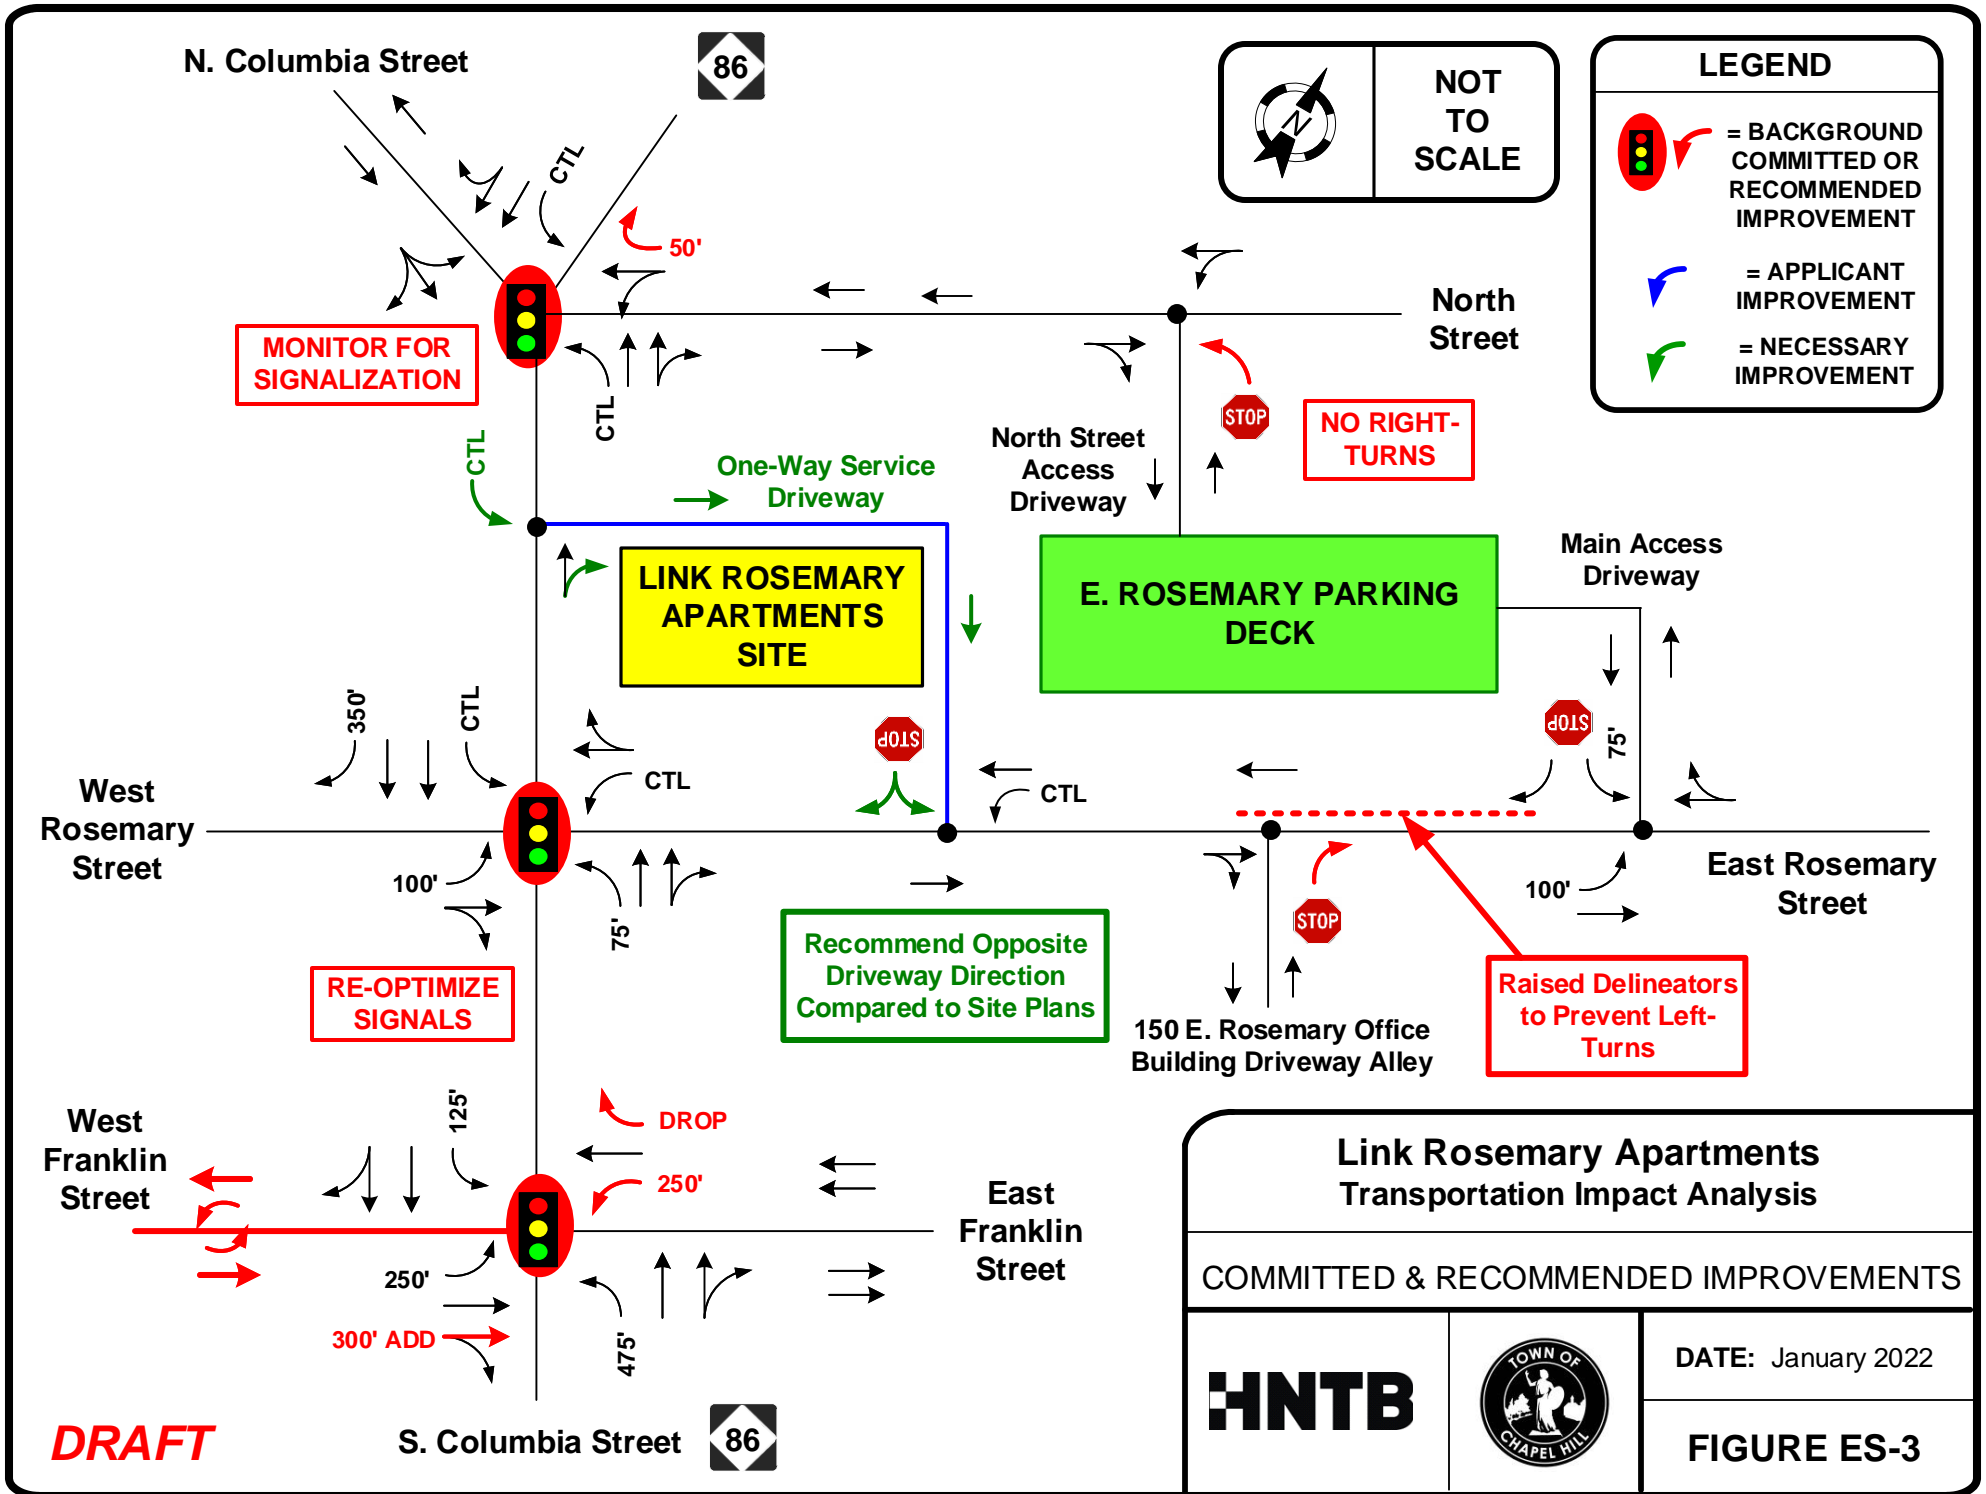
FIGURE ES-3

MONITOR FOR SIGNALIZATION

NO RIGHT-TURNS

RE-OPTIMIZE SIGNALS

Recommend Opposite Driveway Direction Compared to Site Plans

Raised Delineators to Prevent Left-Turns
