| Building 1 - West Elevation | | Building 1 - West Elevation | |

TARHEEL LODGING  
CHAPEL HILL, NC

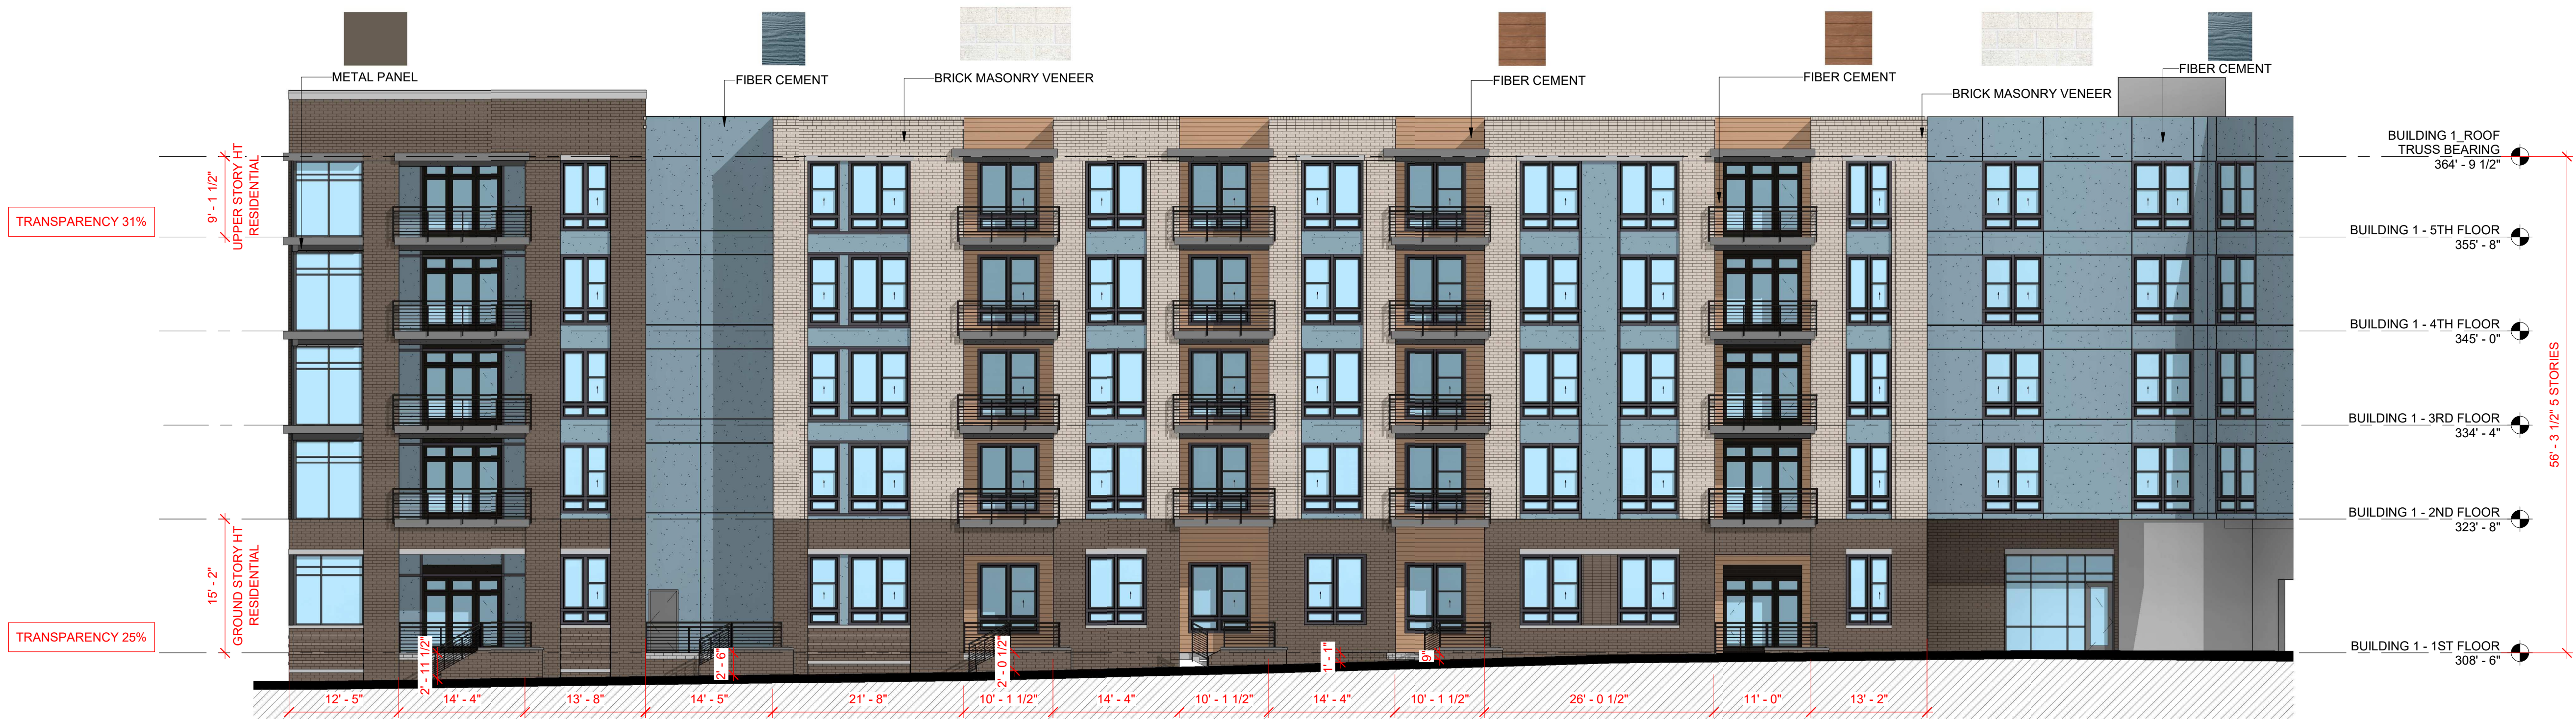
BUILDING 3 - ELEVATION - STREET A 2  
3/32" = 1'-0"

| Building 1 - West Elevation | | Building 1 - West Elevation | |
|---|---|---|---|
| Primary Materials | | Floor | Transparency |
| Brick | 56% | First Floor | 59% |
| Total | 56% | Second Floor | 46% |
| Metal Panel | 5% | Fifth Floor | 34% |
| Fiber Cement | 40% | Overall | 46% |
| Total | 44% | | |
| Primary + Accent | 100% | | |

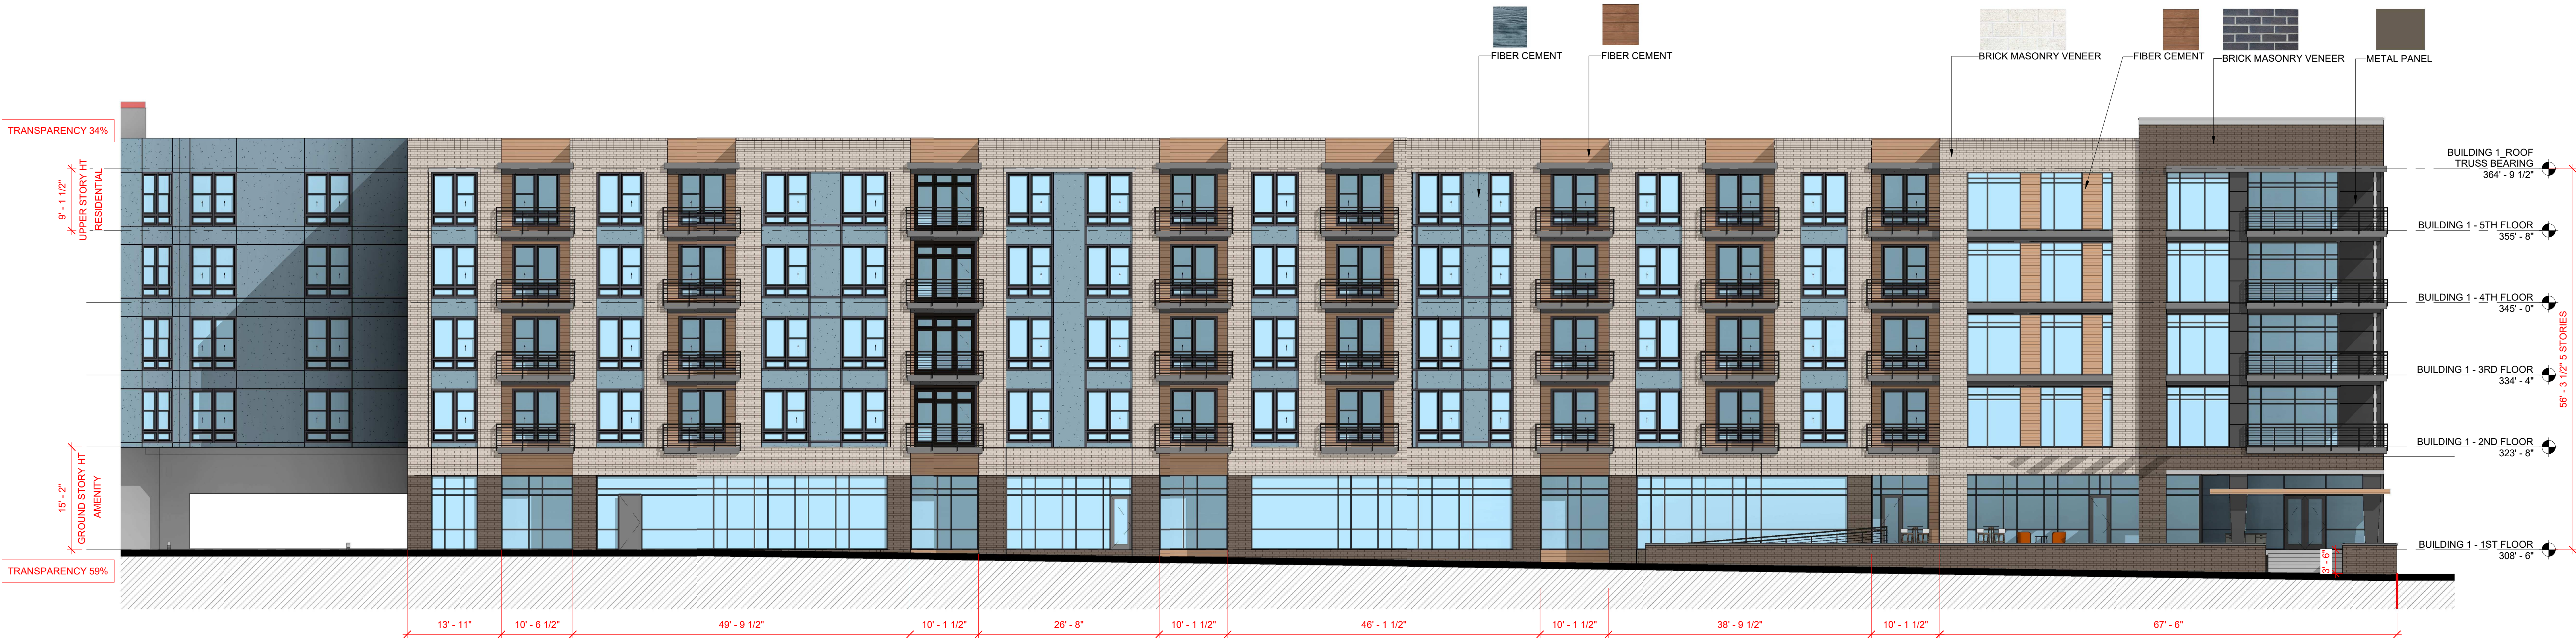
BUILDING 4 - ELEVATION - STREET A

| Building 1 - West Elevation | | Building 1 - West Elevation | |
|---|---|---|---|
| Primary Materials | | Floor | Transparency |
| Brick | 56% | First Floor | 59% |
| Total | 56% | Second Floor | 46% |
| Accent Materials | | Third Floor | 46% |
| Metal Panel | 5% | Fourth Floor | 46% |
| Fiber Cement | 40% | Fifth Floor | 34% |
| Total | 44% | Overall | 46% |

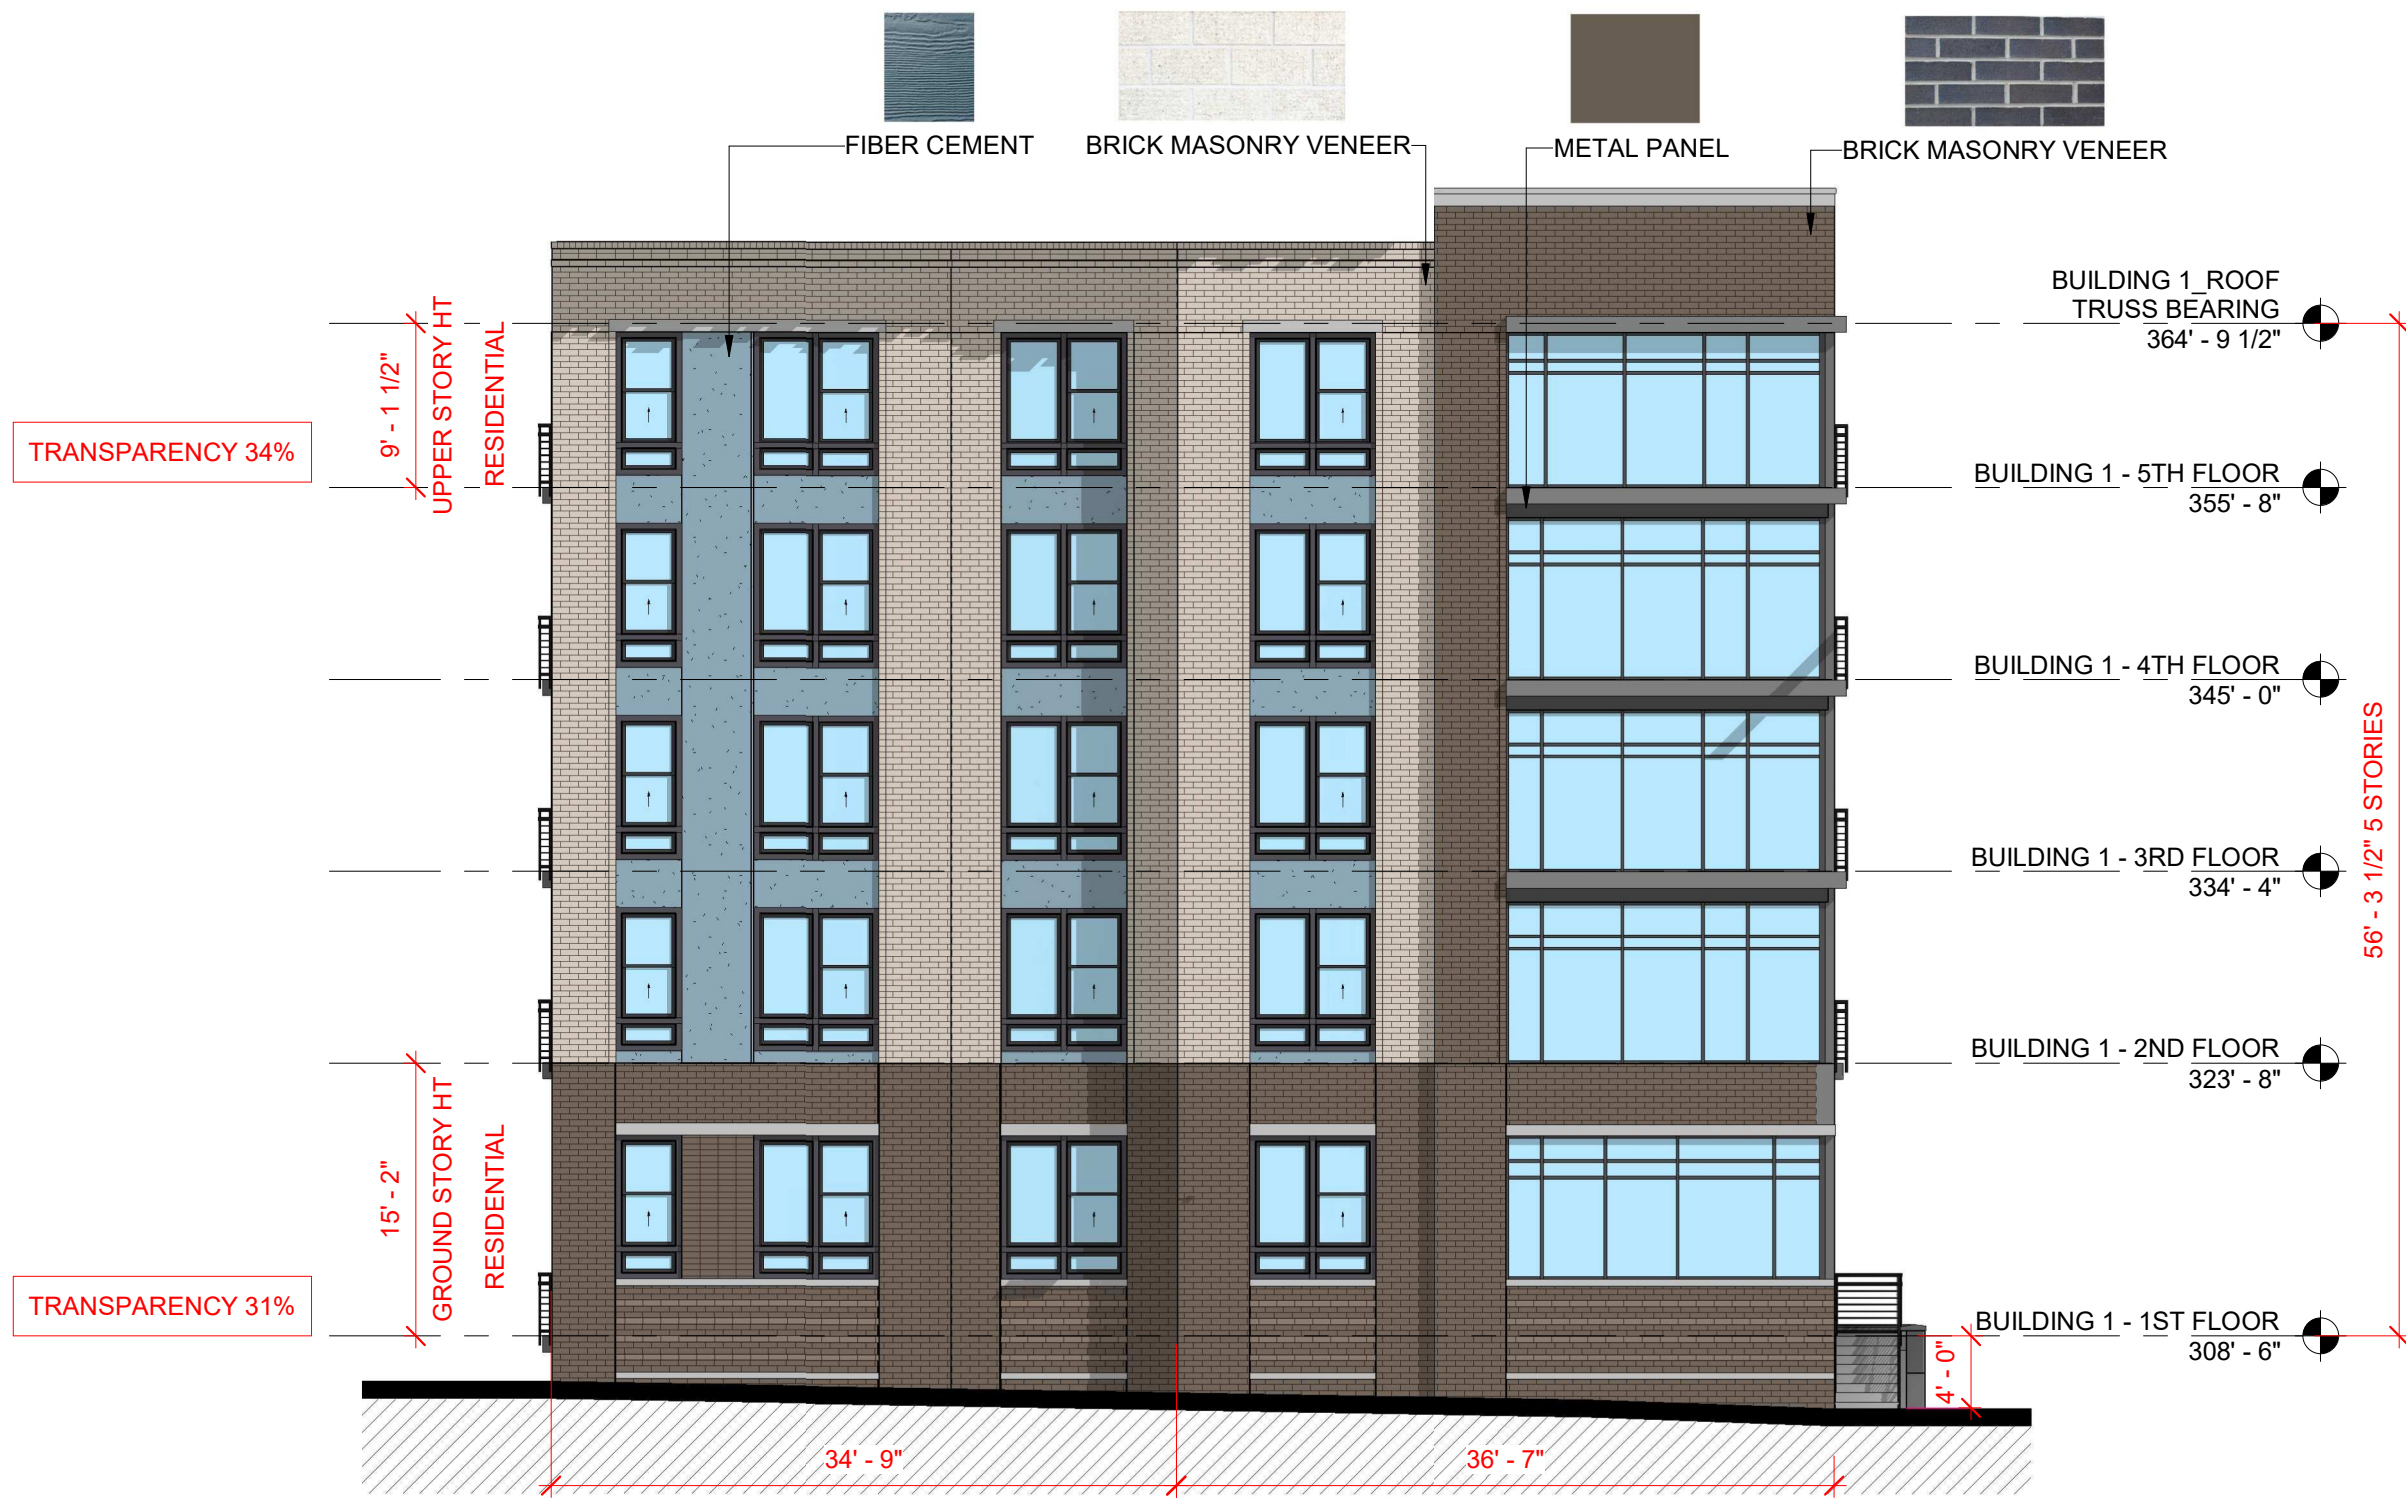
BUILDING 4 - ELEVATION - NORTHWEST 2  
3/32" = 1'-0"

| Building 1 - Northwest Elevation | | Building 1 - Northwest Elevation | |
|---|---|---|---|
| Primary Materials | | Floor | Transparency |
| Brick | 91% | First Floor | 31% |
| Total | 91% | Second Floor | 47% |
| Accent Materials | | Fourth Floor | 47% |
| Metal Panel | 2% | Fifth Floor | 34% |
| Fiber Cement | 8% | Overall | 40% |

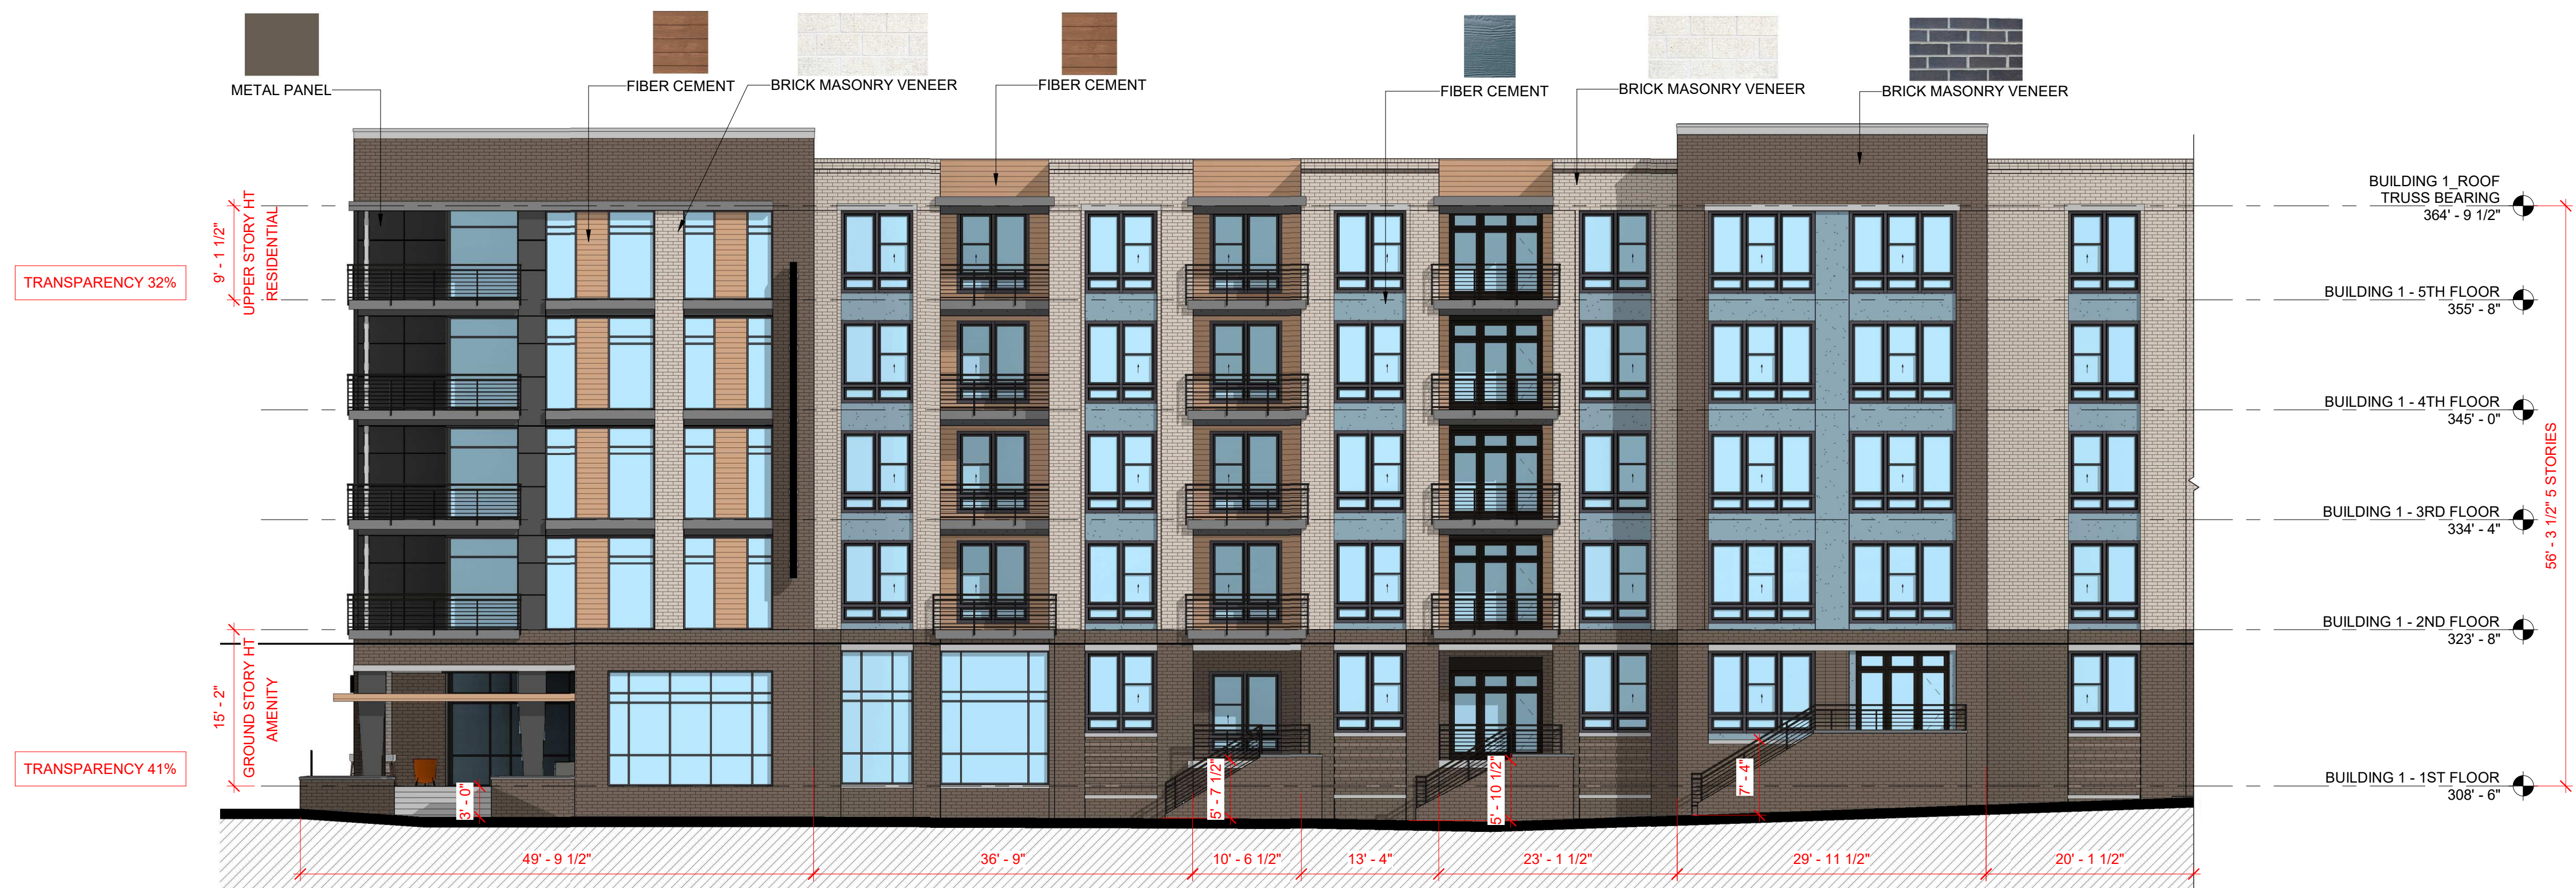
BUILDING 3 - ELEVATION - NOVUS LANE 2  
3/32" = 1'-0"

| Building 1 - South Elevation | | Building 1 - South Elevation | |
|---|---|---|---|
| Primary Materials | | Floor | Transparency |
| Brick | 73% | First Floor | 41% |
| Total | 73% | Second Floor | 46% |
| Accent Materials | | Third Floor | 46% |
| Metal Panel | 10% | Fourth Floor | 46% |
| Fiber Cement | 16% | Fifth Floor | 32% |
| Total | 27% | Overall | 42% |

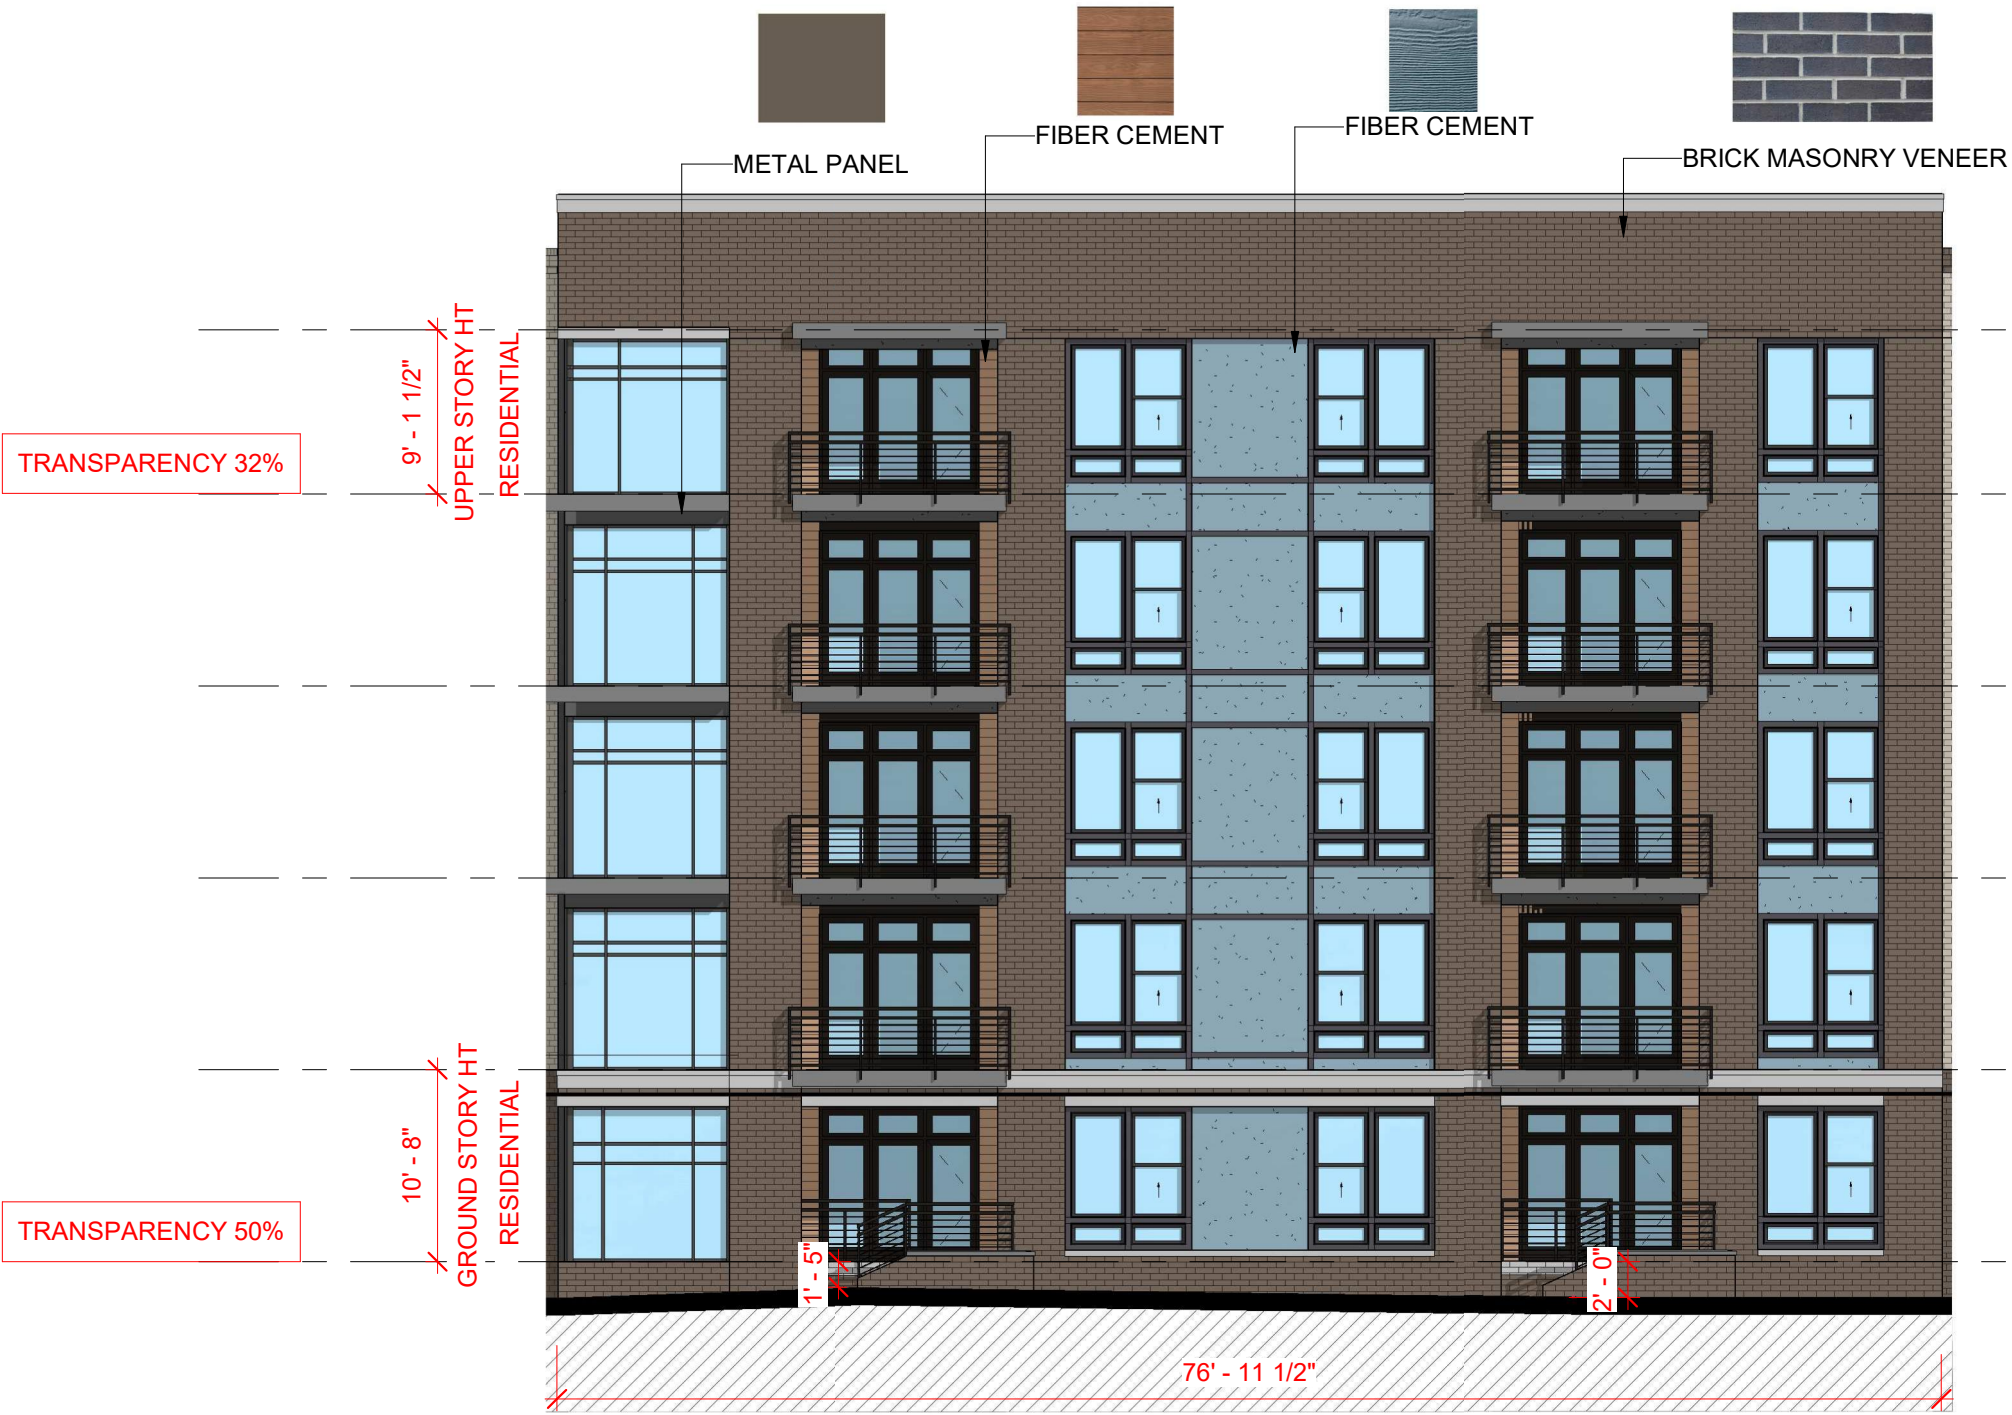
**BUILDING 3 - ELEVATION - STREET B** 4  
3/32" = 1'-0"

| Building 1 - Northeast Elevation | | Building 1 - Northeast Elevation | |
|---|---|---|---|
| Primary Materials | | Floor | Transparency |
| Brick | 67% | First Floor | 50% |
| Total | 67% | Second Floor | 51% |
| Accent Materials | | Fourth Floor | 51% |
| Metal Panel | 1% | Fifth Floor | 32% |
| Fiber Cement | 31% | Overall | 45% |

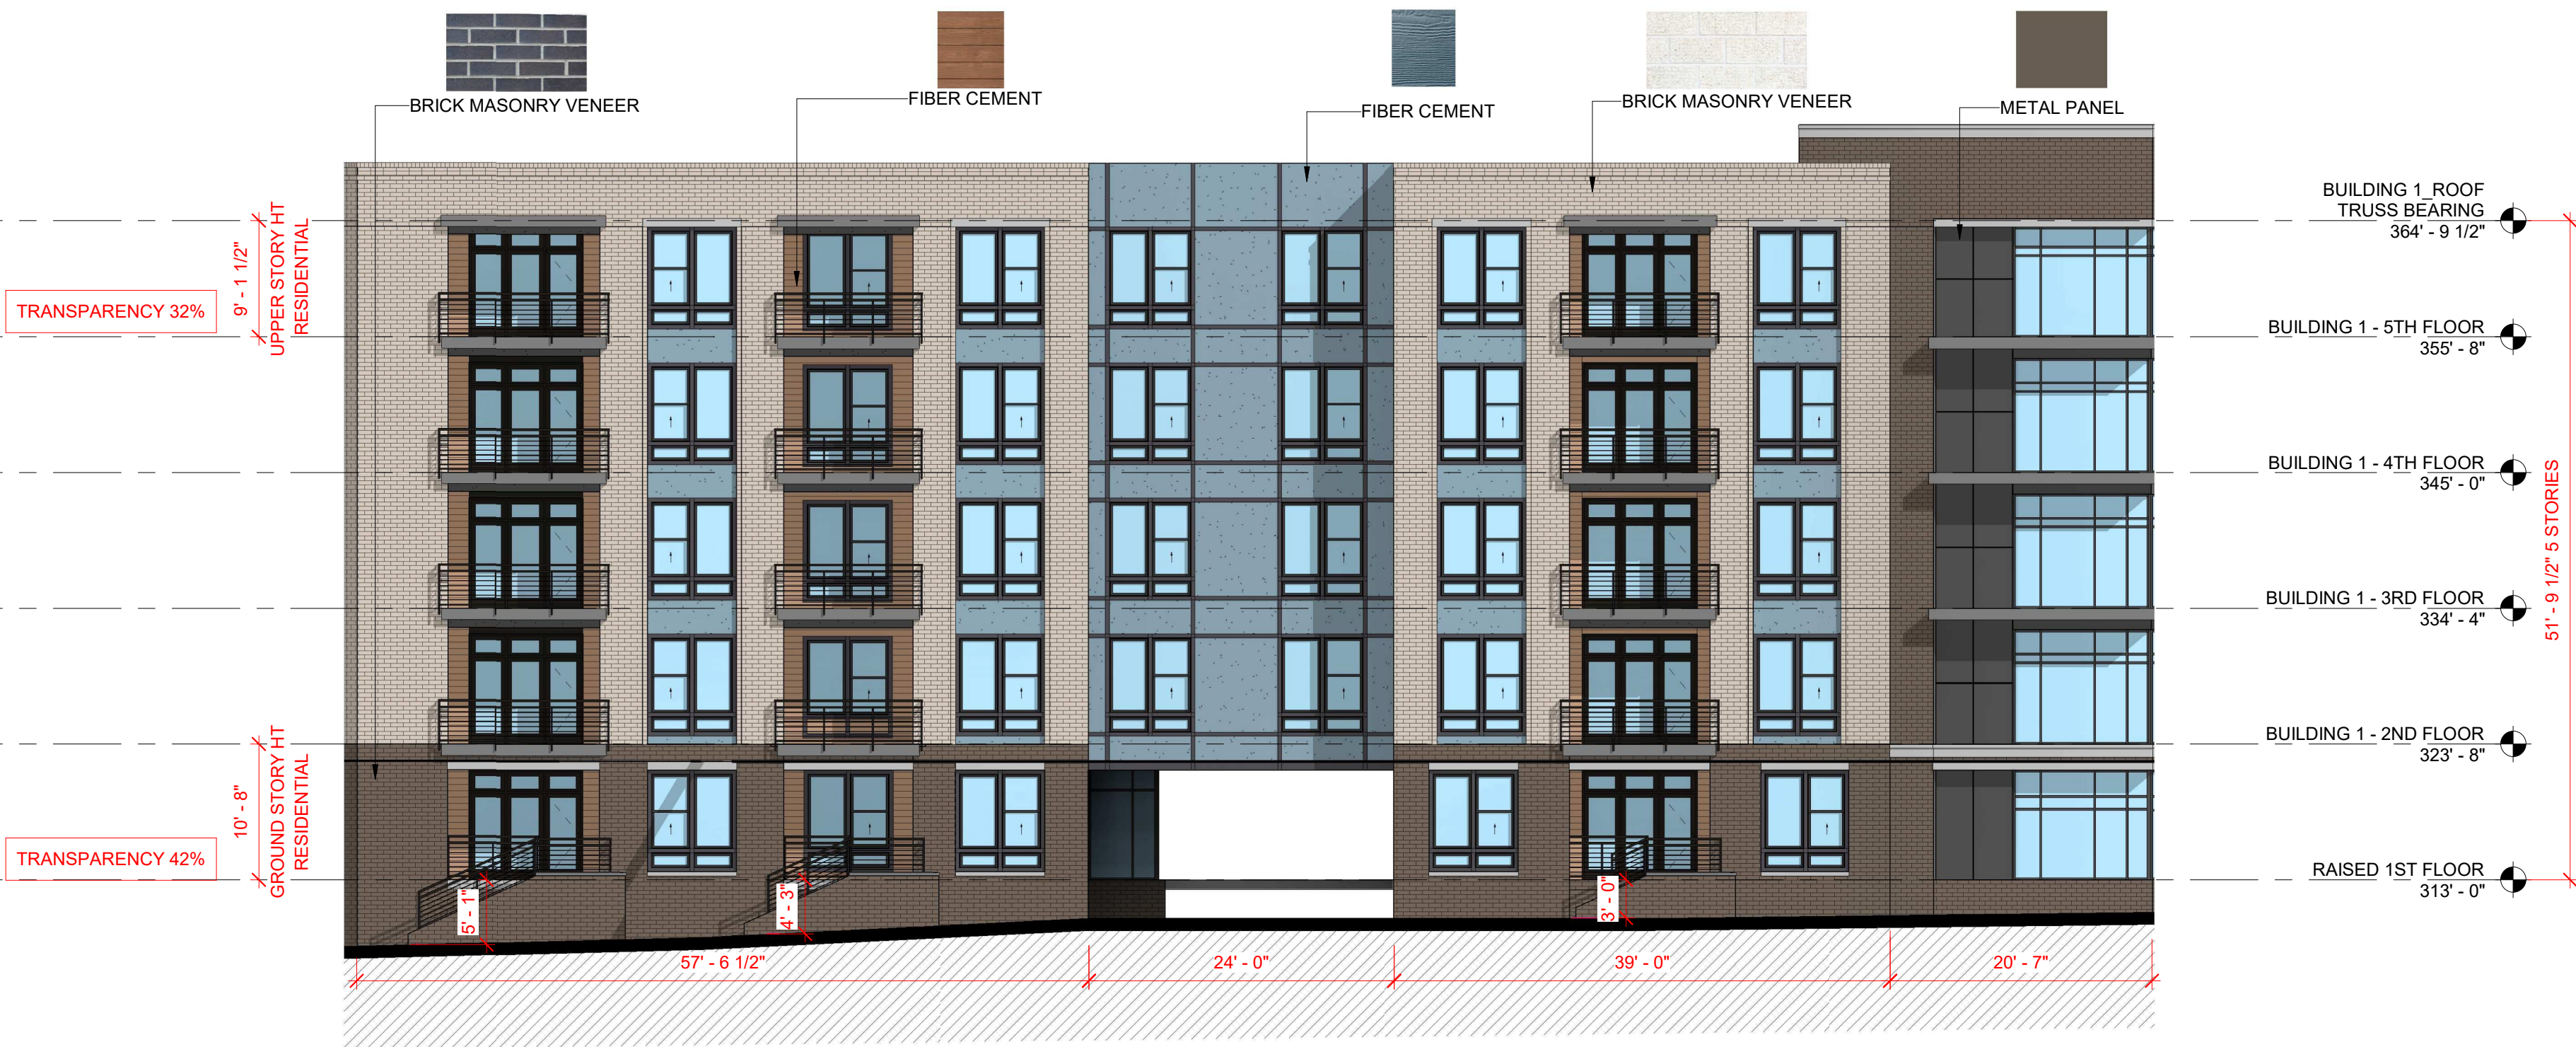
**BUILDING 3 - ELEVATION - NOVUS LANE** 2  
3/32" = 1'-0"

| Building 1 - Southeast Elevation | | Building 1 - Southeast Elevation | |
|---|---|---|---|
| Primary Materials | | Floor | Transparency |
| Brick | 62% | First Floor | 42% |
| Total | 62% | Second Floor | 43% |
| Accent Materials | | Fourth Floor | 43% |
| Metal Panel | 7% | Fifth Floor | 32% |
| Fiber Cement | 31% | Overall | 40% |

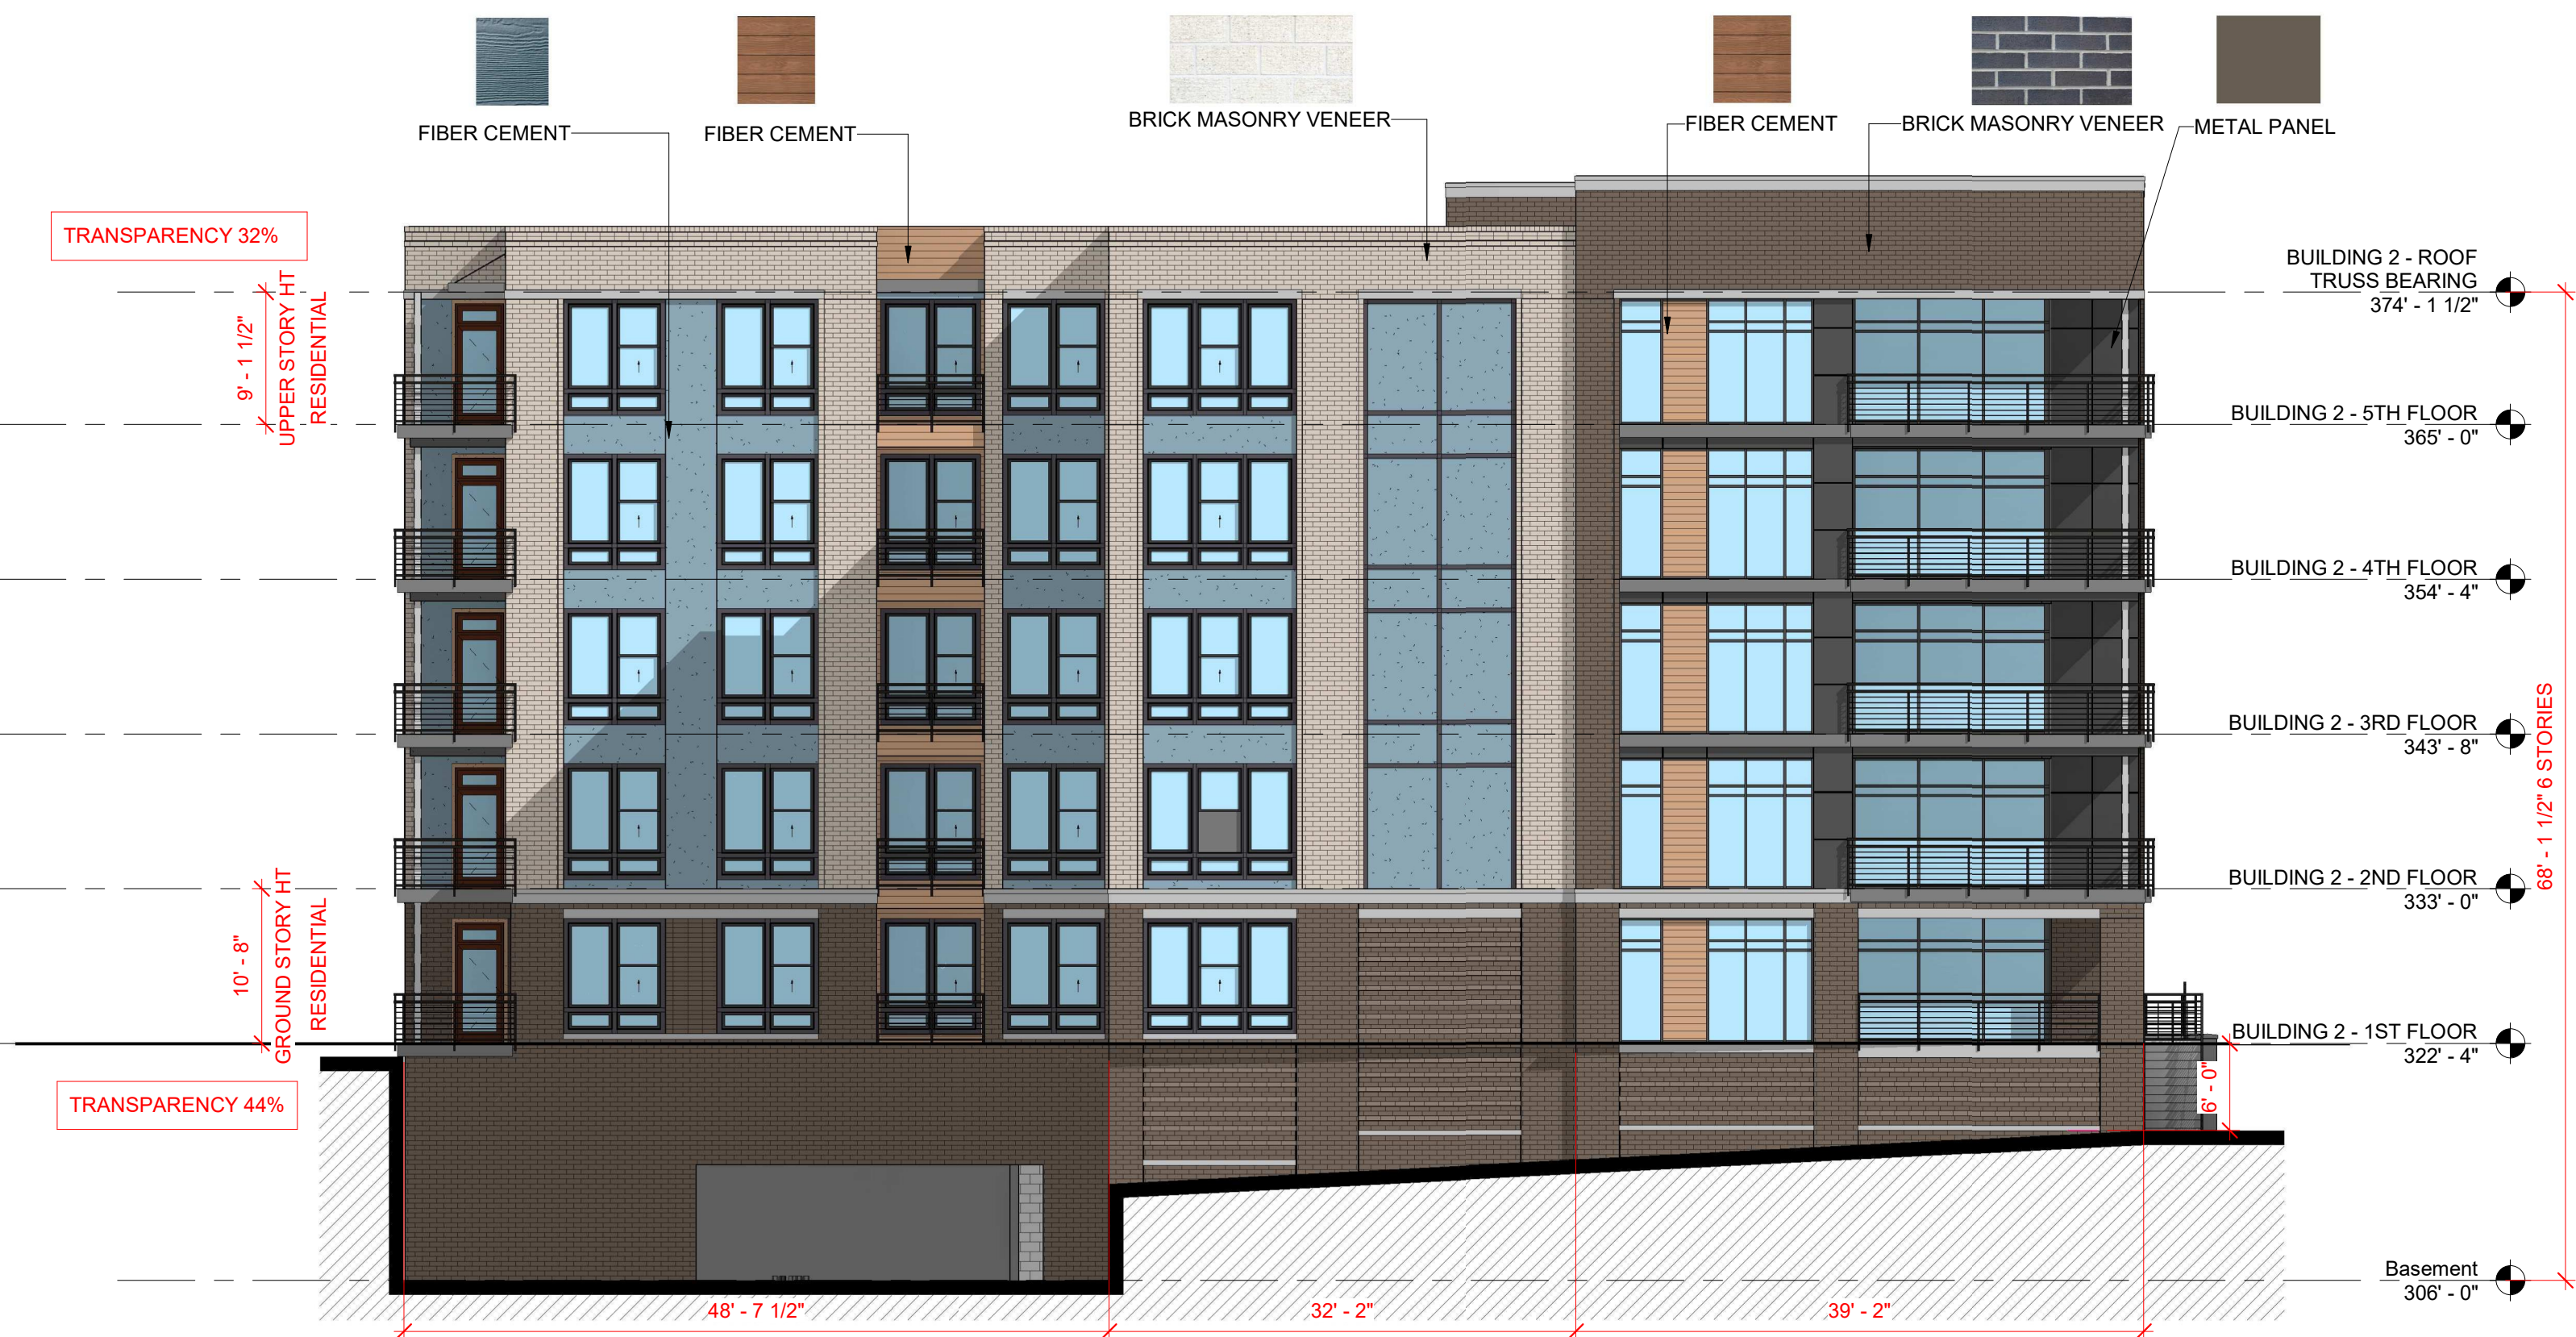
**BUILDING ELEVATION - STREET B** 4  
3/32" = 1'-0"

| Building 2 - West Elevation | | Building 2 - West Elevation | |
|---|---|---|---|
| Primary Materials | | Floor | Transparency |
| Brick | 82% | Basement | 14% |
| Total | 82% | First Floor | 44% |
| Accent Materials | | Third Floor | 45% |
| Metal Panel | 8% | Fourth Floor | 45% |
| Fiber Cement | 10% | Fifth Floor | 32% |
| Total | 18% | Overall | 37% |

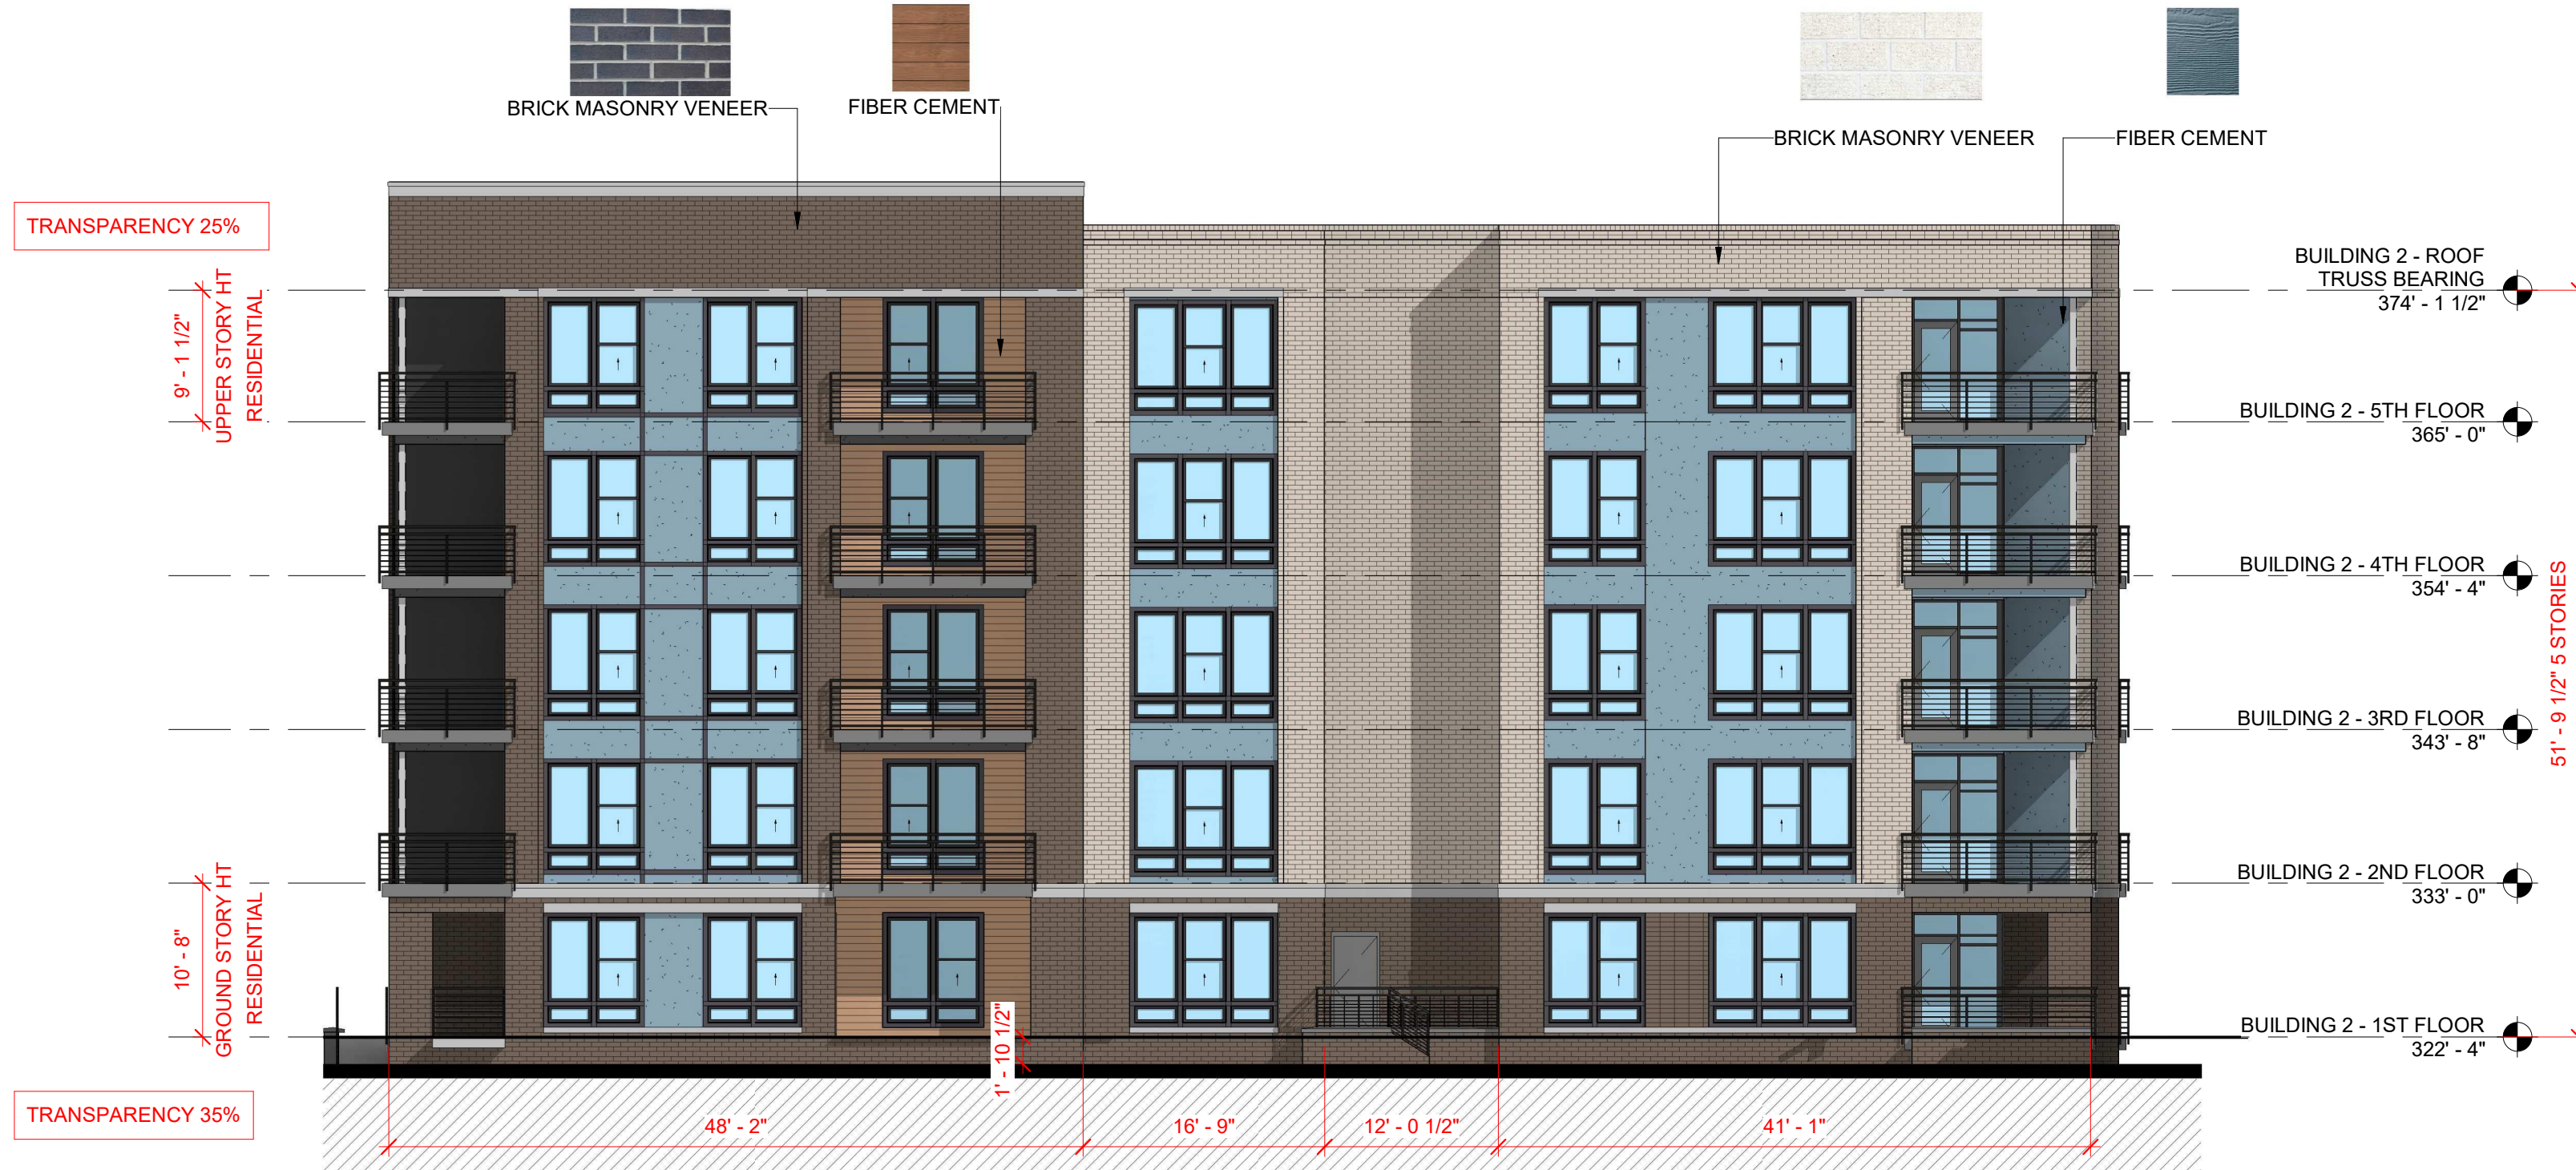
**BUILDING 5 ELEVATION - LEGION ROAD** 2  
3/32" = 1'-0"

| Building 2 - East Elevation | | Building 2 - East Elevation | |
|---|---|---|---|
| Primary Materials | | Floor | Transparency |
| Brick | 71% | First Floor | 35% |
| Total | 71% | Second Floor | 35% |
| Accent Materials | | Fourth Floor | 35% |
| Metal Panel | 0% | Fifth Floor | 25% |
| Fiber Cement | 29% | Overall | 32% |
