| Building 1 - West Elevation | | Building 1 - West Elevation | |

TARHEEL LODGING  
CHAPEL HILL, NC

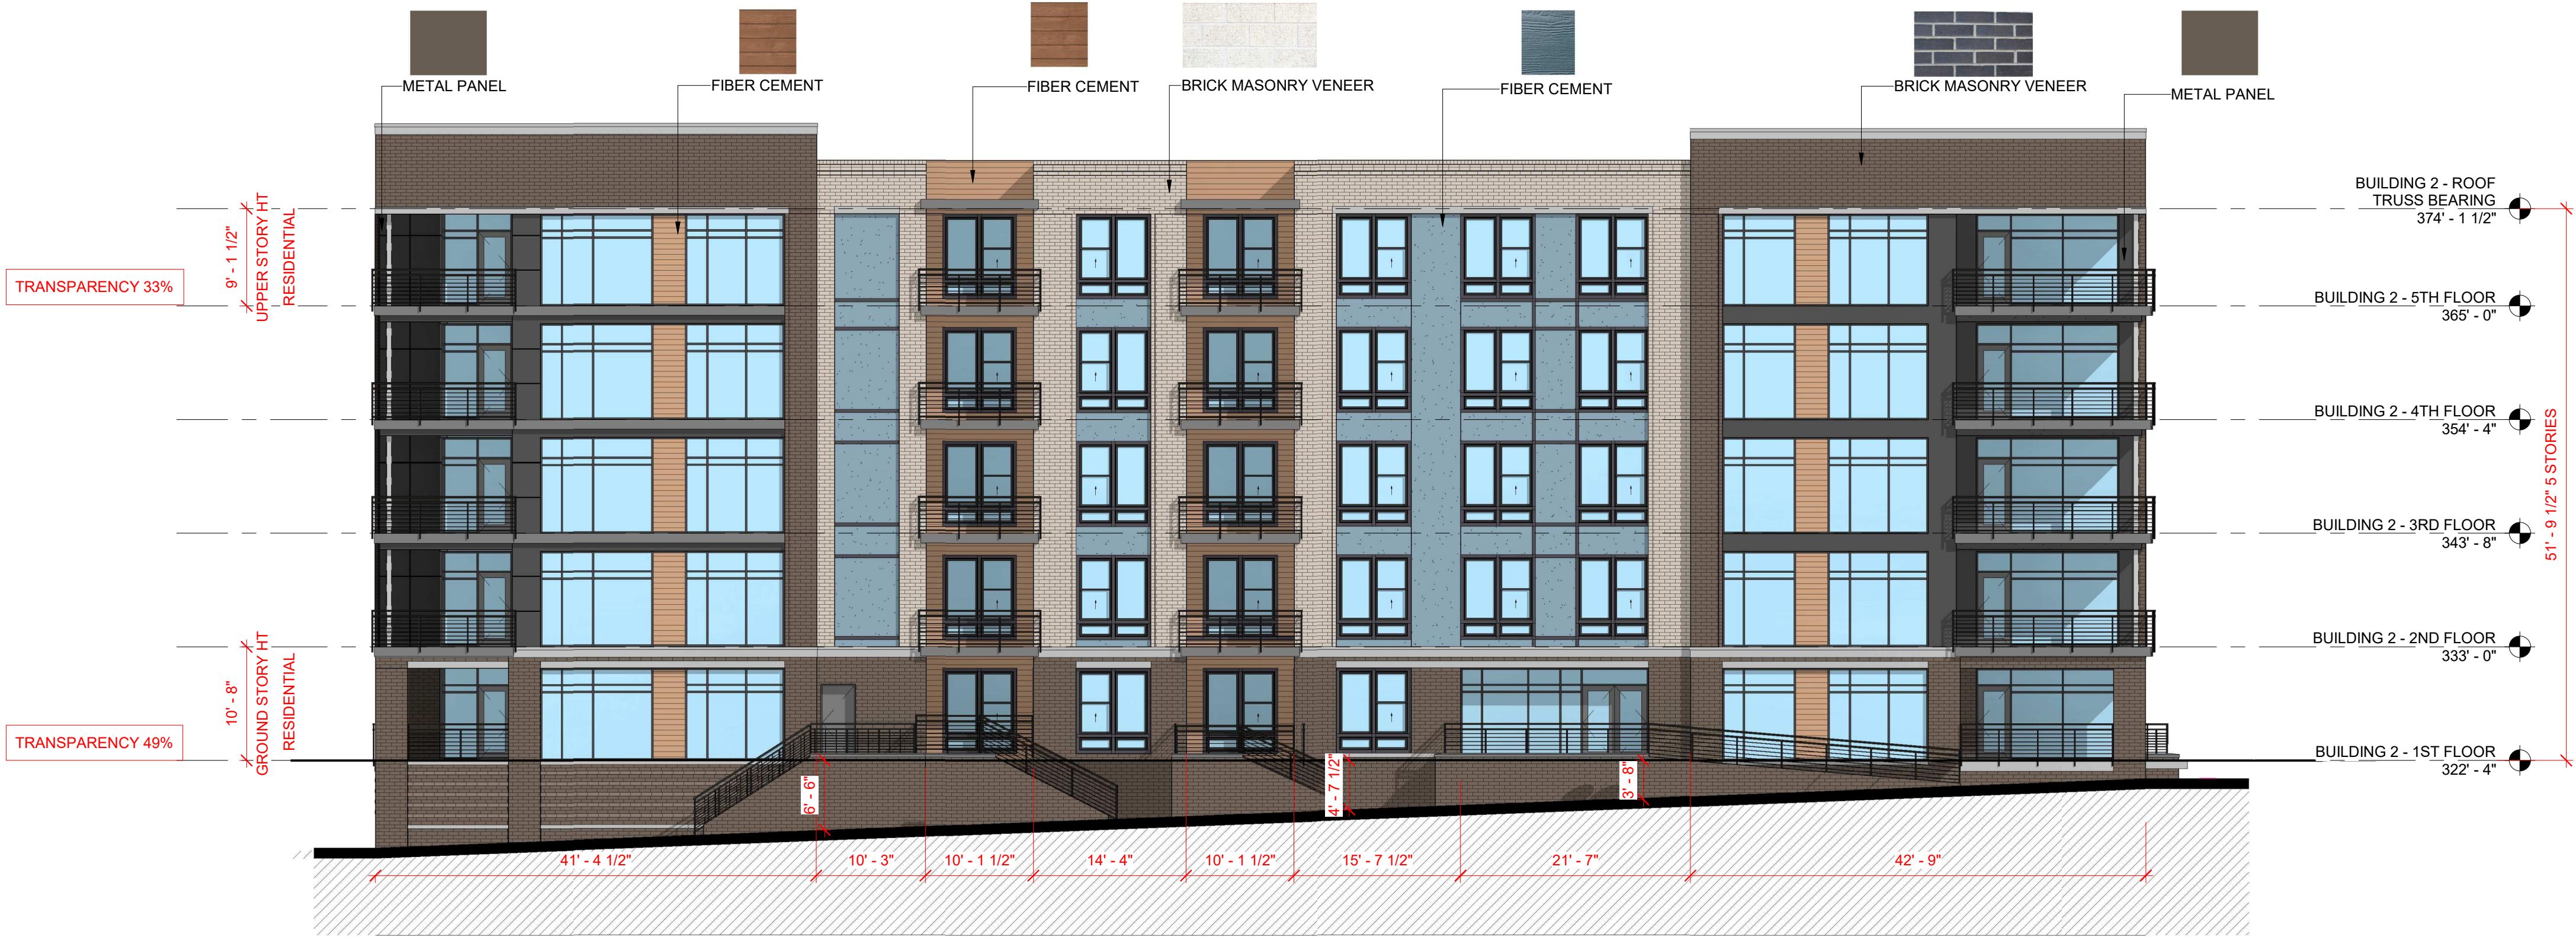
BUILDING 5 - ELEVATION - NOVUS LANE 2

| Building 2 - South Elevation | | Building 2 - South Elevation | |
|---|---|---|---|
| Primary Materials | | Floor | Transparency |
| Brick | 65% | First Floor | 49% |
| Total | 65% | Second Floor | 47% |
| Accent Materials | | Third Floor | 47% |
| Metal Panel | 7% | Fifth Floor | 33% |
| Fiber Cement | 28% | Overall | 43% |
